Manhole Inspection Report

Date:	04/25/2018	Weather:		Coding:	RZMACP
MH#:	M-507-040	Owner:	NA	Len. Surveyed:	9.0
P.O.#:		Surveyor:	John Kuglmaier	Rim to Invert:	9.9
Customer:		Cert. #:	U-1215-07002349	Wall Material:	Concrete (reinforced)

Street:	10th Pl. and Virginia St.	Project:	Hobart, IN
City:	Hobart, IN	GPS Northing:	41.52132416
Location:		GPS Easting:	-87.27087402
Drain Area:	Southwest	GPS Accuracy:	Nearest Meter
Cover Shape:	Circular	Evidence of Surcharge:	Yes
Cover Size:	22.5	Potential for Runoff:	None
Comments:

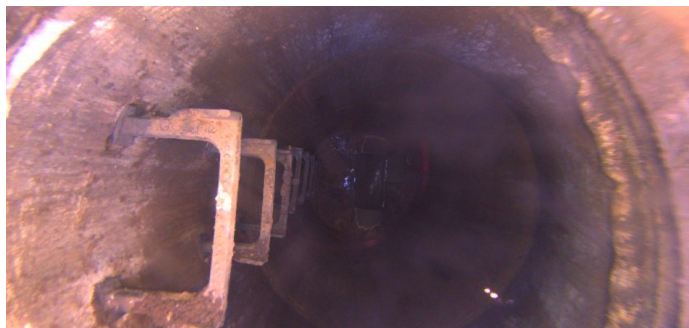
Code: **MGP**
Description: **General Photo**

Distance (ft): **.0**
Structural Grade: **0**
O&M Grade: **0**
Clock Start/From:
Clock To:
1st Value:
2nd Value:
Value Percent:
Step: **NO**
Remarks:

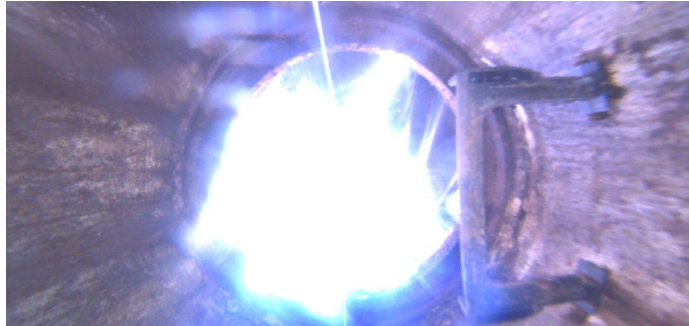
Code:	MGP
Description:	General Photo
Distance (ft):	2.6
Structural Grade:	0
O&M Grade:	0
Clock Start/From:	
Clock To:	
1st Value:	
2nd Value:	
Value Percent:	
Step:	NO
Remarks:

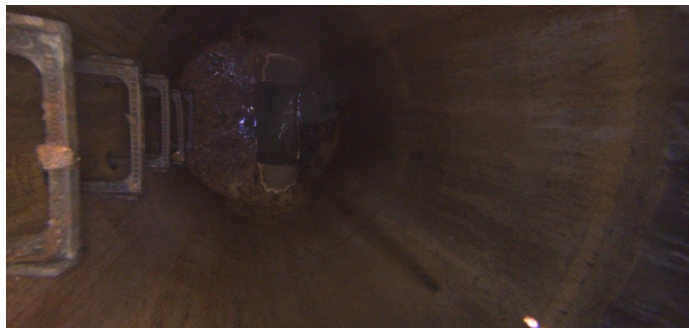
Code:	IS
Description:	Infil Stain
Distance (ft):	2.9
Structural Grade:	0
O&M Grade:	0
Clock Start/From:	5
Clock To:	
1st Value:	
2nd Value:	
Value Percent:	
Step:	NO
Remarks:

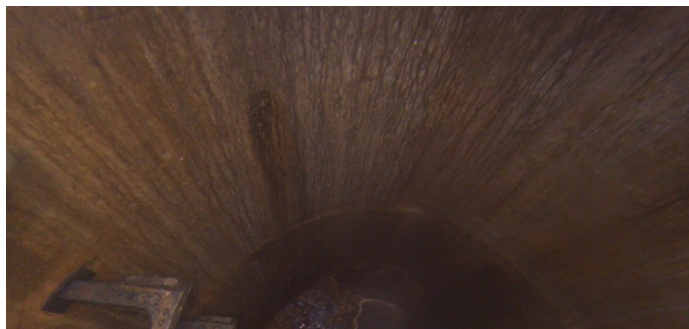
Code:	IS
Description:	Infil Stain
Distance (ft):	4.1
Structural Grade:	0
O&M Grade:	0
Clock Start/From:	11
Clock To:	
1st Value:	
2nd Value:	
Value Percent:	
Step:	NO
Remarks:

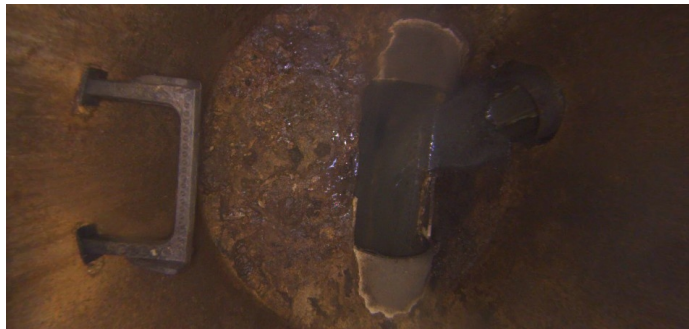
Code:	DAZ
Description:	Deposits Attached Other
Distance (ft):	6.9
Structural Grade:	0
O&M Grade:	2
Clock Start/From:	12
Clock To:	12
1st Value:	
2nd Value:	
Value Percent:	10.000
Step:	NO
Remarks:	Mixed materials

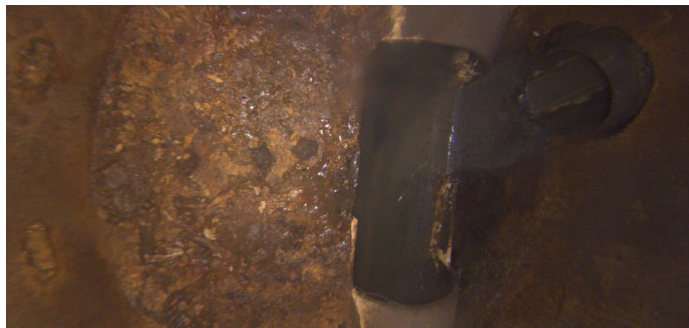
Code:	MGO
Description:	General Observation
Distance (ft):	7.9
Structural Grade:	0
O&M Grade:	0
Clock Start/From:	
Clock To:	
1st Value:	
2nd Value:	
Value Percent:	
Step:	NO
Remarks:	Ins. Comp.
