# Manhole Inspection Report

Date:	<b>04/25/2018</b>	Weather:		Coding:	<b>RZMACP</b>
MH#:	<b>M-507-040</b>	Owner:	<b>NA</b>	Len. Surveyed:	<b>9.5</b>
P.O.#:		Surveyor:	<b>John Kuglmaier</b>	Rim to Invert:	<b>9.9</b>
Customer:		Cert. #:	<b>U-1215-07002349</b>	Wall Material:	<b>Concrete (reinforced)</b>

Street:	<b>10th Pl. and Virginia St.</b>	Project:	<b>Hobart, IN</b>
City:	<b>Hobart, IN</b>	GPS Northing:	<b>41.52202606</b>
Location:		GPS Easting:	<b>-87.26920319</b>
Drain Area:	<b>Southwest</b>	GPS Accuracy:	<b>Nearest Meter</b>
Cover Shape:	<b>Circular</b>	Evidence of Surcharge:	<b>Yes</b>
Cover Size:	<b>22.5</b>	Potential for Runoff:	<b>None</b>
Comments:

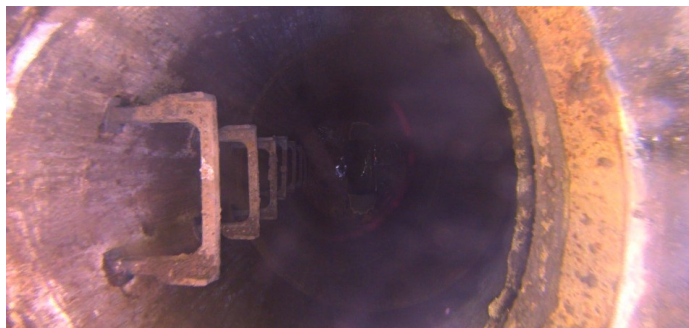
Code: **MGP**  
Description: **General Photo**

Distance (ft): **.0**  
Structural Grade: **0**  
O&M Grade: **0**  
Clock Start/From:  
Clock To:  
1st Value:  
2nd Value:  
Value Percent:  
Step: **NO**  
Remarks:

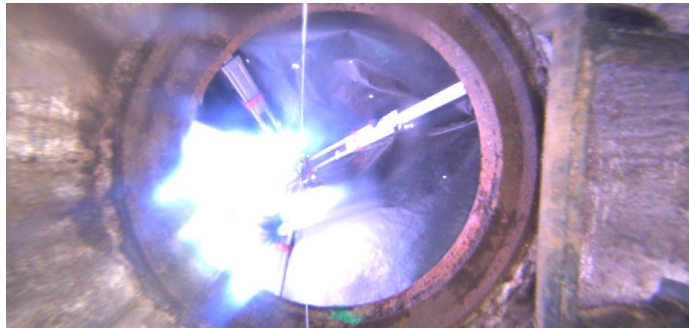
Code: **MGP**  
Description: **General Photo**

Distance (ft): **2.3**  
Structural Grade: **0**  
O&M Grade: **0**  
Clock Start/From:  
Clock To:  
1st Value:  
2nd Value:  
Value Percent:  
Step: **NO**  
Remarks:

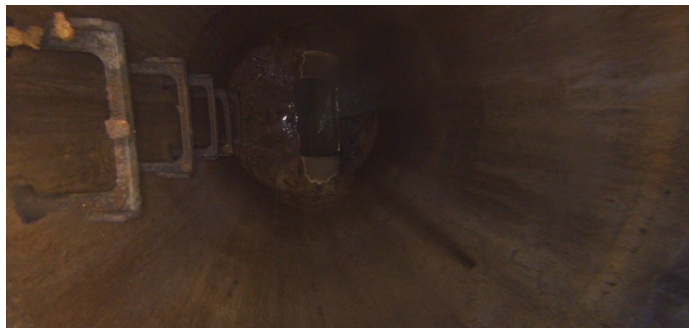
Code: **IS**  
Description: **Infil Stain**

Distance (ft): **2.8**  
Structural Grade: **0**  
O&M Grade: **0**  
Clock Start/From: **5**  
Clock To:  
1st Value:  
2nd Value:  
Value Percent:  
Step: **NO**  
Remarks:

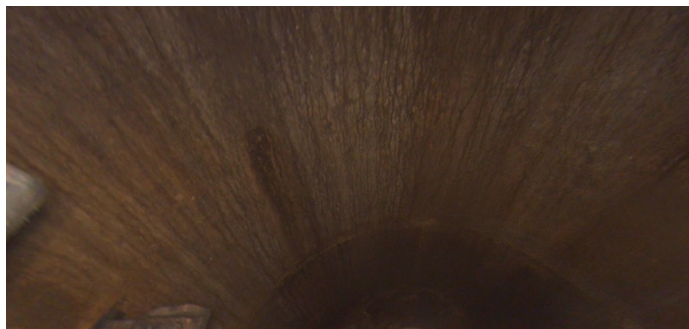
Code: **IS**  
Description: **Infil Stain**

Distance (ft): **4.2**  
Structural Grade: **0**  
O&M Grade: **0**  
Clock Start/From: **11**  
Clock To:  
1st Value:  
2nd Value:  
Value Percent:  
Step: **NO**  
Remarks:

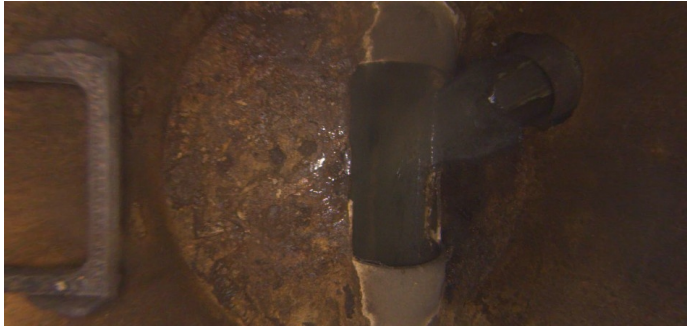
Code:	<b>DAZ</b>
Description:	<b>Deposits Attached Other</b>
Distance (ft):	<b>7.4</b>
Structural Grade:	<b>0</b>
O&M Grade:	<b>2</b>
Clock Start/From:	<b>12</b>
Clock To:	<b>12</b>
1st Value:	
2nd Value:	
Value Percent:	<b>10.000</b>
Step:	<b>NO</b>
Remarks:	<b>Mixed materials</b>

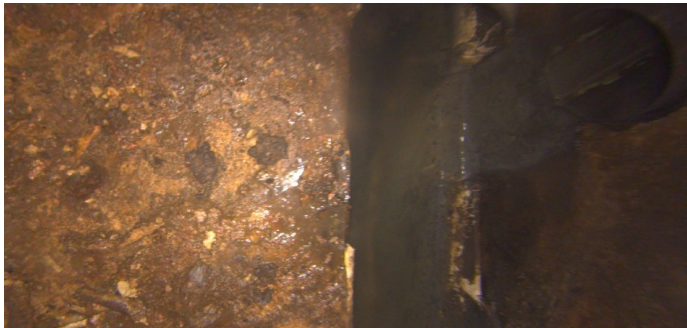
Code:	<b>MGO</b>
Description:	<b>General Observation</b>
Distance (ft):	<b>8.6</b>
Structural Grade:	<b>0</b>
O&M Grade:	<b>0</b>
Clock Start/From:	
Clock To:	
1st Value:	
2nd Value:	
Value Percent:	
Step:	<b>NO</b>
Remarks:	<b>Ins. Comp.</b>
