# Manhole Inspection Report

Date:	<b>04/25/2018</b>	Weather:		Coding:	<b>RZMACP</b>
MH#:	<b>M-507-054</b>	Owner:	<b>NA</b>	Len. Surveyed:	<b>7.2</b>
P.O.#:		Surveyor:	<b>John Kuglmaier</b>	Rim to Invert:	<b>8.0</b>
Customer:		Cert. #:	<b>U-1215-07002349</b>	Wall Material:	<b>Concrete (reinforced)</b>

Street:	<b>Virginia St. and 11th St. to the South</b>	Project:	<b>Hobart, IN</b>
City:	<b>Hobart, IN</b>	GPS Northing:	<b>2901426.356</b>
Location:		GPS Easting:	<b>2901426.356</b>
Drain Area:	<b>Southwest</b>	GPS Accuracy:	<b>Sub-Meter</b>
Cover Shape:	<b>Circular</b>	Evidence of Surcharge:	<b>No</b>
Cover Size:	<b>22.5</b>	Potential for Runoff:	<b>None</b>
Comments:

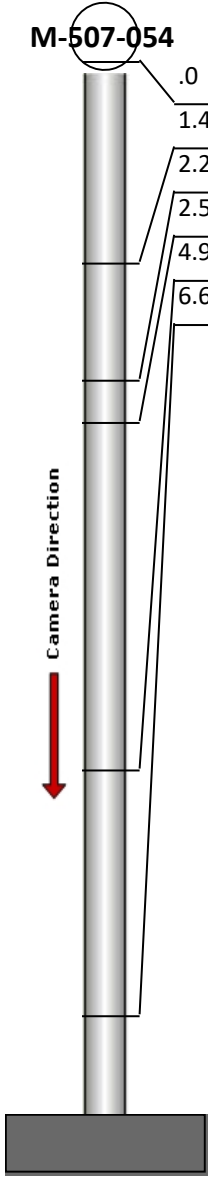
Position	Code	Observation	Video (sec)	Grade

.0	MGP	General Photo	10	NA
	1.4	IS	Infil Stain	24	NA
	2.2	MGP	General Photo	40	NA
	2.5	IS	Infil Stain	54	NA
	4.9	DSF	Deposits Settled Fine	71	M 2
	6.6	MGO	General Observation	86	NA

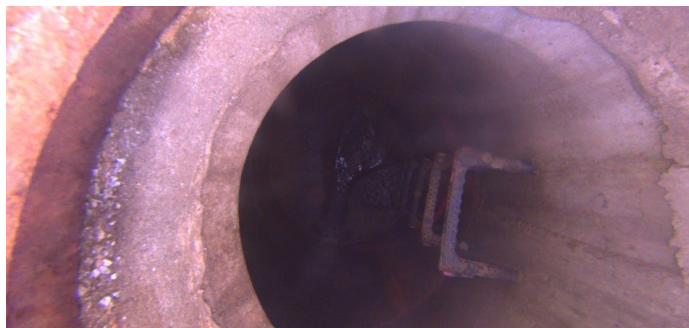
Code: **MGP**  
Description: **General Photo**

Distance (ft): **.0**  
Structural Grade: **0**  
O&M Grade: **0**  
Clock Start/From:  
Clock To:  
1st Value:  
2nd Value:  
Value Percent:  
Step: **NO**  
Remarks:

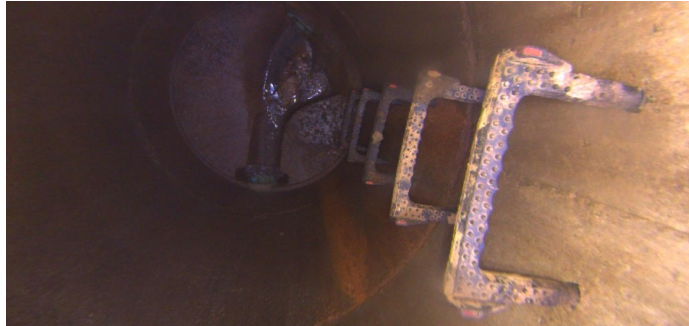
Code: **IS**  
Description: **Infil Stain**

Distance (ft): **1.4**  
Structural Grade: **0**  
O&M Grade: **0**  
Clock Start/From: **3**  
Clock To: **4**  
1st Value:  
2nd Value:  
Value Percent:  
Step: **NO**  
Remarks:

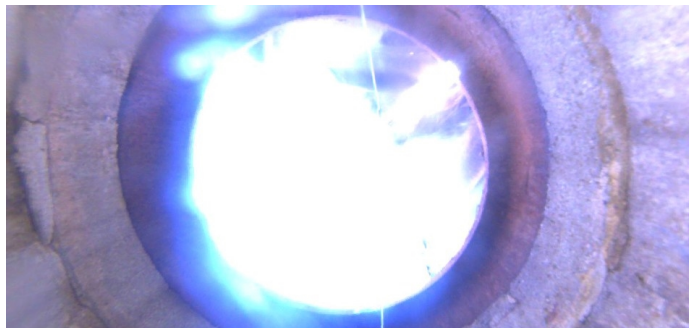
Code: **MGP**  
Description: **General Photo**

Distance (ft): **2.2**  
Structural Grade: **0**  
O&M Grade: **0**  
Clock Start/From:  
Clock To:  
1st Value:  
2nd Value:  
Value Percent:  
Step: **NO**  
Remarks:

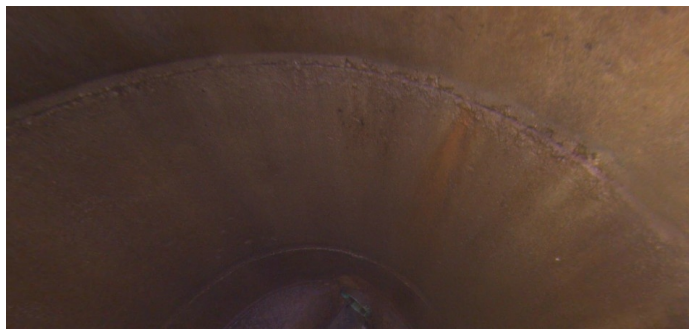
Code: **IS**  
Description: **Infil Stain**

Distance (ft): **2.5**  
Structural Grade: **0**  
O&M Grade: **0**  
Clock Start/From: **2**  
Clock To:  
1st Value:  
2nd Value:  
Value Percent:  
Step: **NO**  
Remarks:

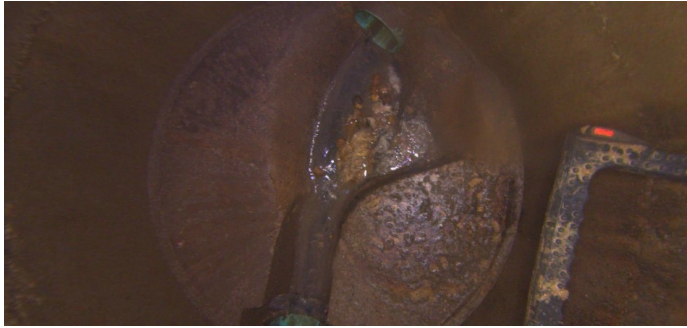
Code:	<b>DSF</b>
Description:	<b>Deposits Settled Fine</b>
Distance (ft):	<b>4.9</b>
Structural Grade:	<b>0</b>
O&M Grade:	<b>2</b>
Clock Start/From:	<b>12</b>
Clock To:	<b>12</b>
1st Value:	
2nd Value:	
Value Percent:	<b>5.000</b>
Step:	<b>NO</b>
Remarks:

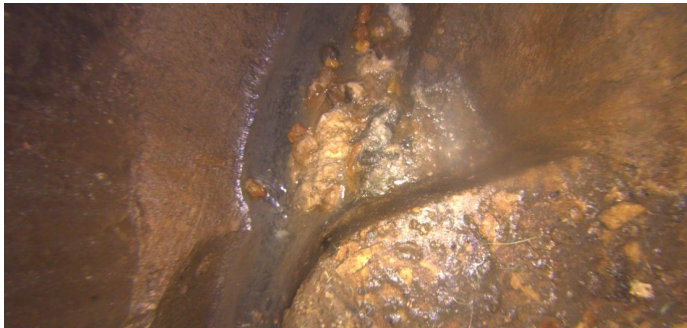
Code:	<b>MGO</b>
Description:	<b>General Observation</b>
Distance (ft):	<b>6.6</b>
Structural Grade:	<b>0</b>
O&M Grade:	<b>0</b>
Clock Start/From:	
Clock To:	
1st Value:	
2nd Value:	
Value Percent:	
Step:	<b>NO</b>
Remarks:	<b>Ins. Comp.</b>
