Manhole Inspection Report

Street:	160' East of Virginia St. North of 11t	Project:	Hobart, IN
City:	Hobart, IN	GPS Northing:	0.0
Location:		GPS Easting:	0.0
Drain Area:	Southwest	GPS Accuracy:	Nearest Meter
Cover Shape:	Circular	Evidence of Surcharge:	No
Cover Size:	22.5	Potential for Runoff:	None
Comments:

M-507-078

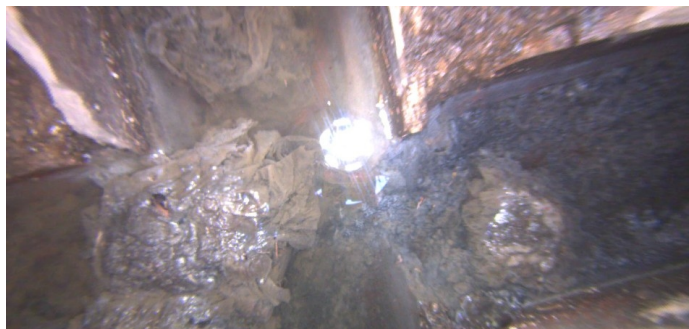
Code: **MGP**
Description: **General Photo**

Distance (ft): **2.2**
Structural Grade: **0**
O&M Grade: **0**
Clock Start/From:
Clock To:
1st Value:
2nd Value:
Value Percent:
Step: **NO**
Remarks:
