Manhole Inspection Report

Date:	04/25/2018	Weather:		Coding:	RZMACP
MH#:	M-507-089	Owner:	NA	Len. Surveyed:	9.6
P.O.#:		Surveyor:	John Kuglmaier	Rim to Invert:	10.2
Customer:		Cert. #:	U-1215-07002349	Wall Material:	Concrete (reinforced)

Street:	Virginia St. South of 10th Pl.	Project:	Hobart, IN
City:	Hobart, IN	GPS Northing:	41.5213623
Location:		GPS Easting:	-87.27085876
Drain Area:	Southwest	GPS Accuracy:	Nearest Meter
Cover Shape:	Circular	Evidence of Surcharge:	No
Cover Size:	22.5	Potential for Runoff:	None
Comments:

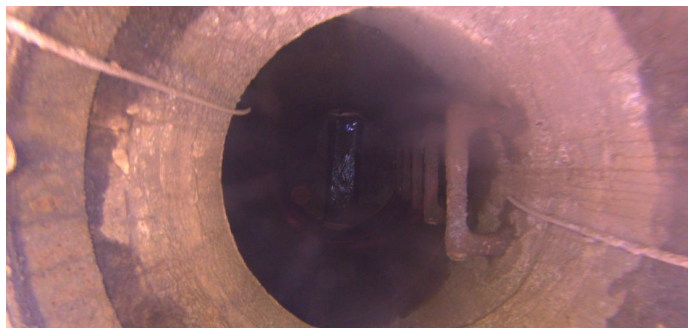
Code: **MGP**
Description: **General Photo**

Distance (ft): **.0**
Structural Grade: **0**
O&M Grade: **0**
Clock Start/From:
Clock To:
1st Value:
2nd Value:
Value Percent:
Step: **NO**
Remarks:

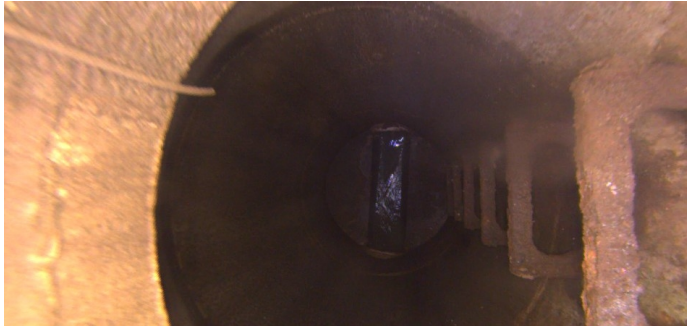
Code: **IS**
Description: **Infil Stain**

Distance (ft): **1.0**
Structural Grade: **0**
O&M Grade: **0**
Clock Start/From: **12**
Clock To: **12**
1st Value:
2nd Value:
Value Percent:
Step: **NO**
Remarks:

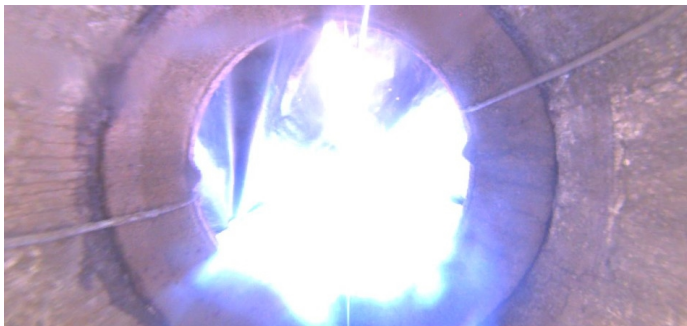
Code: **MGP**
Description: **General Photo**

Distance (ft): **2.4**
Structural Grade: **0**
O&M Grade: **0**
Clock Start/From:
Clock To:
1st Value:
2nd Value:
Value Percent:
Step: **NO**
Remarks:

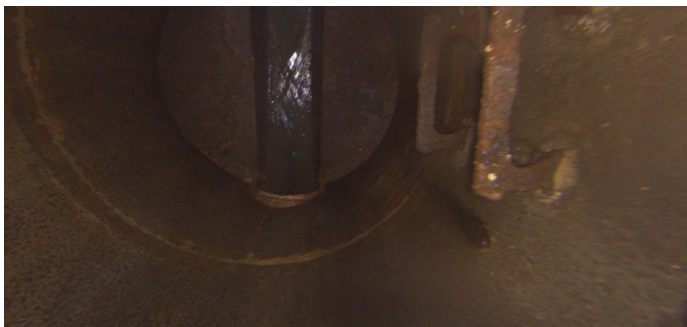
Code: **IS**
Description: **Infil Stain**

Distance (ft): **4.9**
Structural Grade: **0**
O&M Grade: **0**
Clock Start/From: **4**
Clock To:
1st Value:
2nd Value:
Value Percent:
Step: **NO**
Remarks:

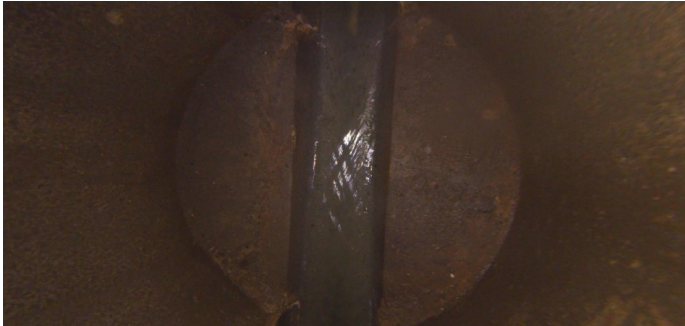
Code:	DSF
Description:	Deposits Settled Fine

Distance (ft):	6.8
Structural Grade:	0
O&M Grade:	2
Clock Start/From:	12
Clock To:	12
1st Value:	
2nd Value:	
Value Percent:	5.000
Step:	NO
Remarks:

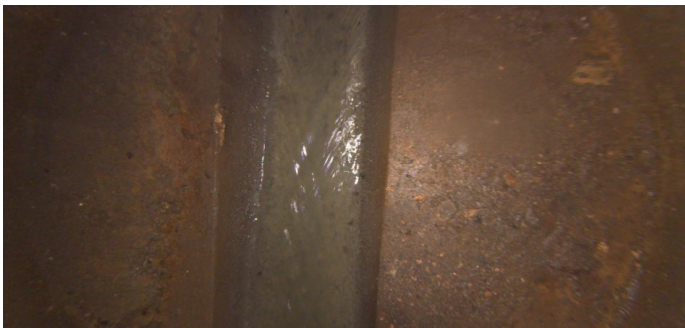
Code:	MGO
Description:	General Observation

Distance (ft):	8.3
Structural Grade:	0
O&M Grade:	0
Clock Start/From:	
Clock To:	
1st Value:	
2nd Value:	
Value Percent:	
Step:	NO
Remarks:	Ins. Comp.
