# Manhole Inspection Report

Date:	<b>04/25/2018</b>	Weather:		Coding:	<b>RZMACP</b>
MH#:	<b>M-507-089</b>	Owner:	<b>NA</b>	Len. Surveyed:	<b>8.9</b>
P.O.#:		Surveyor:	<b>John Kuglmaier</b>	Rim to Invert:	<b>10.2</b>
Customer:		Cert. #:	<b>U-1215-07002349</b>	Wall Material:	<b>Concrete (reinforced)</b>

Street:	<b>Virginia St. South of 10th Pl.</b>	Project:	<b>Hobart, IN</b>
City:	<b>Hobart, IN</b>	GPS Northing:	<b>41.52083206</b>
Location:		GPS Easting:	<b>-87.27095032</b>
Drain Area:	<b>Southwest</b>	GPS Accuracy:	<b>Nearest Meter</b>
Cover Shape:	<b>Circular</b>	Evidence of Surcharge:	<b>No</b>
Cover Size:	<b>22.5</b>	Potential for Runoff:	<b>None</b>
Comments:

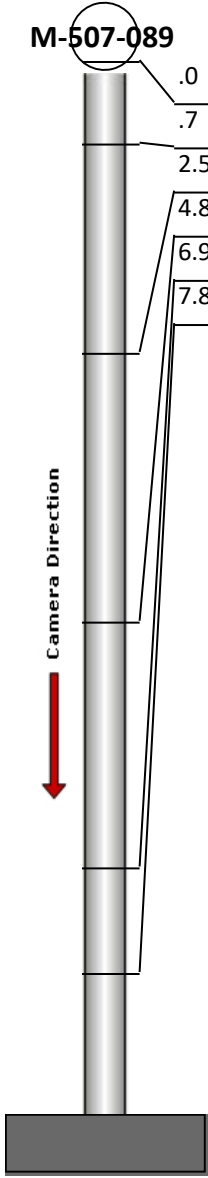
.0	MGP	General Photo	10	NA
	.7	IS	Infil Stain	23	NA
	2.5	MGP	General Photo	40	NA
	4.8	IS	Infil Stain	59	NA
	6.9	DSF	Deposits Settled Fine	74	M 2
	7.8	MGO	General Observation	88	NA

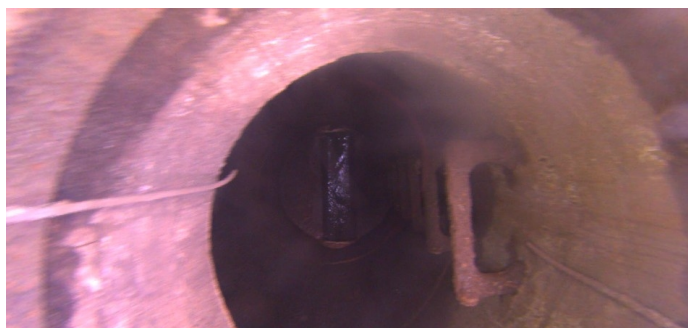
Code: **MGP**  
Description: **General Photo**

Distance (ft): **.0**  
Structural Grade: **0**  
O&M Grade: **0**  
Clock Start/From:  
Clock To:  
1st Value:  
2nd Value:  
Value Percent:  
Step: **NO**  
Remarks:

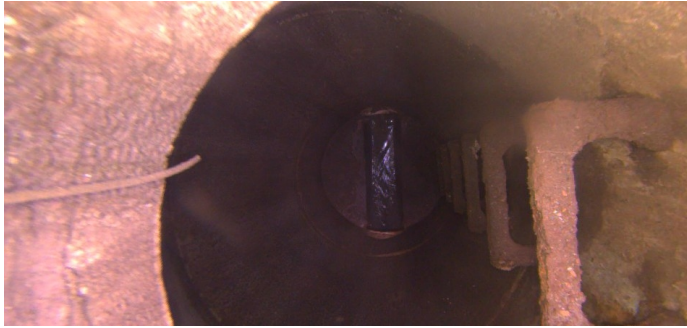
Code: **IS**  
Description: **Infil Stain**

Distance (ft): **.7**  
Structural Grade: **0**  
O&M Grade: **0**  
Clock Start/From: **12**  
Clock To: **12**  
1st Value:  
2nd Value:  
Value Percent:  
Step: **NO**  
Remarks:

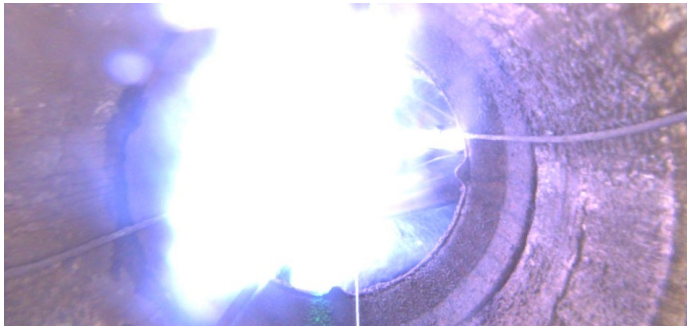
Code: **MGP**  
Description: **General Photo**

Distance (ft): **2.5**  
Structural Grade: **0**  
O&M Grade: **0**  
Clock Start/From:  
Clock To:  
1st Value:  
2nd Value:  
Value Percent:  
Step: **NO**  
Remarks:

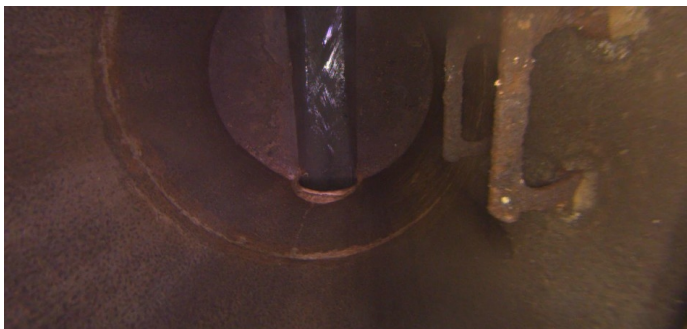
Code: **IS**  
Description: **Infil Stain**

Distance (ft): **4.8**  
Structural Grade: **0**  
O&M Grade: **0**  
Clock Start/From: **4**  
Clock To:  
1st Value:  
2nd Value:  
Value Percent:  
Step: **NO**  
Remarks:

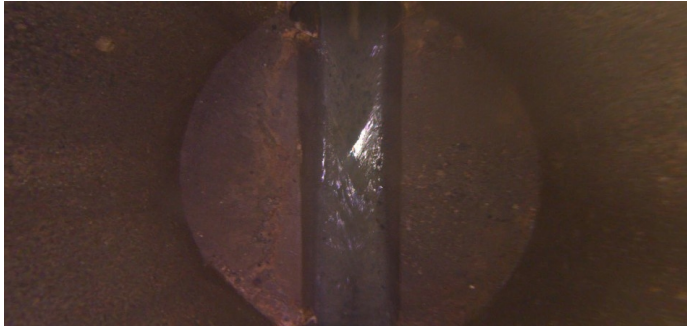
Code: **DSF**  
Description: **Deposits Settled Fine**

Distance (ft): **6.9**  
Structural Grade: **0**  
O&M Grade: **2**  
Clock Start/From: **12**  
Clock To: **12**  
1st Value:  
2nd Value:  
Value Percent: **10.000**  
Step: **NO**  
Remarks:

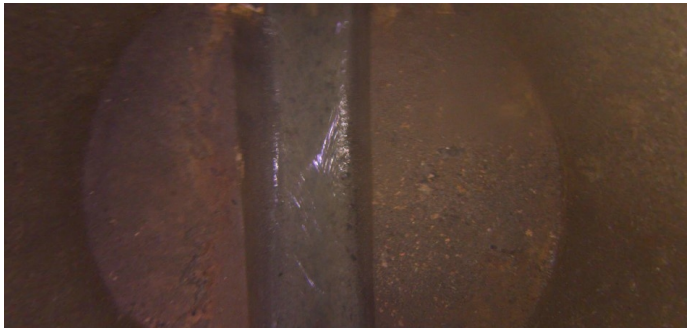
Code: **MGO**  
Description: **General Observation**

Distance (ft): **7.8**  
Structural Grade: **0**  
O&M Grade: **0**  
Clock Start/From:  
Clock To:  
1st Value:  
2nd Value:  
Value Percent:  
Step: **NO**  
Remarks: **Ins. Comp.**
