Manhole Inspection Report

Date:	03/28/2018	Weather:		Coding:	RZMACP
MH#:	M-507-090	Owner:	NA	Len. Surveyed:	5.4
P.O.#:		Surveyor:	John Kuglmaier	Rim to Invert:	7.9
Customer:		Cert. #:	U-1215-07002349	Wall Material:	Concrete (reinforced)

Street:	East of Delaware St. and Csokasy Ln.	Project:	Hobart, IN
City:	Hobart, IN	GPS Northing:	0.0
Location:		GPS Easting:	0.0
Drain Area:	Southwest	GPS Accuracy:	Nearest Meter
Cover Shape:	Circular	Evidence of Surcharge:	No
Cover Size:	22.5	Potential for Runoff:	None
Comments:

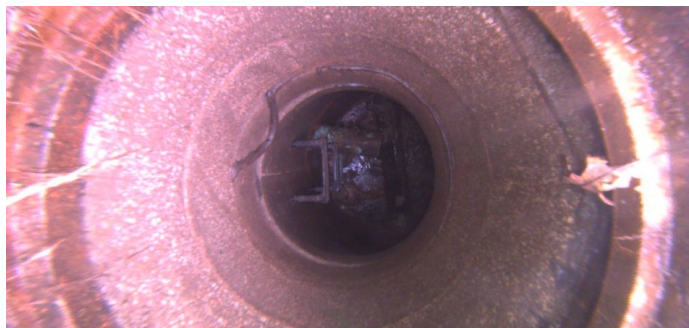
Code: **MGP**
Description: **General Photo**

Distance (ft): **.0**
Structural Grade: **0**
O&M Grade: **0**
Clock Start/From:
Clock To:
1st Value:
2nd Value:
Value Percent:
Step: **NO**
Remarks:

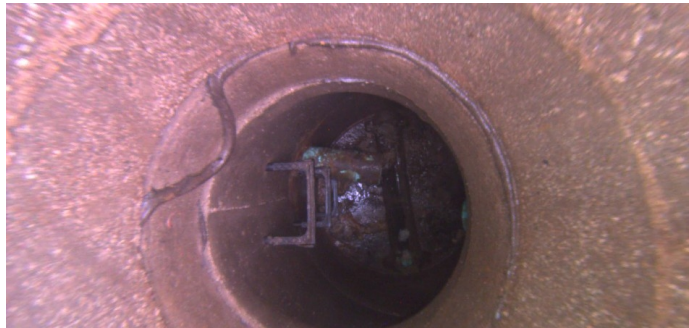
Code: **ISSRH**
Description: **Intruding Sealing Ring Hanging**

Distance (ft): **1.0**
Structural Grade: **0**
O&M Grade: **2**
Clock Start/From: **9**
Clock To: **10**
1st Value:
2nd Value:
Value Percent: **5.000**
Step: **NO**
Remarks:

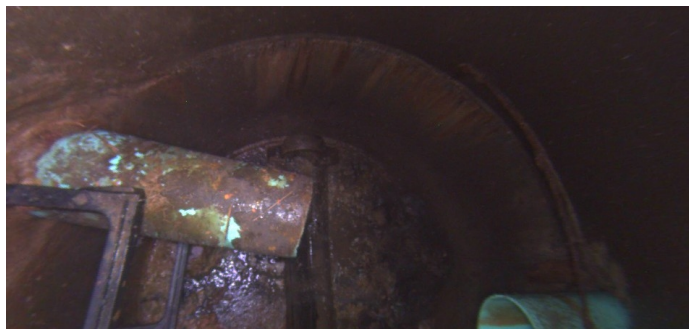
Code: **IS**
Description: **Infil Stain**

Distance (ft): **3.8**
Structural Grade: **0**
O&M Grade: **0**
Clock Start/From: **11**
Clock To: **3**
1st Value:
2nd Value:
Value Percent:
Step: **NO**
Remarks:

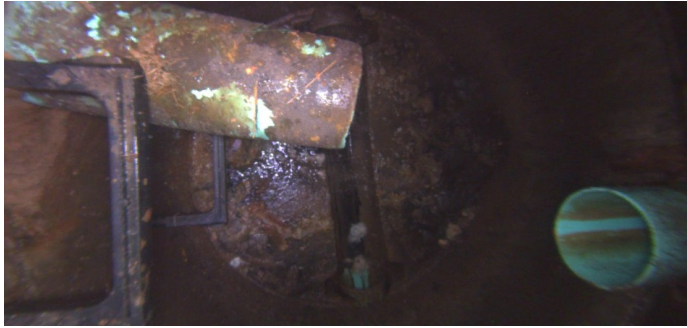
Code:	DAZ
Description:	Deposits Attached Other
Distance (ft):	4.3
Structural Grade:	0
O&M Grade:	2
Clock Start/From:	12
Clock To:	12
1st Value:	
2nd Value:	
Value Percent:	10.000
Step:	NO
Remarks:	Mixed materials

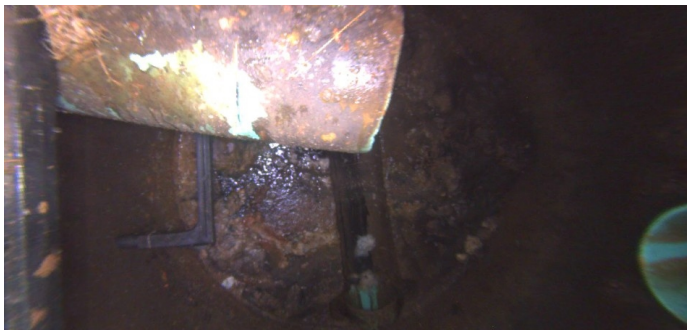
Code:	MGO
Description:	General Observation
Distance (ft):	4.7
Structural Grade:	0
O&M Grade:	0
Clock Start/From:	
Clock To:	
1st Value:	
2nd Value:	
Value Percent:	
Step:	NO
Remarks:	Ins. Comp.
