Manhole Inspection Report

Date:	09/25/2022	Weather:		Coding:	RZMACP
MH#:	M-507-096	Owner:	NA	Len. Surveyed:	4.3
P.O.#:		Surveyor:	Jen Costello	Rim to Invert:	5.2
Customer:		Cert. #:	U-907-5518	Wall Material:	Concrete (cast in place)

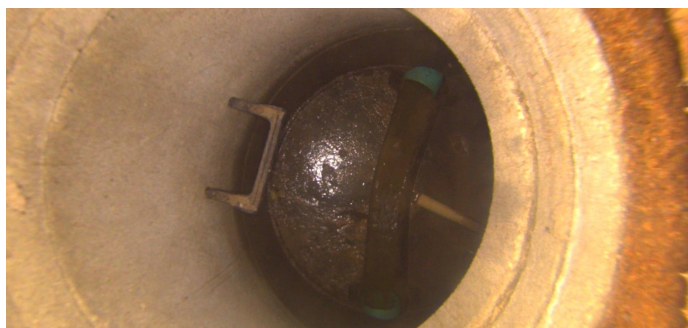
Code: **MGO**
Description: **General Observation**

Distance (ft): **.0**
Structural Grade: **0**
O&M Grade: **0**
Clock Start/From:
Clock To:
1st Value:
2nd Value:
Value Percent:
Step: **NO**
Remarks: **access mh**

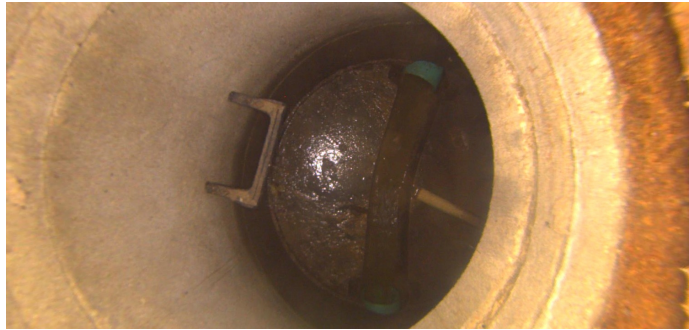
Code:	SRI
Description:	Surface Roughness Increased
Distance (ft):	.0
Structural Grade:	1
O&M Grade:	0
Clock Start/From:	12
Clock To:	12
1st Value:	
2nd Value:	
Value Percent:	
Step:	NO
Remarks:

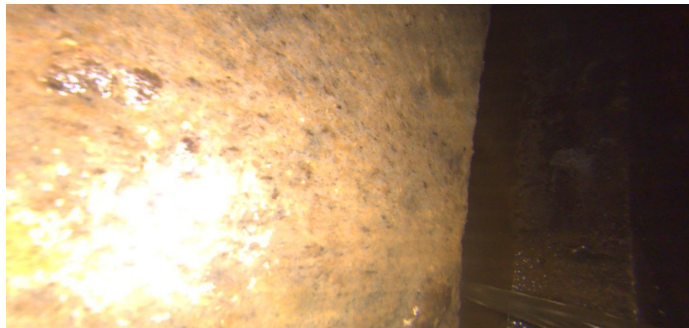
Code:	DSF
Description:	Deposits Settled Fine
Distance (ft):	4.3
Structural Grade:	0
O&M Grade:	2
Clock Start/From:	12
Clock To:	12
1st Value:	
2nd Value:	
Value Percent:	5.000
Step:	NO
Remarks:

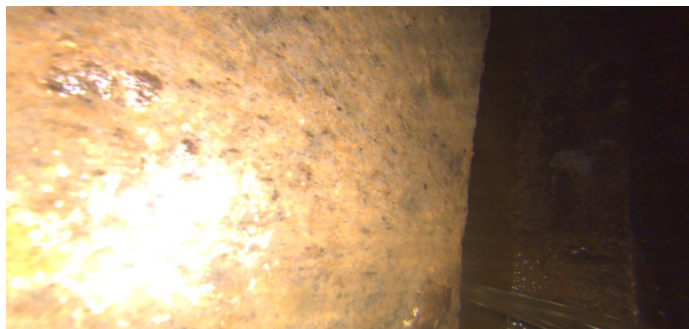
Code:	SRI
Description:	Surface Roughness Increased
Distance (ft):	4.3
Structural Grade:	1
O&M Grade:	0
Clock Start/From:	12
Clock To:	12
1st Value:	
2nd Value:	
Value Percent:	
Step:	NO
Remarks:

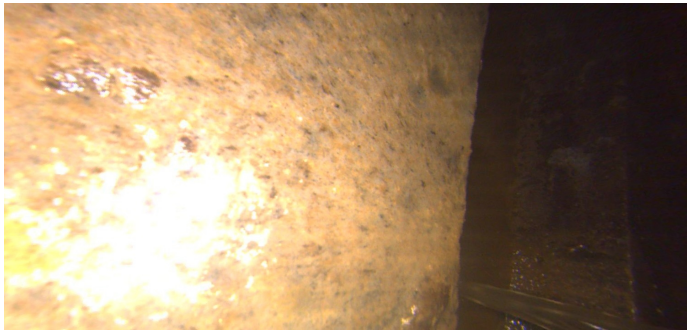
Code:	MGO
Description:	General Observation
Distance (ft):	4.3
Structural Grade:	0
O&M Grade:	0
Clock Start/From:	
Clock To:	
1st Value:	
2nd Value:	
Value Percent:	
Step:	NO
Remarks:	end of survey
