Manhole Inspection Report

Date:	09/20/2022	Weather:		Coding:	RZMACP
MH#:	M-508-002	Owner:	NA	Len. Surveyed:	5.9
P.O.#:		Surveyor:	Jen Costello	Rim to Invert:	6.7
Customer:		Cert. #:	U-907-5518	Wall Material:	Concrete (cast in place)

Street:	14th St. and Wisconsin St.	Project:	Hobart, IN
City:	Hobart, IN	GPS Northing:	2282550.111
Location:	Local Rural Streets	GPS Easting:	2902033.596
Drain Area:	Southwest	GPS Accuracy:	Sub-Meter
Cover Shape:	Circular	Evidence of Surcharge:	No
Cover Size:	24.0	Potential for Runoff:	None
Comments:

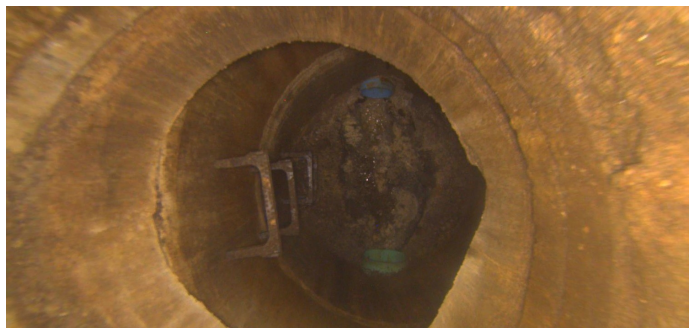
Code: **MGO**
Description: **General Observation**

Distance (ft): **.0**
Structural Grade: **0**
O&M Grade: **0**
Clock Start/From:
Clock To:
1st Value:
2nd Value:
Value Percent:
Step: **NO**
Remarks: **access mh**

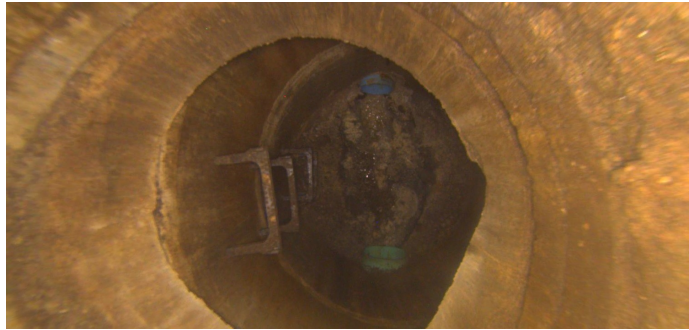
Code: **SRI**
Description: **Surface Roughness Increased**

Distance (ft): **.0**
Structural Grade: **1**
O&M Grade: **0**
Clock Start/From: **12**
Clock To: **12**
1st Value:
2nd Value:
Value Percent:
Step: **NO**
Remarks:

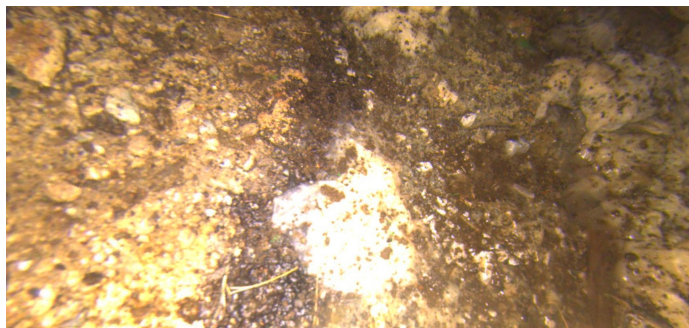
Code: **SRI**
Description: **Surface Roughness Increased**

Distance (ft): **5.9**
Structural Grade: **1**
O&M Grade: **0**
Clock Start/From: **12**
Clock To: **12**
1st Value:
2nd Value:
Value Percent:
Step: **NO**
Remarks:
