# Manhole Inspection Report

Date:	<b>10/09/2022</b>	Weather:		Coding:	<b>RZMACP</b>
MH#:	<b>M-603-003</b>	Owner:	<b>NA</b>	Len. Surveyed:	<b>4.7</b>
P.O.#:		Surveyor:	<b>Jen Costello</b>	Rim to Invert:	<b>5.9</b>
Customer:		Cert. #:	<b>U-907-5518</b>	Wall Material:	<b>Concrete (cast in place)</b>

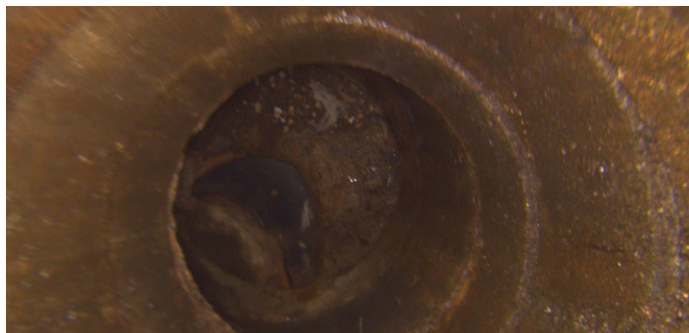
Code: **MGO**  
Description: **General Observation**

Distance (ft): **.0**  
Structural Grade: **0**  
O&M Grade: **0**  
Clock Start/From:  
Clock To:  
1st Value:  
2nd Value:  
Value Percent:  
Step: **NO**  
Remarks: **access mh**

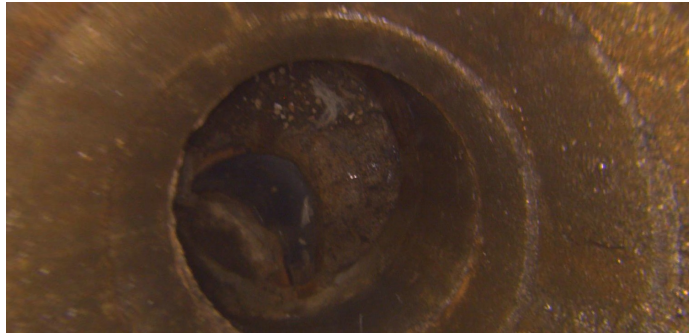
Code: **SRI**  
Description: **Surface Roughness Increased**

Distance (ft): **.0**  
Structural Grade: **1**  
O&M Grade: **0**  
Clock Start/From: **12**  
Clock To: **12**  
1st Value:  
2nd Value:  
Value Percent:  
Step: **NO**  
Remarks:

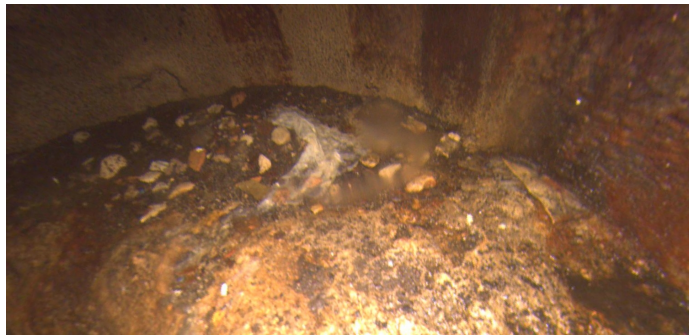
Code: **IW**  
Description: **Infil Weeper**

Distance (ft): **3.9**  
Structural Grade: **0**  
O&M Grade: **2**  
Clock Start/From: **12**  
Clock To: **3**  
1st Value:  
2nd Value:  
Value Percent:  
Step: **NO**  
Remarks:

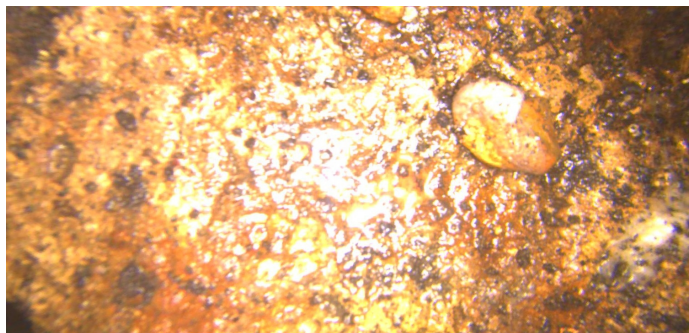
Code: **MGO**  
Description: **General Observation**

Distance (ft): **4.7**  
Structural Grade: **0**  
O&M Grade: **0**  
Clock Start/From:  
Clock To:  
1st Value:  
2nd Value:  
Value Percent:  
Step: **NO**  
Remarks: **end of survey**

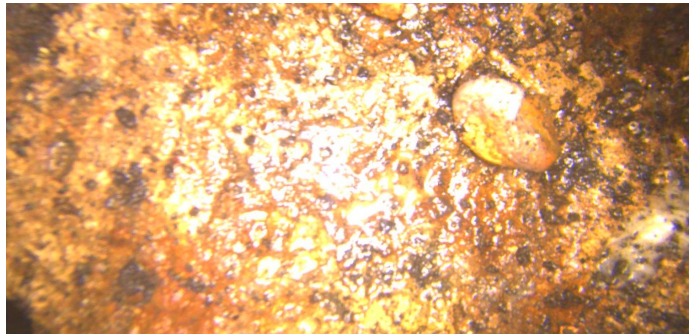
Code: **DSF**  
Description: **Deposits Settled Fine**

Distance (ft): **4.7**  
Structural Grade: **0**  
O&M Grade: **2**  
Clock Start/From: **12**  
Clock To: **12**  
1st Value:  
2nd Value:  
Value Percent: **5.000**  
Step: **NO**  
Remarks:

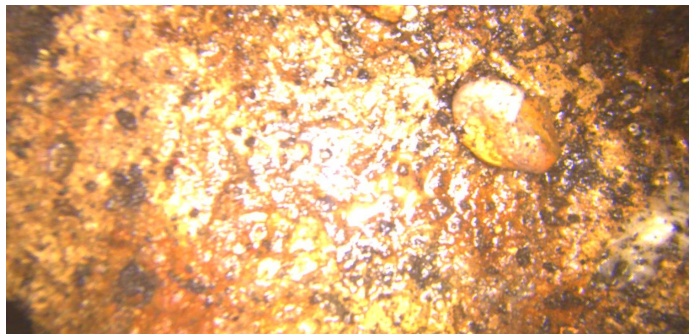
Code: **SRI**  
Description: **Surface Roughness Increased**

Distance (ft): **4.7**  
Structural Grade: **1**  
O&M Grade: **0**  
Clock Start/From: **12**  
Clock To: **12**  
1st Value:  
2nd Value:  
Value Percent:  
Step: **NO**  
Remarks:
