Manhole Inspection Report

Date:	04/11/2018	Weather:		Coding:	RZMACP
MH#:	M-603-011	Owner:	NA	Len. Surveyed:	6.0
P.O.#:		Surveyor:	John Kuglmaier	Rim to Invert:	7.4
Customer:		Cert. #:	U-1215-07002349	Wall Material:	Concrete (reinforced)

Street:	39th Pl. 188' East of Wisconsin St.	Project:	Hobart, IN
City:	Hobart, IN	GPS Northing:	2901957.483
Location:		GPS Easting:	2901957.483
Drain Area:	Northwest	GPS Accuracy:	Sub-Meter
Cover Shape:	Circular	Evidence of Surcharge:	No
Cover Size:	23.0	Potential for Runoff:	None
Comments:

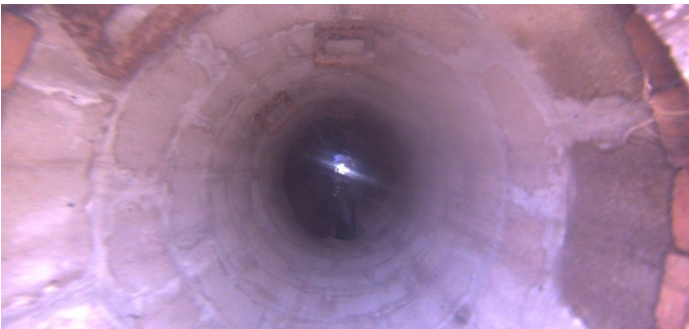
Code:

MGP

Description:

General Photo

Distance (ft):

.0

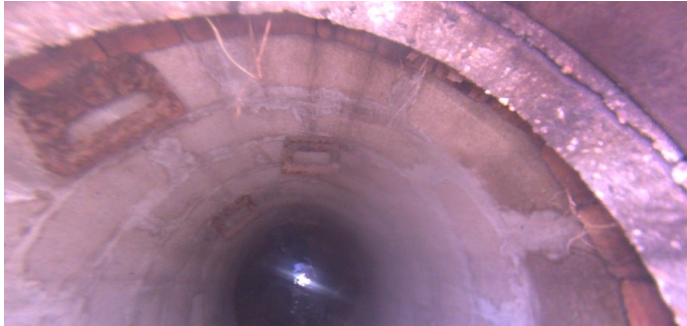
Code: **RFJ**
Description: **Roots Fine Joint**

Distance (ft): **.0**
Structural Grade: **0**
O&M Grade: **1**
Clock Start/From: **11**
Clock To: **2**
1st Value:
2nd Value:
Value Percent:
Step: **NO**
Remarks:

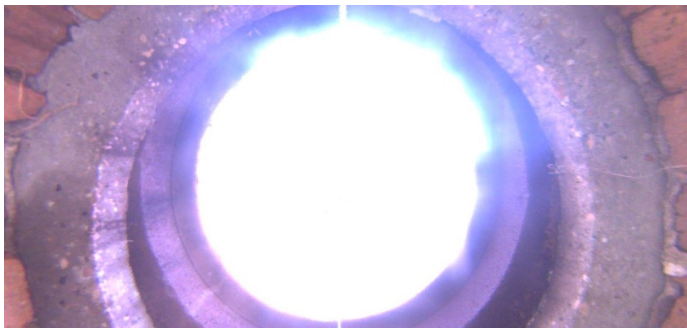
Code: **MGP**
Description: **General Photo**

Distance (ft): **1.9**
Structural Grade: **0**
O&M Grade: **0**
Clock Start/From:
Clock To:
1st Value:
2nd Value:
Value Percent:
Step: **NO**
Remarks:

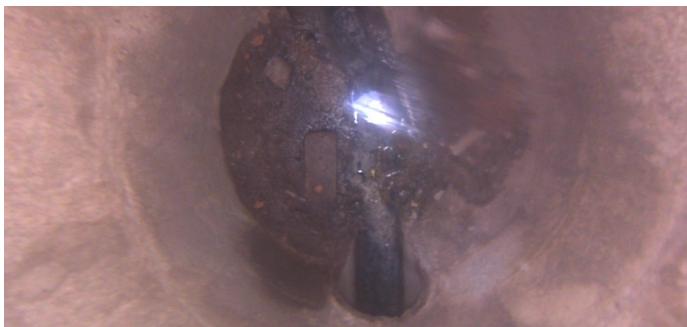
Code: **IS**
Description: **Infil Stain**

Distance (ft): **4.4**
Structural Grade: **0**
O&M Grade: **0**
Clock Start/From: **7**
Clock To:
1st Value:
2nd Value:
Value Percent:
Step: **NO**
Remarks:

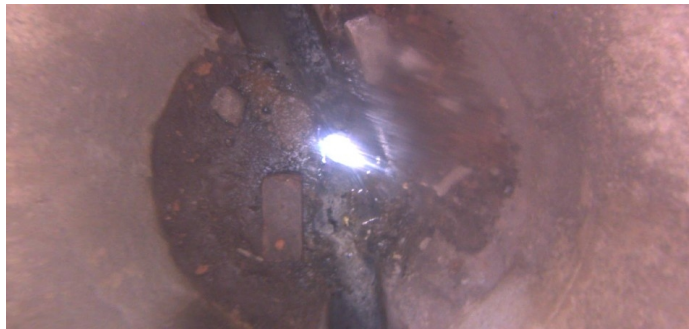
Code: **DAZ**
Description: **Deposits Attached Other**

Distance (ft): **4.9**
Structural Grade: **0**
O&M Grade: **2**
Clock Start/From: **12**
Clock To: **12**
1st Value:
2nd Value:
Value Percent: **5.000**
Step: **NO**
Remarks: **Mixed materials**

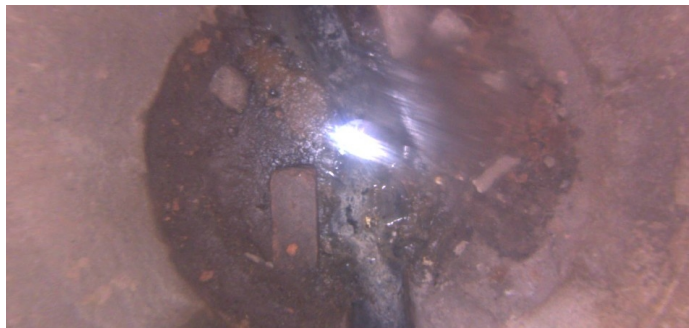
Code: **OBB**
Description: **Obstacle Brick**

Distance (ft): **5.3**
Structural Grade: **0**
O&M Grade: **2**
Clock Start/From: **7**
Clock To:
1st Value:
2nd Value:
Value Percent: **5.000**
Step: **NO**
Remarks:

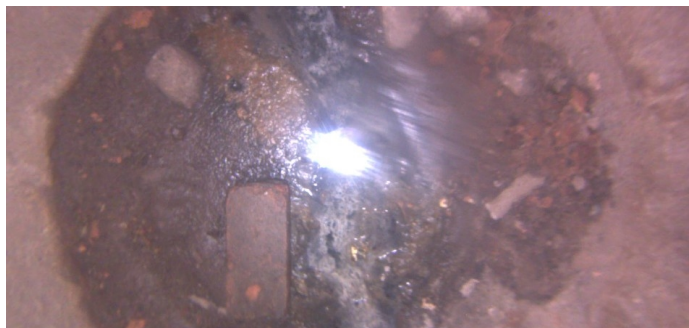
Code: **MGO**
Description: **General Observation**

Distance (ft): **5.5**
Structural Grade: **0**
O&M Grade: **0**
Clock Start/From:
Clock To:
1st Value:
2nd Value:
Value Percent:
Step: **NO**
Remarks: **Ins. Comp.**
