# Manhole Inspection Report

Date:	10/09/2022	Weather:		Coding:	RZMACP
MH#:	M-603-022	Owner:	NA	Len. Surveyed:	4.2
P.O.#:		Surveyor:	Jen Costello	Rim to Invert:	4.8
Customer:		Cert. #:	U-907-5518	Wall Material:	Concrete (cast in place)

**M-603-022**

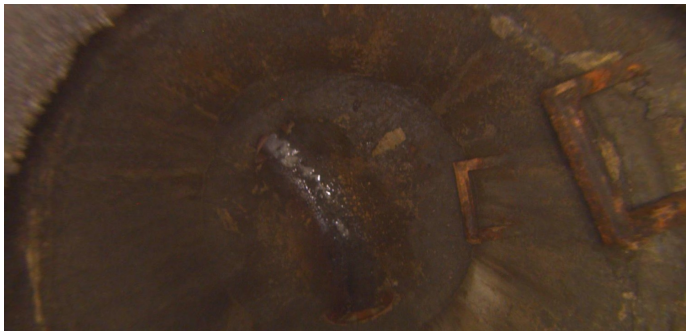
Code:	MGO
Description:	General Observation

Distance (ft):	.0
Structural Grade:	0
O&M Grade:	0
Clock Start/From:	
Clock To:	
1st Value:	
2nd Value:	
Value Percent:	
Step:	NO
Remarks:	ac

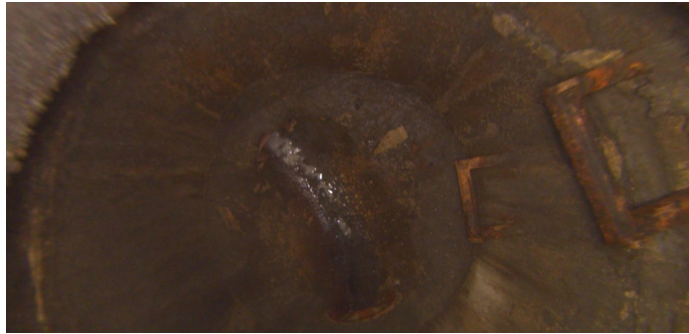
Code: **SRI**  
Description: **Surface Roughness Increased**

Distance (ft): **.0**  
Structural Grade: **1**  
O&M Grade: **0**  
Clock Start/From: **12**  
Clock To: **12**  
1st Value:  
2nd Value:  
Value Percent:  
Step: **NO**  
Remarks:

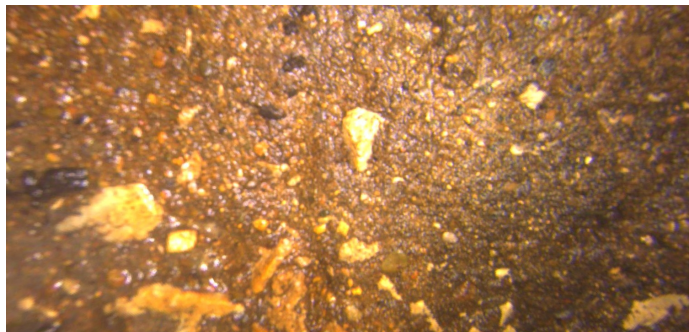
Code: **SRI**  
Description: **Surface Roughness Increased**

Distance (ft): **3.9**  
Structural Grade: **1**  
O&M Grade: **0**  
Clock Start/From: **12**  
Clock To: **12**  
1st Value:  
2nd Value:  
Value Percent:  
Step: **NO**  
Remarks:

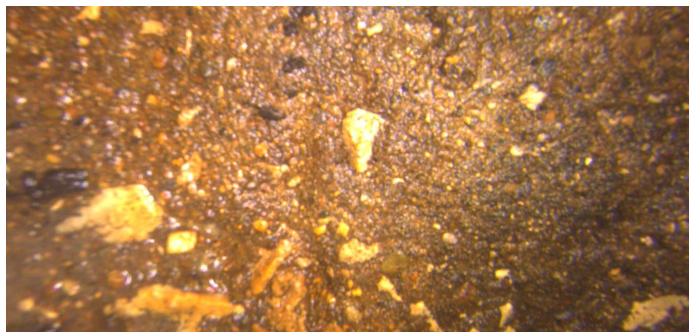
Code: **MGO**  
Description: **General Observation**

Distance (ft): **3.9**  
Structural Grade: **0**  
O&M Grade: **0**  
Clock Start/From:  
Clock To:  
1st Value:  
2nd Value:  
Value Percent:  
Step: **NO**  
Remarks: **end of survey**
