# Manhole Inspection Report

Date:	<b>04/11/2018</b>	Weather:		Coding:	<b>RZMACP</b>
MH#:	<b>M-603-023</b>	Owner:	<b>NA</b>	Len. Surveyed:	<b>3.8</b>
P.O.#:		Surveyor:	<b>John Kuglmaier</b>	Rim to Invert:	<b>4.8</b>
Customer:		Cert. #:	<b>U-1215-07002349</b>	Wall Material:	<b>Concrete (reinforced)</b>

Street:	<b>40th Pl. 191' East of Wisconsin St.</b>	Project:	<b>Hobart, IN</b>
City:	<b>Hobart, IN</b>	GPS Northing:	<b>0.0</b>
Location:		GPS Easting:	<b>0.0</b>
Drain Area:	<b>Northwest</b>	GPS Accuracy:	<b>Nearest Meter</b>
Cover Shape:	<b>Circular</b>	Evidence of Surcharge:	<b>No</b>
Cover Size:	<b>23.0</b>	Potential for Runoff:	<b>None</b>
Comments:

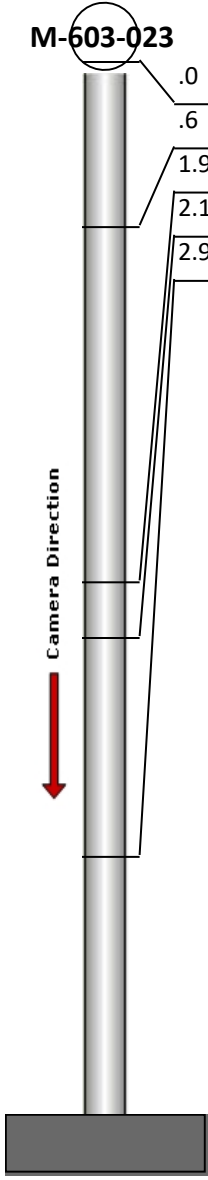
.0	MGP	General Photo	10	NA
	.6	IS	Infil Stain	23	NA
	1.9	DSF	Deposits Settled Fine	37	M 2
	2.1	MGP	General Photo	51	NA
	2.9	MGO	General Observation	66	NA

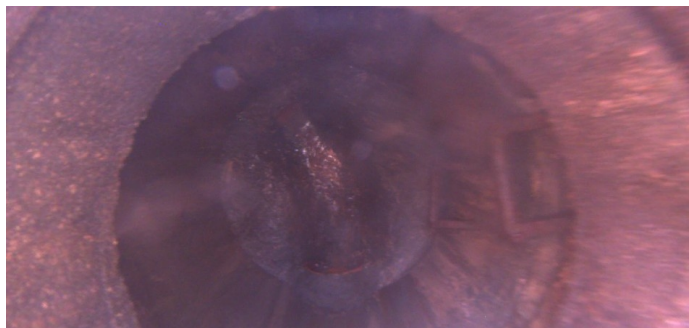
Code: **MGP**  
Description: **General Photo**

Distance (ft): **.0**  
Structural Grade: **0**  
O&M Grade: **0**  
Clock Start/From:  
Clock To:  
1st Value:  
2nd Value:  
Value Percent:  
Step: **NO**  
Remarks:

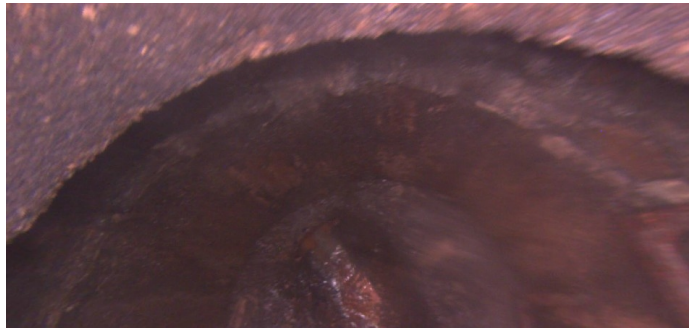
Code: **IS**  
Description: **Infil Stain**

Distance (ft): **.6**  
Structural Grade: **0**  
O&M Grade: **0**  
Clock Start/From: **12**  
Clock To: **12**  
1st Value:  
2nd Value:  
Value Percent:  
Step: **NO**  
Remarks:

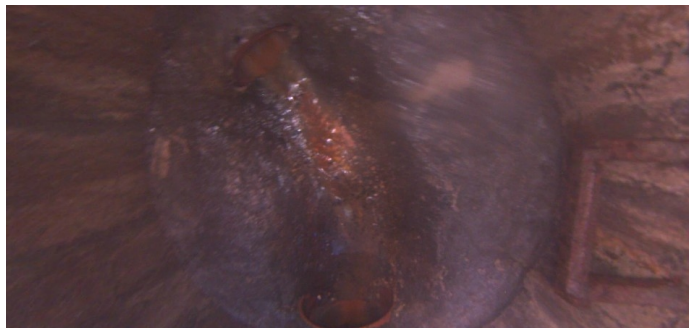
Code: **DSF**  
Description: **Deposits Settled Fine**

Distance (ft): **1.9**  
Structural Grade: **0**  
O&M Grade: **2**  
Clock Start/From: **12**  
Clock To: **12**  
1st Value:  
2nd Value:  
Value Percent: **5.000**  
Step: **NO**  
Remarks:

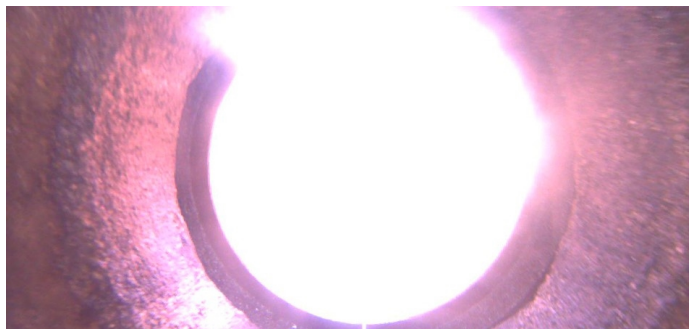
Code: **MGP**  
Description: **General Photo**

Distance (ft): **2.1**  
Structural Grade: **0**  
O&M Grade: **0**  
Clock Start/From:  
Clock To:  
1st Value:  
2nd Value:  
Value Percent:  
Step: **NO**  
Remarks:

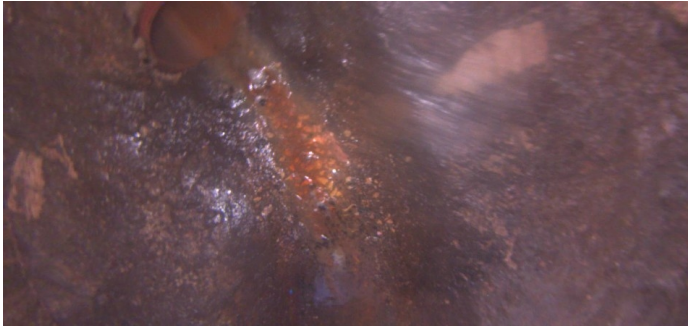
Code:	<b>MGO</b>
Description:	<b>General Observation</b>
Distance (ft):	<b>2.9</b>
Structural Grade:	<b>0</b>
O&M Grade:	<b>0</b>
Clock Start/From:	
Clock To:	
1st Value:	
2nd Value:	
Value Percent:	
Step:	<b>NO</b>
Remarks:	<b>Ins. Comp.</b>
