Manhole Inspection Report

| MH#: | M-603-030 | Owner: | NA | Len. Surveyed: | 4.1 |

| Street: | South of Hwy 6. 954' East of Wiscon | Project: | Hobart, IN |

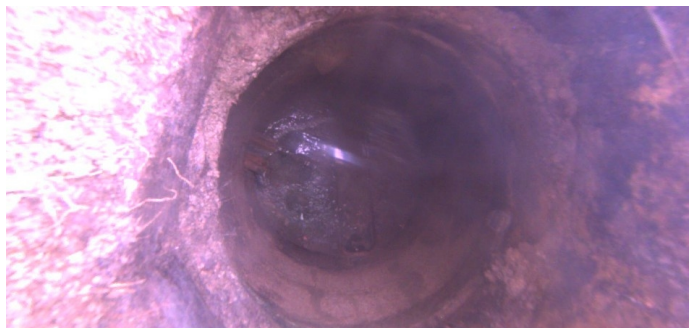
Code: **MGP**
Description: **General Photo**

Distance (ft): **.0**
Structural Grade: **0**
O&M Grade: **0**
Clock Start/From:
Clock To:
1st Value:
2nd Value:
Value Percent:
Step: **NO**
Remarks:

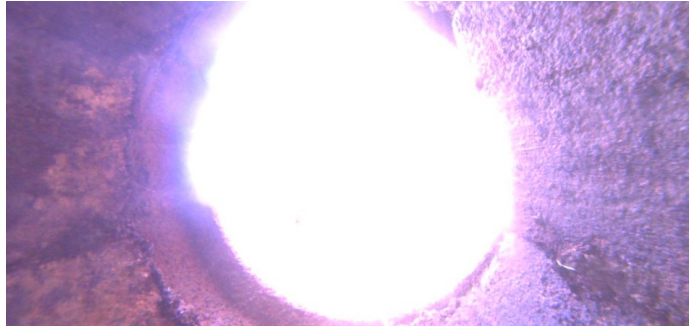
Code: **MGP**
Description: **General Photo**

Distance (ft): **1.8**
Structural Grade: **0**
O&M Grade: **0**
Clock Start/From:
Clock To:
1st Value:
2nd Value:
Value Percent:
Step: **NO**
Remarks:

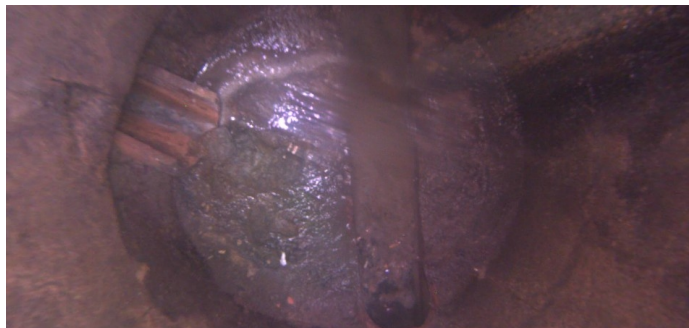
Code: **DSF**
Description: **Deposits Settled Fine**

Distance (ft): **2.5**
Structural Grade: **0**
O&M Grade: **2**
Clock Start/From: **12**
Clock To: **12**
1st Value:
2nd Value:
Value Percent: **10.000**
Step: **NO**
Remarks:

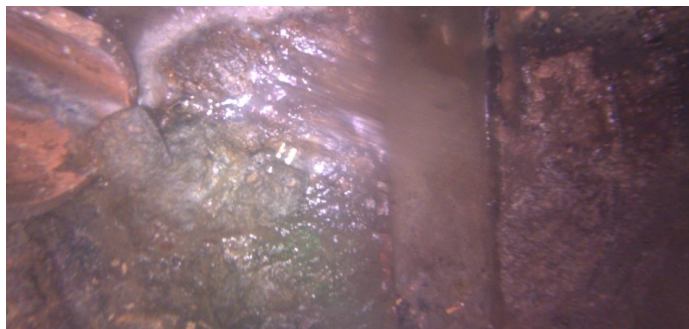
Code: **MGO**
Description: **General Observation**

Distance (ft): **3.5**
Structural Grade: **0**
O&M Grade: **0**
Clock Start/From:
Clock To:
1st Value:
2nd Value:
Value Percent:
Step: **NO**
Remarks: **Ins. Comp.**
