# Manhole Inspection Report

Date:	<b>04/08/2018</b>	Weather:		Coding:	<b>RZMACP</b>
MH#:	<b>M-603-032</b>	Owner:	<b>NA</b>	Len. Surveyed:	<b>7.8</b>
P.O.#:		Surveyor:	<b>John Kuglmaier</b>	Rim to Invert:	<b>9.6</b>
Customer:		Cert. #:	<b>U-1215-07002349</b>	Wall Material:	<b>Concrete (reinforced)</b>

Street:	<b>South of Hwy 6. 714' East of Wiscon</b>	Project:	<b>Hobart, IN</b>
City:	<b>Hobart, IN</b>	GPS Northing:	<b>2902473.369</b>
Location:		GPS Easting:	<b>2902473.369</b>
Drain Area:	<b>Northwest</b>	GPS Accuracy:	<b>Sub-Meter</b>
Cover Shape:	<b>Circular</b>	Evidence of Surcharge:	<b>No</b>
Cover Size:	<b>23.0</b>	Potential for Runoff:	<b>None</b>
Comments:

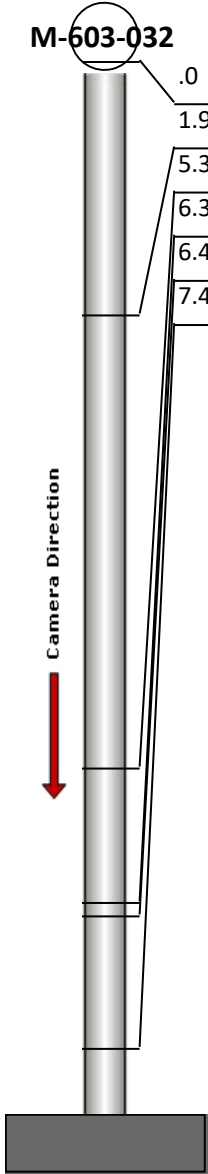
M-603-032				
	.0	MGP	General Photo	10	NA
	1.9	MGP	General Photo	28	NA
	5.3	IS	Infil Stain	48	NA
	6.3	DSF	Deposits Settled Fine	62	M 2
	6.4	IS	Infil Stain	74	NA
	7.4	MGO	General Observation	87	NA

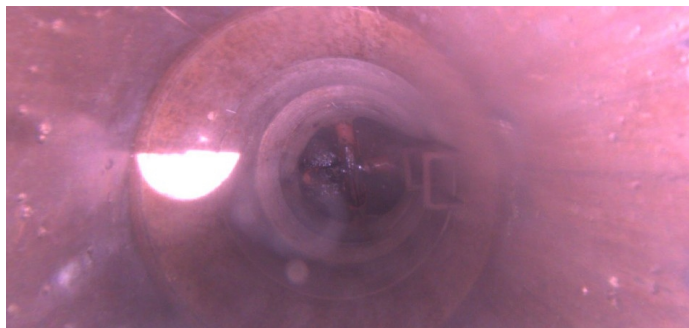
Code: **MGP**  
Description: **General Photo**

Distance (ft): **.0**  
Structural Grade: **0**  
O&M Grade: **0**  
Clock Start/From:  
Clock To:  
1st Value:  
2nd Value:  
Value Percent:  
Step: **NO**  
Remarks:

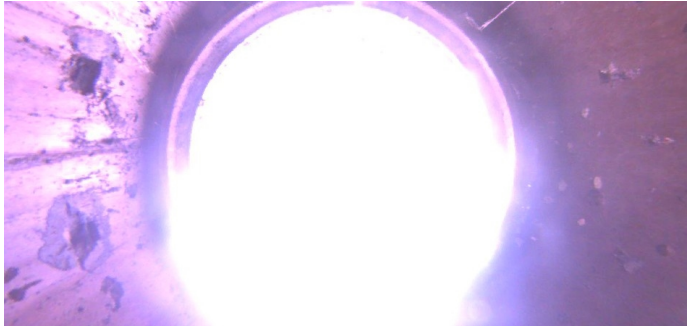
Code: **MGP**  
Description: **General Photo**

Distance (ft): **1.9**  
Structural Grade: **0**  
O&M Grade: **0**  
Clock Start/From:  
Clock To:  
1st Value:  
2nd Value:  
Value Percent:  
Step: **NO**  
Remarks:

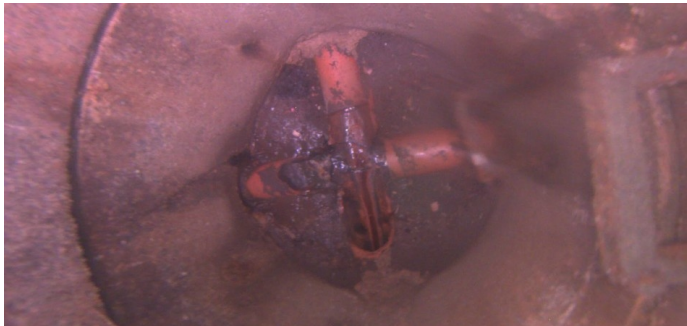
Code: **IS**  
Description: **Infil Stain**

Distance (ft): **5.3**  
Structural Grade: **0**  
O&M Grade: **0**  
Clock Start/From: **8**  
Clock To: **9**  
1st Value:  
2nd Value:  
Value Percent:  
Step: **NO**  
Remarks:

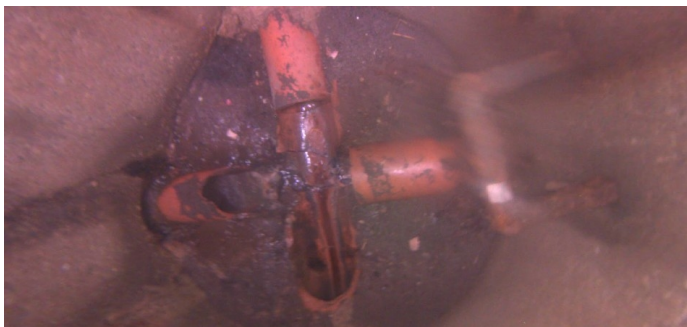
Code: **DSF**  
Description: **Deposits Settled Fine**

Distance (ft): **6.3**  
Structural Grade: **0**  
O&M Grade: **2**  
Clock Start/From: **12**  
Clock To: **12**  
1st Value:  
2nd Value:  
Value Percent: **5.000**  
Step: **NO**  
Remarks:

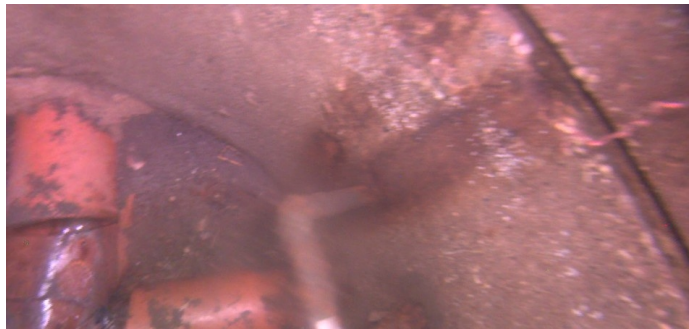
Code: **IS**  
Description: **Infil Stain**

Distance (ft): **6.4**  
Structural Grade: **0**  
O&M Grade: **0**  
Clock Start/From: **2**  
Clock To:  
1st Value:  
2nd Value:  
Value Percent:  
Step: **NO**  
Remarks:

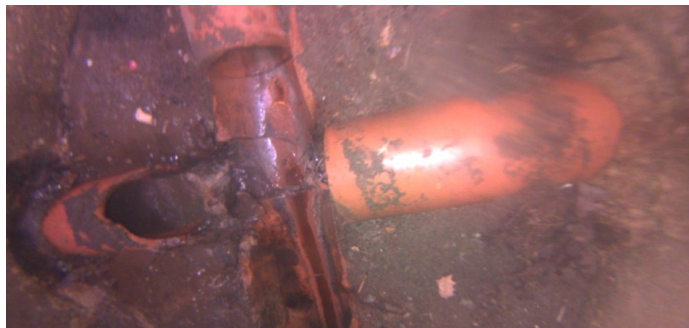
Code: **MGO**  
Description: **General Observation**

Distance (ft): **7.4**  
Structural Grade: **0**  
O&M Grade: **0**  
Clock Start/From:  
Clock To:  
1st Value:  
2nd Value:  
Value Percent:  
Step: **NO**  
Remarks: **Ins. Comp.**
