# Manhole Inspection Report

Date:	<b>04/08/2018</b>	Weather:		Coding:	<b>RZMACP</b>
MH#:	<b>M-603-037</b>	Owner:	<b>NA</b>	Len. Surveyed:	<b>3.2</b>
P.O.#:		Surveyor:	<b>John Kuglmaier</b>	Rim to Invert:	<b>4.5</b>
Customer:		Cert. #:	<b>U-1215-07002349</b>	Wall Material:	<b>Concrete (reinforced)</b>

Street:	<b>Wisconsin St. 219' South of Hwy 6.</b>	Project:	<b>Hobart, IN</b>
City:	<b>Hobart, IN</b>	GPS Northing:	<b>2901790.682</b>
Location:		GPS Easting:	<b>2901790.682</b>
Drain Area:	<b>Northwest</b>	GPS Accuracy:	<b>Sub-Meter</b>
Cover Shape:	<b>Circular</b>	Evidence of Surcharge:	<b>Yes</b>
Cover Size:	<b>23.0</b>	Potential for Runoff:	<b>None</b>
Comments:

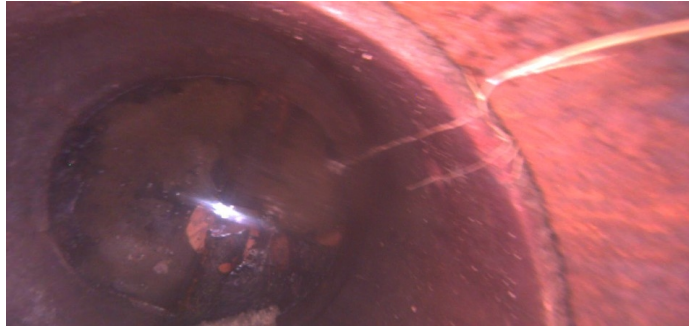
Code:	<b>MGP</b>
Description:	<b>General Photo</b>

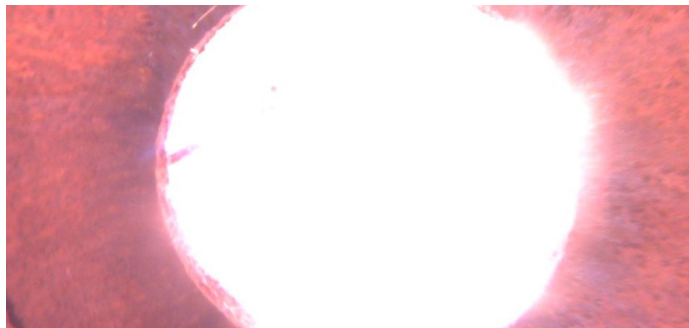
Code: **RFJ**  
Description: **Roots Fine Joint**

Distance (ft): **.0**  
Structural Grade: **0**  
O&M Grade: **1**  
Clock Start/From: **2**  
Clock To:  
1st Value:  
2nd Value:  
Value Percent:  
Step: **NO**  
Remarks:

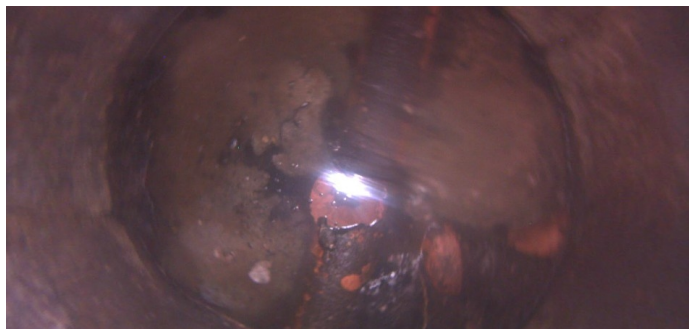
Code: **MGP**  
Description: **General Photo**

Distance (ft): **1.2**  
Structural Grade: **0**  
O&M Grade: **0**  
Clock Start/From:  
Clock To:  
1st Value:  
2nd Value:  
Value Percent:  
Step: **NO**  
Remarks:

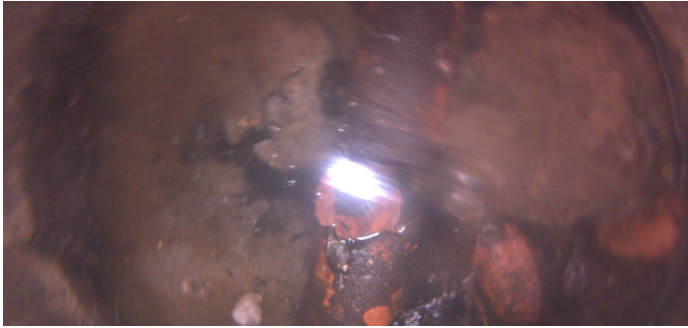
Code: **MGO**  
Description: **General Observation**

Distance (ft): **2.1**  
Structural Grade: **0**  
O&M Grade: **0**  
Clock Start/From:  
Clock To:  
1st Value:  
2nd Value:  
Value Percent:  
Step: **NO**  
Remarks: **Surcharge**
