# Manhole Inspection Report

| MH#: | <b>M-604-007</b> | Owner: | <b>NA</b> | Len. Surveyed: | <b>7.4</b> |

| Street: | <b>Beverly Blvd. 297' North of Clevelan</b> | Project: | <b>Hobart, IN</b> |

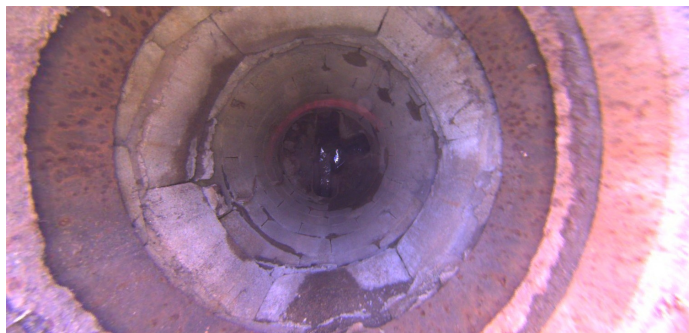
Code: **MGO**  
Description: **General Observation**

Distance (ft): **.0**  
Structural Grade: **0**  
O&M Grade: **0**  
Clock Start/From:  
Clock To:  
1st Value:  
2nd Value:  
Value Percent:  
Step: **NO**  
Remarks: **ACCESS MH**

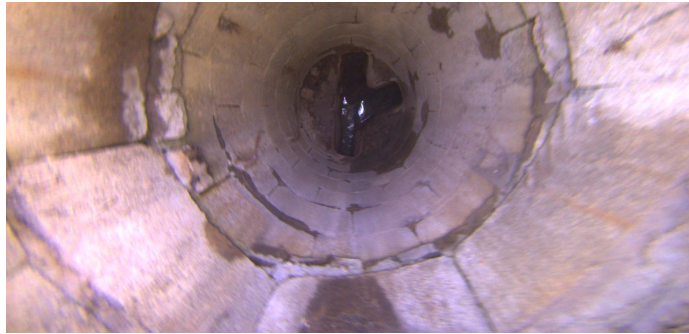
Code: **IS**  
Description: **Infil Stain**

Distance (ft): **.9**  
Structural Grade: **0**  
O&M Grade: **0**  
Clock Start/From: **6**  
Clock To:  
1st Value:  
2nd Value:  
Value Percent:  
Step: **NO**  
Remarks:

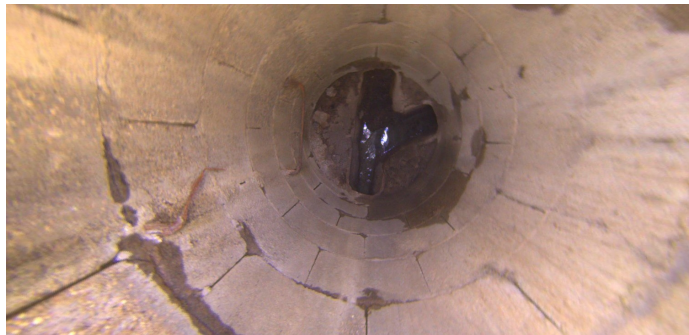
Code: **RFB**  
Description: **Roots Fine Barrel**

Distance (ft): **2.3**  
Structural Grade: **0**  
O&M Grade: **2**  
Clock Start/From: **8**  
Clock To:  
1st Value:  
2nd Value:  
Value Percent:  
Step: **NO**  
Remarks:

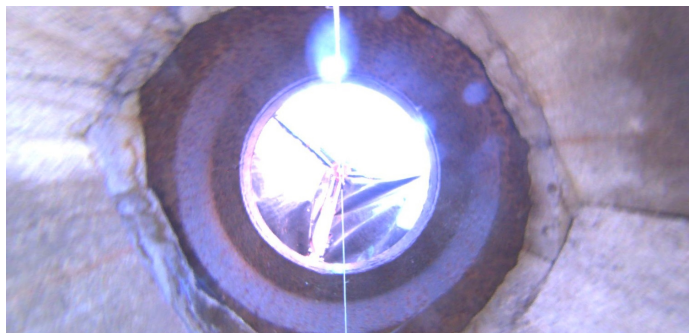
Code: **MGO**  
Description: **General Observation**

Distance (ft): **2.9**  
Structural Grade: **0**  
O&M Grade: **0**  
Clock Start/From:  
Clock To:  
1st Value:  
2nd Value:  
Value Percent:  
Step: **NO**  
Remarks: **UNDERSIDE OF FRAME**

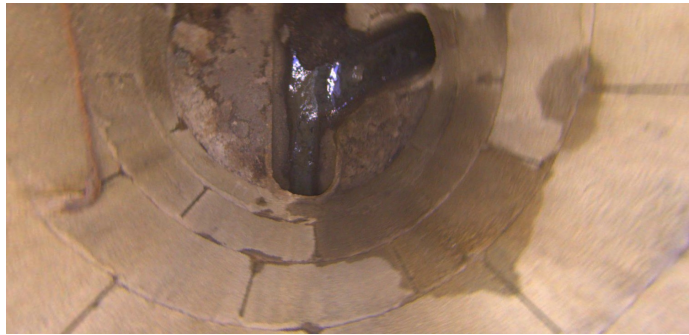
Code: **IW**  
Description: **Infil Weeper**

Distance (ft): **4.0**  
Structural Grade: **0**  
O&M Grade: **2**  
Clock Start/From: **3**  
Clock To: **6**  
1st Value:  
2nd Value:  
Value Percent:  
Step: **NO**  
Remarks:

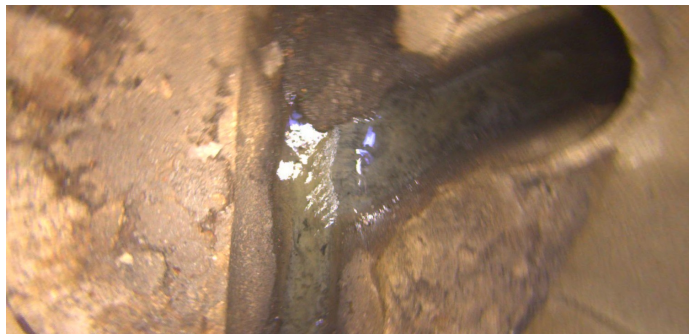
Code: **DSGV**  
Description: **Deposits Settled Gravel**

Distance (ft): **6.1**  
Structural Grade: **0**  
O&M Grade: **2**  
Clock Start/From: **12**  
Clock To: **12**  
1st Value:  
2nd Value:  
Value Percent: **5.000**  
Step: **NO**  
Remarks:

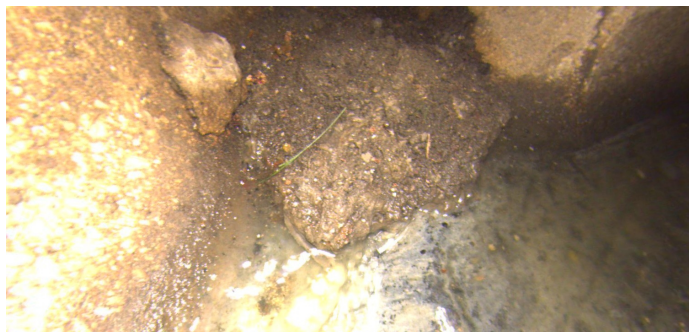
Code: **DSF**  
Description: **Deposits Settled Fine**

Distance (ft): **7.4**  
Structural Grade: **0**  
O&M Grade: **3**  
Clock Start/From: **4**  
Clock To: **8**  
1st Value:  
2nd Value:  
Value Percent: **20.000**  
Step: **NO**  
Remarks:

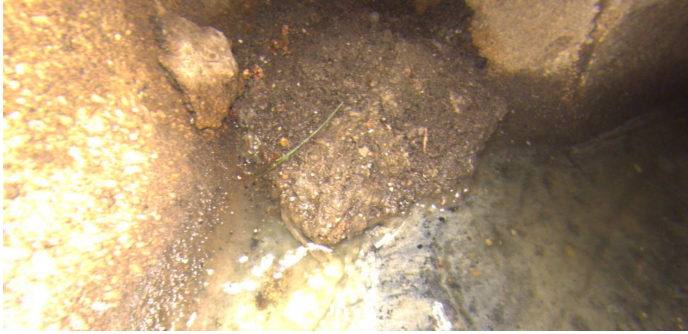
| Code: | MGO |
| Description: | General Observation |
| Distance (ft): | 7.4 |
| Remarks: | END SURVEY |
