Manhole Inspection Report

Street:	Beverly Blvd. 93' South of Old Ridge	Project:	Hobart, IN
City:	Hobart, IN	GPS Northing:	2903905.409
Location:		GPS Easting:	2903905.409
Drain Area:	West	GPS Accuracy:	Sub-Meter
Cover Shape:	Circular	Evidence of Surcharge:	No
Cover Size:	22.5	Potential for Runoff:	None
Comments:

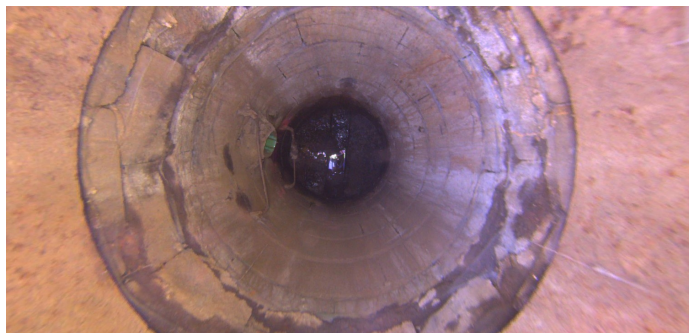
Code: **MGO**
Description: **General Observation**

Distance (ft): **.0**
Structural Grade: **0**
O&M Grade: **0**
Clock Start/From:
Clock To:
1st Value:
2nd Value:
Value Percent:
Step: **NO**
Remarks: **ACCESS MH**

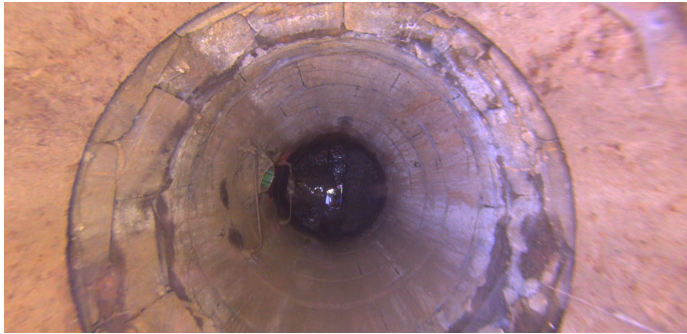
Code: **RFJ**
Description: **Roots Fine Joint**

Distance (ft): **.2**
Structural Grade: **0**
O&M Grade: **1**
Clock Start/From: **12**
Clock To: **12**
1st Value:
2nd Value:
Value Percent:
Step: **NO**
Remarks:

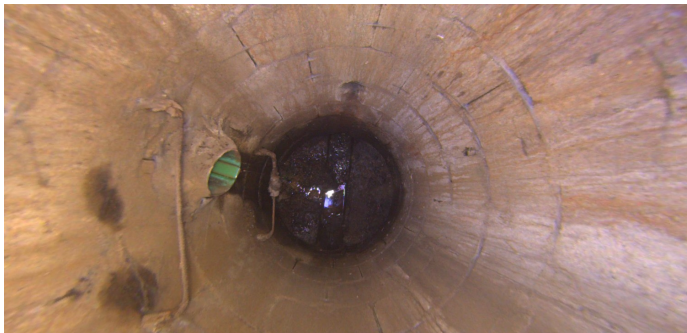
Code: **CC**
Description: **Crack Circumferential**

Distance (ft): **1.6**
Structural Grade: **1**
O&M Grade: **0**
Clock Start/From: **9**
Clock To: **10**
1st Value:
2nd Value:
Value Percent:
Step: **NO**
Remarks:

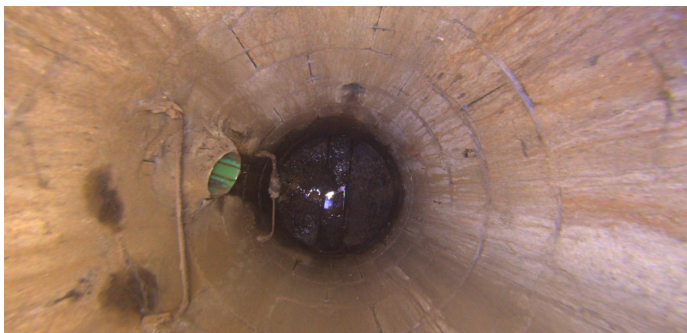
Code: **IS**
Description: **Infil Stain**

Distance (ft): **1.6**
Structural Grade: **0**
O&M Grade: **0**
Clock Start/From: **8**
Clock To: **9**
1st Value:
2nd Value:
Value Percent:
Step: **NO**
Remarks:

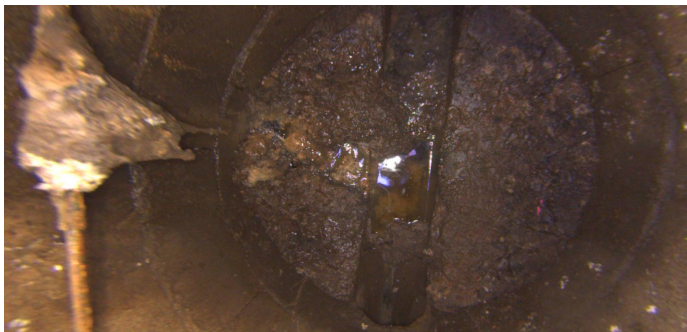
Code: **DAR**
Description: **Deposits Attached Ragging**

Distance (ft): **4.8**
Structural Grade: **0**
O&M Grade: **2**
Clock Start/From: **9**
Clock To:
1st Value:
2nd Value:
Value Percent: **5.000**
Step: **YES**
Remarks:

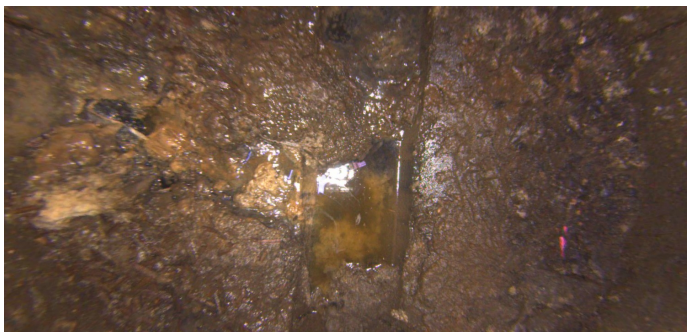
Code: **DSF**
Description: **Deposits Settled Fine**

Distance (ft): **5.8**
Structural Grade: **0**
O&M Grade: **2**
Clock Start/From: **12**
Clock To: **12**
1st Value:
2nd Value:
Value Percent: **5.000**
Step: **NO**
Remarks:
