Manhole Inspection Report

Date:	04/28/2018	Weather:		Coding:	RZMACP
MH#:	M-604-010	Owner:	NA	Len. Surveyed:	17.4
P.O.#:		Surveyor:	Jen Costello	Rim to Invert:	18.3
Customer:		Cert. #:	U-907-5518	Wall Material:	Concrete (reinforced)

Street:	Old Ridge Rd. and Lake Park Ave. To	Project:	Hobart, IN
City:	Hobart, IN	GPS Northing:	41.53735352
Location:		GPS Easting:	-87.25989532
Drain Area:	Northwest	GPS Accuracy:	Nearest Meter
Cover Shape:	Circular	Evidence of Surcharge:	No
Cover Size:	22.5	Potential for Runoff:	None
Comments:

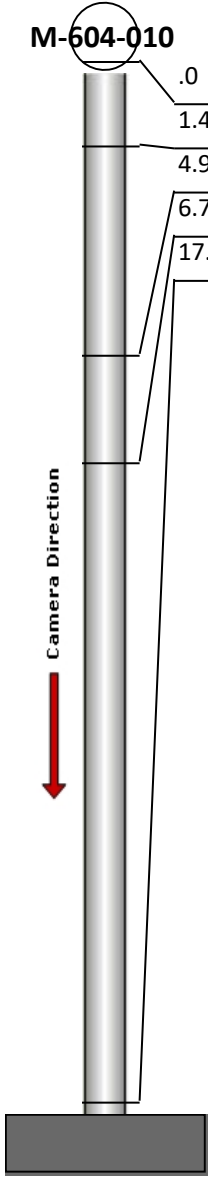
.0	MGO	General Observation	10	NA
	1.4	MGO	General Observation	26	NA
	4.9	MGO	General Observation	46	NA
	6.7	IW	Infil Weeper	60	M 2
	17.4	MGO	General Observation	92	NA

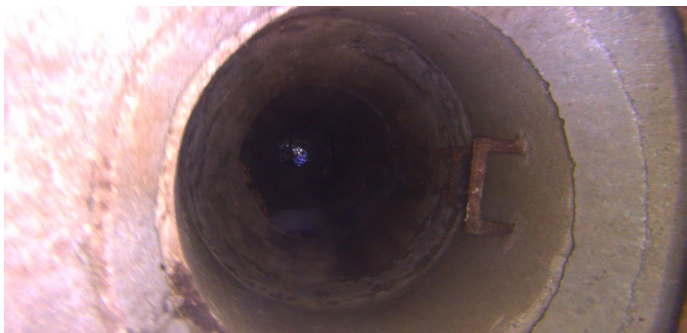
Code: **MGO**
Description: **General Observation**

Distance (ft): **.0**
Structural Grade: **0**
O&M Grade: **0**
Clock Start/From:
Clock To:
1st Value:
2nd Value:
Value Percent:
Step: **NO**
Remarks: **ACCESS MH**

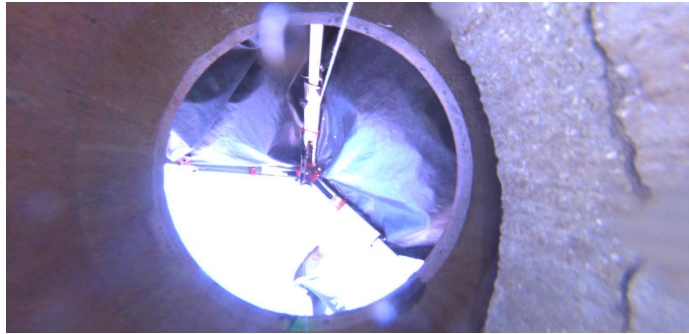
Code:	MGO
Description:	General Observation
Distance (ft):	1.4
Structural Grade:	0
O&M Grade:	0
Clock Start/From:	
Clock To:	
1st Value:	
2nd Value:	
Value Percent:	
Step:	NO
Remarks:	UNDERSIDE OF FRAME

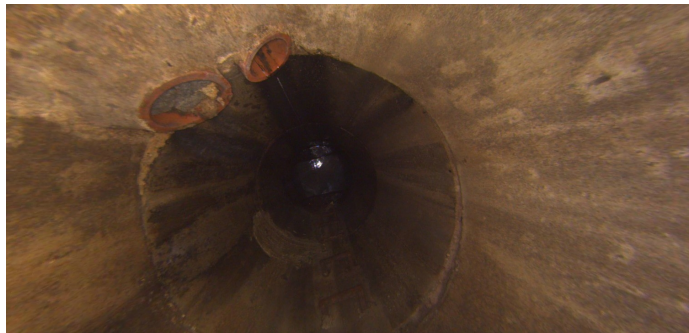
Code:	MGO
Description:	General Observation
Distance (ft):	4.9
Structural Grade:	0
O&M Grade:	0
Clock Start/From:	
Clock To:	
1st Value:	
2nd Value:	
Value Percent:	
Step:	NO
Remarks:	ROBOT POSITION OFFSET

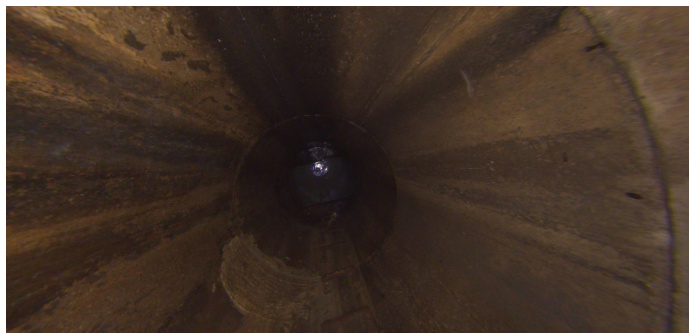
Code:	IW
Description:	Infil Weeper
Distance (ft):	6.7
Structural Grade:	0
O&M Grade:	2
Clock Start/From:	12
Clock To:	12
1st Value:	
2nd Value:	
Value Percent:	
Step:	NO
Remarks:

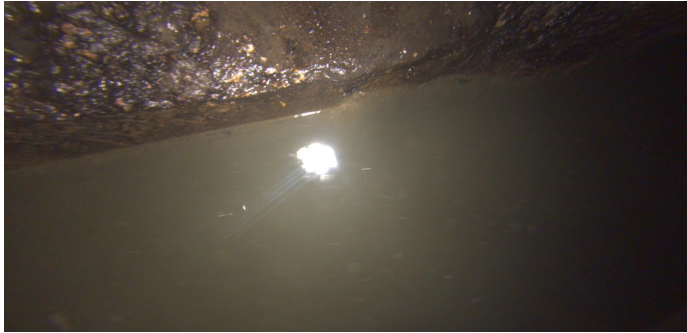
Code:	MGO
Description:	General Observation
Distance (ft):	17.4
Structural Grade:	0
O&M Grade:	0
Clock Start/From:	
Clock To:	
1st Value:	
2nd Value:	
Value Percent:	
Step:	NO
Remarks:	END SURVEY
