Manhole Inspection Report

Date:	04/28/2018	Weather:		Coding:	RZMACP
MH#:	M-604-012	Owner:	NA	Len. Surveyed:	18.4
P.O.#:		Surveyor:	Jen Costello	Rim to Invert:	19.7
Customer:		Cert. #:	U-907-5518	Wall Material:	Concrete (reinforced)

Street:	Old Ridge Rd. 133' East of Beverly Bl	Project:	Hobart, IN
City:	Hobart, IN	GPS Northing:	2904083.269
Location:		GPS Easting:	2904083.269
Drain Area:	Northwest	GPS Accuracy:	Sub-Meter
Cover Shape:	Circular	Evidence of Surcharge:	No
Cover Size:	22.5	Potential for Runoff:	None
Comments:

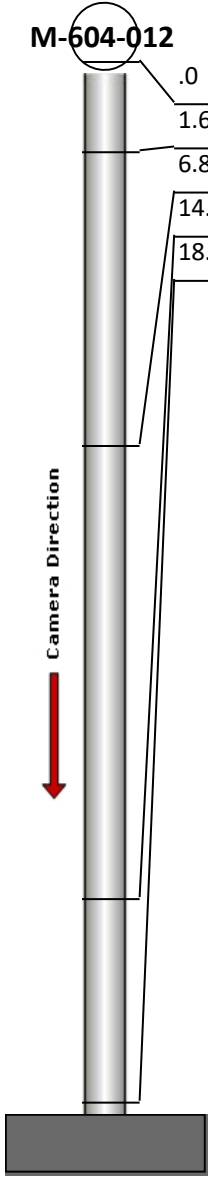
Position	Code	Observation	Video (sec)	Grade

.0	MGO	General Observation	10	NA
	1.6	MGO	General Observation	27	NA
	6.8	IW	Infil Weeper	51	M 2
	14.8	IW	Infil Weeper	78	M 2
	18.4	MGO	General Observation	97	NA

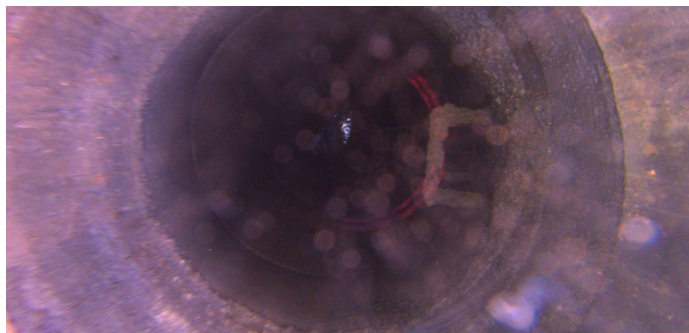
Code: **MGO**
Description: **General Observation**

Distance (ft): **.0**
Structural Grade: **0**
O&M Grade: **0**
Clock Start/From:
Clock To:
1st Value:
2nd Value:
Value Percent:
Step: **NO**
Remarks: **ACCESS MH**

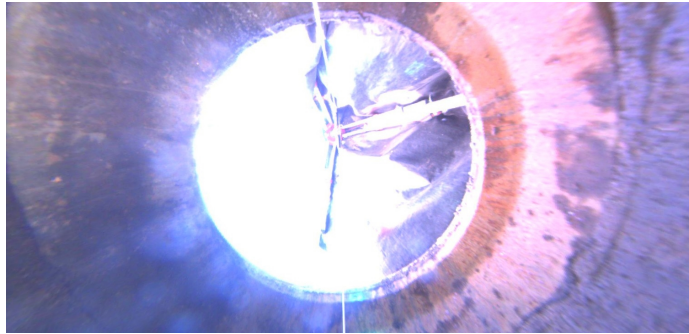
Code:	MGO
Description:	General Observation
Distance (ft):	1.6
Structural Grade:	0
O&M Grade:	0
Clock Start/From:	
Clock To:	
1st Value:	
2nd Value:	
Value Percent:	
Step:	NO
Remarks:	UNDERSIDE OF FRAME

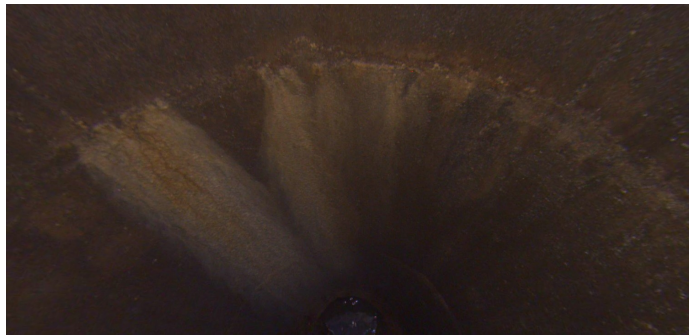
Code:	IW
Description:	Infil Weeper
Distance (ft):	6.8
Structural Grade:	0
O&M Grade:	2
Clock Start/From:	11
Clock To:	12
1st Value:	
2nd Value:	
Value Percent:	
Step:	NO
Remarks:

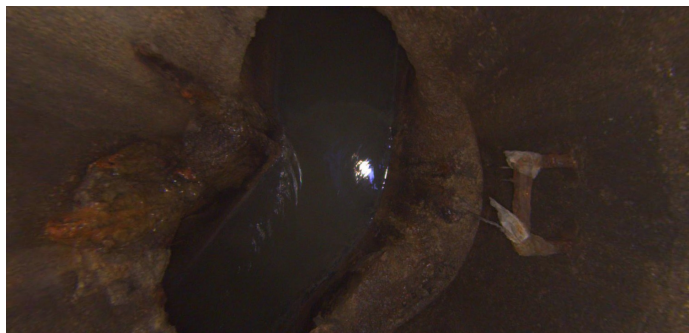
Code:	IW
Description:	Infil Weeper
Distance (ft):	14.8
Structural Grade:	0
O&M Grade:	2
Clock Start/From:	8
Clock To:	11
1st Value:	
2nd Value:	
Value Percent:	
Step:	NO
Remarks:

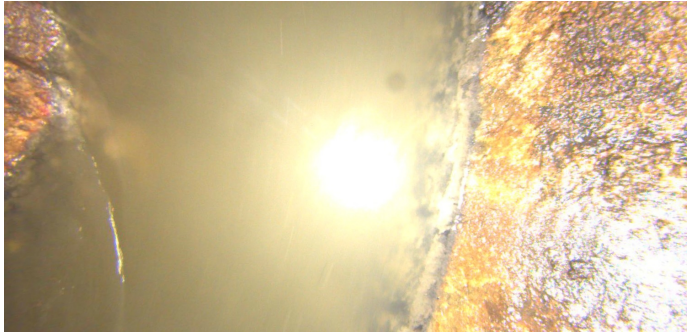
Code: **MGO**
Description: **General Observation**

Distance (ft): **18.4**
Structural Grade: **0**
O&M Grade: **0**
Clock Start/From:
Clock To:
1st Value:
2nd Value:
Value Percent:
Step: **NO**
Remarks: **END SURVEY**
