Manhole Inspection Report

Date:	04/28/2018	Weather:		Coding:	RZMACP
MH#:	M-604-013	Owner:	NA	Len. Surveyed:	17.9
P.O.#:		Surveyor:	Jen Costello	Rim to Invert:	19.6
Customer:		Cert. #:	U-907-5518	Wall Material:	Concrete (reinforced)

Street:	Intersection of Old Ridge Rd. and Be	Project:	Hobart, IN
City:	Hobart, IN	GPS Northing:	2903989.866
Location:		GPS Easting:	2903989.866
Drain Area:	Northwest	GPS Accuracy:	Sub-Meter
Cover Shape:	Circular	Evidence of Surcharge:	No
Cover Size:	22.5	Potential for Runoff:	None
Comments:

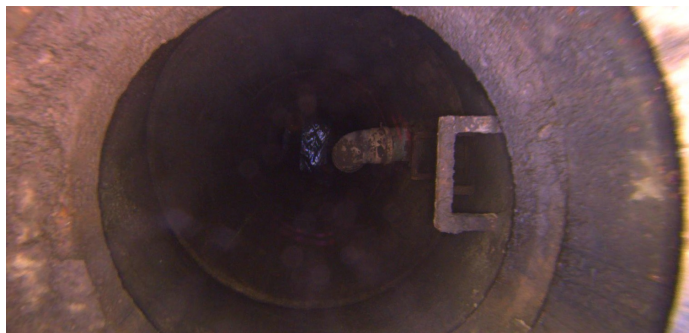
Code: **MGO**
Description: **General Observation**

Distance (ft): **.0**
Structural Grade: **0**
O&M Grade: **0**
Clock Start/From:
Clock To:
1st Value:
2nd Value:
Value Percent:
Step: **NO**
Remarks: **access MH**

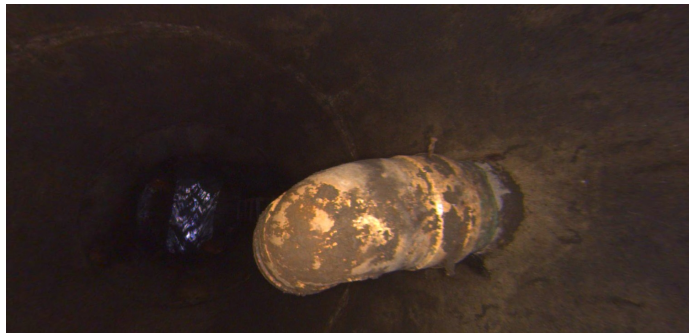
Code: **OBP**
Description: **Obstacle External Pipe or Cable**

Distance (ft): **4.4**
Structural Grade: **0**
O&M Grade: **2**
Clock Start/From: **3**
Clock To:
1st Value:
2nd Value:
Value Percent: **10.000**
Step: **NO**
Remarks:

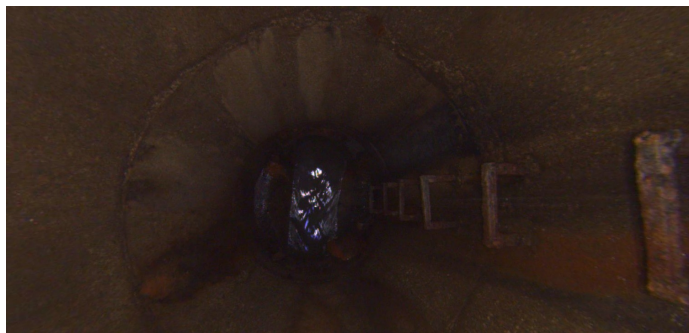
Code: **SAV**
Description: **Surface Aggregate Visible**

Distance (ft): **8.8**
Structural Grade: **3**
O&M Grade: **0**
Clock Start/From: **12**
Clock To: **12**
1st Value:
2nd Value:
Value Percent:
Step: **NO**
Remarks:

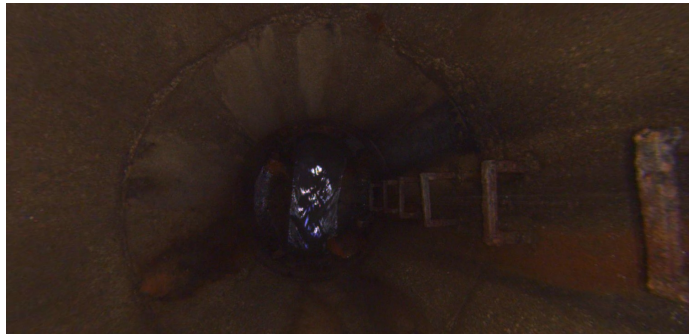
Code: **IW**
Description: **Infil Weeper**

Distance (ft): **8.8**
Structural Grade: **0**
O&M Grade: **2**
Clock Start/From: **12**
Clock To: **12**
1st Value:
2nd Value:
Value Percent:
Step: **NO**
Remarks:

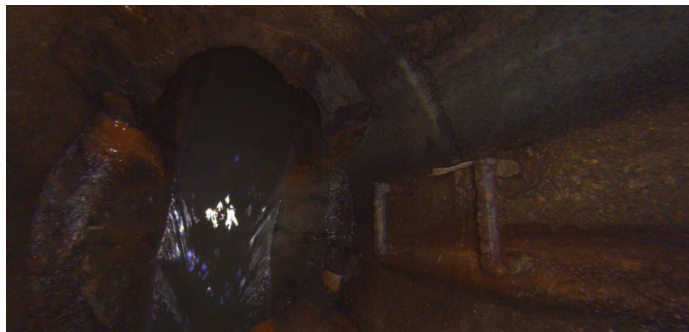
Code: **IW**
Description: **Infil Weeper**

Distance (ft): **13.9**
Structural Grade: **0**
O&M Grade: **2**
Clock Start/From: **4**
Clock To:
1st Value:
2nd Value:
Value Percent:
Step: **NO**
Remarks:

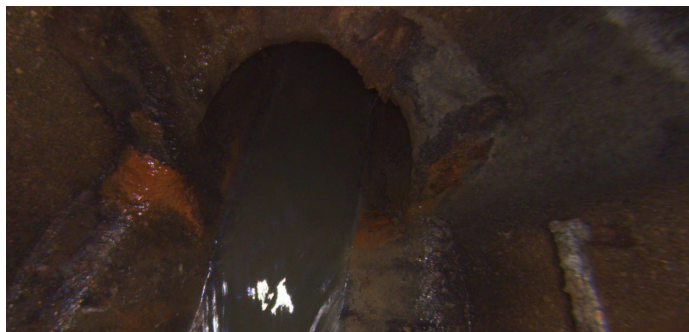
Code: **IW**
Description: **Infil Weeper**

Distance (ft): **15.4**
Structural Grade: **0**
O&M Grade: **2**
Clock Start/From: **10**
Clock To: **2**
1st Value:
2nd Value:
Value Percent:
Step: **NO**
Remarks:

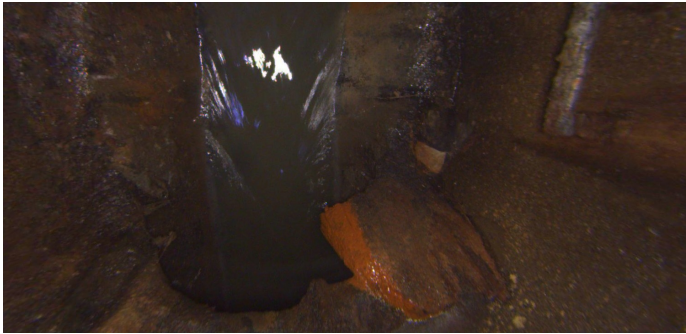
Code: **DAE**
Description: **Deposits Attached Encrustation**

Distance (ft): **15.4**
Structural Grade: **0**
O&M Grade: **2**
Clock Start/From: **4**
Clock To: **5**
1st Value:
2nd Value:
Value Percent: **10.000**
Step: **NO**
Remarks:

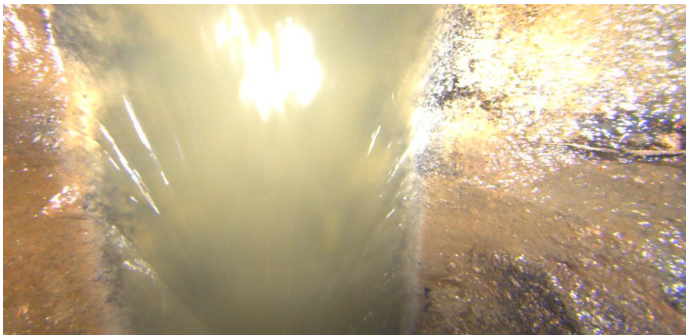
Code: **MGO**
Description: **General Observation**

Distance (ft): **17.9**
Structural Grade: **0**
O&M Grade: **0**
Clock Start/From:
Clock To:
1st Value:
2nd Value:
Value Percent:
Step: **NO**
Remarks: **END SURVEY**
