# Manhole Inspection Report

Date:	<b>05/13/2018</b>	Weather:		Coding:	<b>RZMACP</b>
MH#:	<b>M-604-021</b>	Owner:	<b>NA</b>	Len. Surveyed:	<b>11.8</b>
P.O.#:		Surveyor:	<b>Jen Costello</b>	Rim to Invert:	<b>13.2</b>
Customer:		Cert. #:	<b>U-907-5518</b>	Wall Material:	<b>Concrete (reinforced)</b>

Street:	<b>Intersection of Ridge Rd. and Washi</b>	Project:	<b>Hobart, IN</b>
City:	<b>Hobart, IN</b>	GPS Northing:	<b>2902120.238</b>
Location:		GPS Easting:	<b>2902120.238</b>
Drain Area:	<b>Northwest</b>	GPS Accuracy:	<b>Sub-Meter</b>
Cover Shape:	<b>Circular</b>	Evidence of Surcharge:	<b>No</b>
Cover Size:	<b>22.5</b>	Potential for Runoff:	<b>None</b>
Comments:

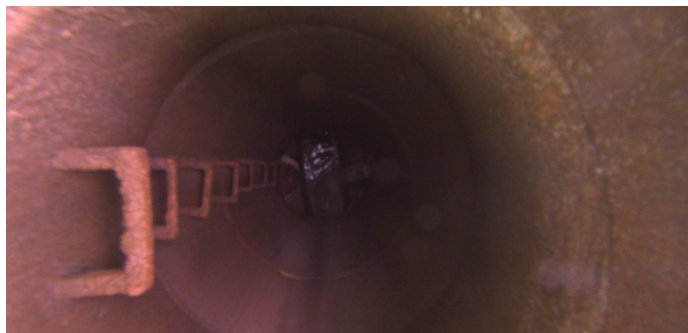
Code: **MGP**  
Description: **General Photo**

Distance (ft): **.0**  
Structural Grade: **0**  
O&M Grade: **0**  
Clock Start/From:  
Clock To:  
1st Value:  
2nd Value:  
Value Percent:  
Step: **NO**  
Remarks: **ACCESS MH**

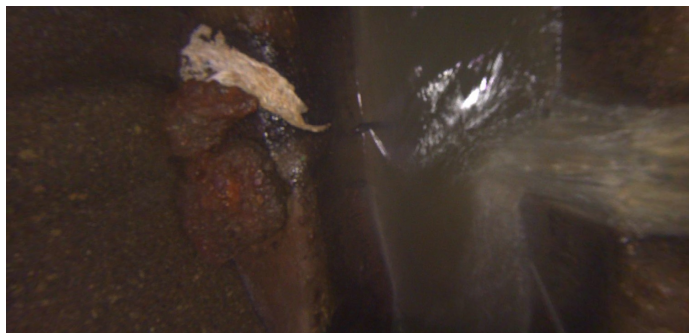
Code: **OBR**  
Description: **Obstacle Rocks**

Distance (ft): **10.9**  
Structural Grade: **0**  
O&M Grade: **2**  
Clock Start/From: **9**  
Clock To:  
1st Value:  
2nd Value:  
Value Percent: **5.000**  
Step: **NO**  
Remarks:
