Manhole Inspection Report

Date:	05/14/2018	Weather:		Coding:	RZMACP
MH#:	M-604-025	Owner:	NA	Len. Surveyed:	10.6
P.O.#:		Surveyor:	Jen Costello	Rim to Invert:	10.5
Customer:		Cert. #:	U-907-5518	Wall Material:	Brick

Street:	Lake Park Ave. 475' North of Old Rid	Project:	Hobart, IN
City:	Hobart, IN	GPS Northing:	2904466.956
Location:		GPS Easting:	2904466.956
Drain Area:	North	GPS Accuracy:	Sub-Meter
Cover Shape:	Circular	Evidence of Surcharge:	No
Cover Size:	22.5	Potential for Runoff:	None
Comments:

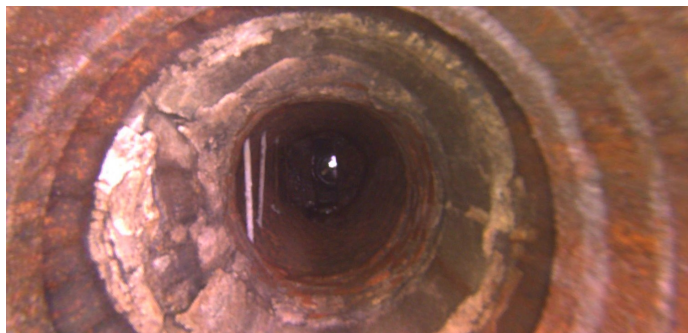
Code: **MGP**
Description: **General Photo**

Distance (ft): **.0**
Structural Grade: **0**
O&M Grade: **0**
Clock Start/From:
Clock To:
1st Value:
2nd Value:
Value Percent:
Step: **NO**
Remarks: **ACCESS MH**

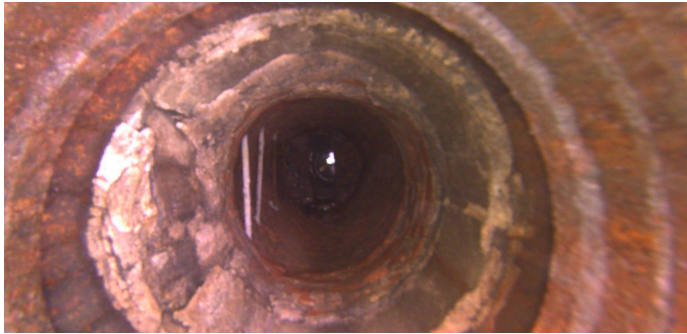
Code: **FM**
Description: **Fracture Multiple**

Distance (ft): **.0**
Structural Grade: **4**
O&M Grade: **0**
Clock Start/From: **8**
Clock To: **10**
1st Value:
2nd Value:
Value Percent:
Step: **NO**
Remarks:

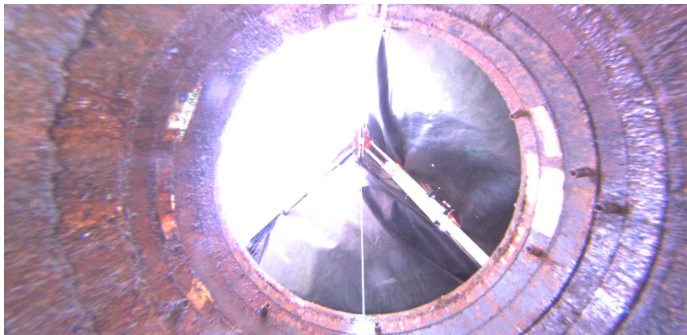
Code: **MGO**
Description: **General Observation**

Distance (ft): **1.3**
Structural Grade: **0**
O&M Grade: **0**
Clock Start/From:
Clock To:
1st Value:
2nd Value:
Value Percent:
Step: **NO**
Remarks: **UNDERSIDE OF FRAME**

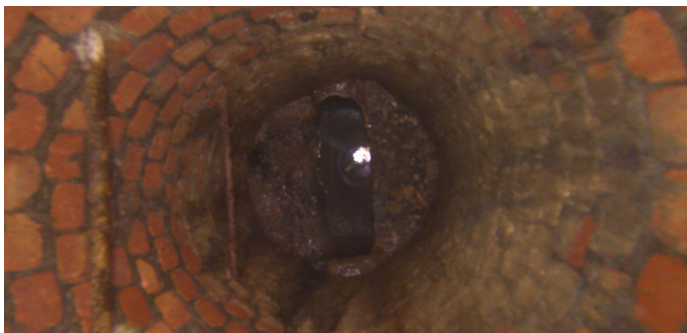
Code: **IS**
Description: **Infil Stain**

Distance (ft): **6.3**
Structural Grade: **0**
O&M Grade: **0**
Clock Start/From: **12**
Clock To: **12**
1st Value:
2nd Value:
Value Percent:
Step: **NO**
Remarks:

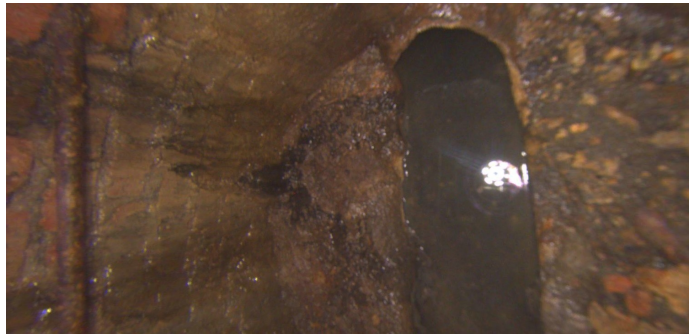
Code: **IW**
Description: **Infil Weeper**

Distance (ft): **8.8**
Structural Grade: **0**
O&M Grade: **2**
Clock Start/From: **10**
Clock To: **11**
1st Value:
2nd Value:
Value Percent:
Step: **NO**
Remarks:

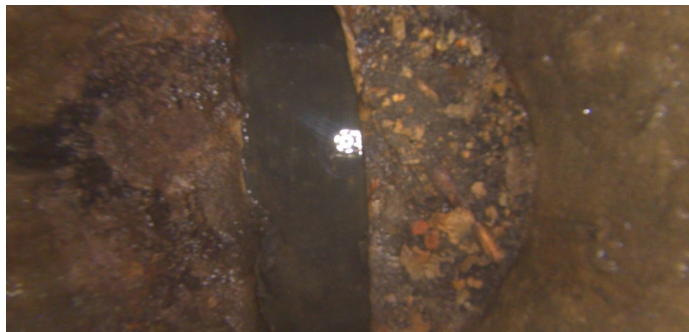
Code: **DSGV**
Description: **Deposits Settled Gravel**

Distance (ft): **9.1**
Structural Grade: **0**
O&M Grade: **2**
Clock Start/From: **12**
Clock To: **12**
1st Value:
2nd Value:
Value Percent: **5.000**
Step: **NO**
Remarks:

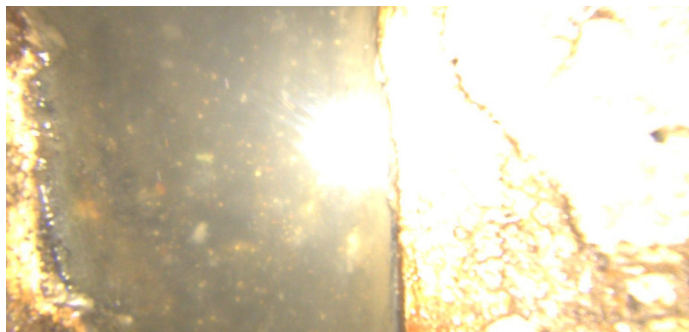
Code: **MGO**
Description: **General Observation**

Distance (ft): **10.6**
Structural Grade: **0**
O&M Grade: **0**
Clock Start/From:
Clock To:
1st Value:
2nd Value:
Value Percent:
Step: **NO**
Remarks: **END SURVEY**
