# Manhole Inspection Report

Date:	<b>10/13/2022</b>	Weather:		Coding:	<b>RZMACP</b>
MH#:	<b>M-604-056</b>	Owner:	<b>NA</b>	Len. Surveyed:	<b>8.4</b>
P.O.#:		Surveyor:	<b>Jen Costello</b>	Rim to Invert:	<b>9.3</b>
Customer:		Cert. #:	<b>U-907-5518</b>	Wall Material:	<b>Brick</b>

Street:	<b>Intersection of Connecticut St. and</b>	Project:	<b>Hobart, IN</b>
City:	<b>Hobart, IN</b>	GPS Northing:	<b>2291572.098</b>
Location:	<b>Local Rural Streets</b>	GPS Easting:	<b>2902794.01</b>
Drain Area:	<b>West</b>	GPS Accuracy:	<b>Sub-Meter</b>
Cover Shape:	<b>Circular</b>	Evidence of Surcharge:	<b>No</b>
Cover Size:	<b>24.0</b>	Potential for Runoff:	<b>None</b>
Comments:

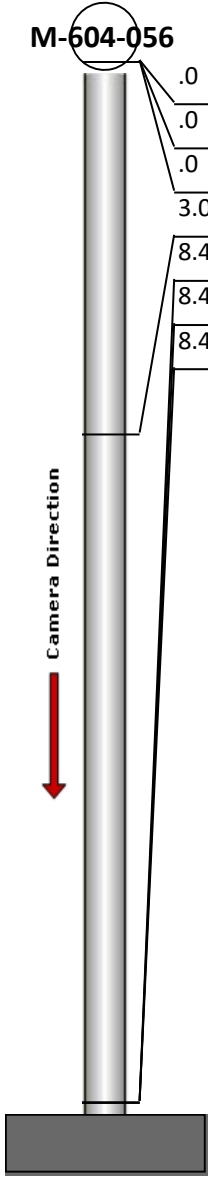
.0	MGO	General Observation	10	NA
	.0	DB	Displaced Brick	22	S 3
	.0	SAV	Surface Aggregate Visible	33	S 3
	3.0	MGO	General Observation	53	NA
	8.4	DSGV	Deposits Settled Gravel	78	M 2
	8.4	MGO	General Observation	89	NA
	8.4	SAV	Surface Aggregate Visible	100	S 3

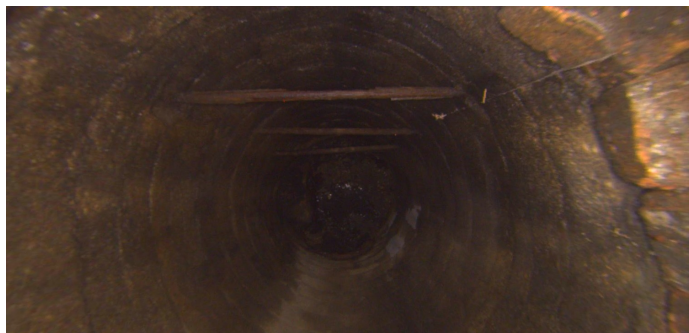
Code: **MGO**  
Description: **General Observation**

Distance (ft): **.0**  
Structural Grade: **0**  
O&M Grade: **0**  
Clock Start/From:  
Clock To:  
1st Value:  
2nd Value:  
Value Percent:  
Step: **NO**  
Remarks: **access mh**

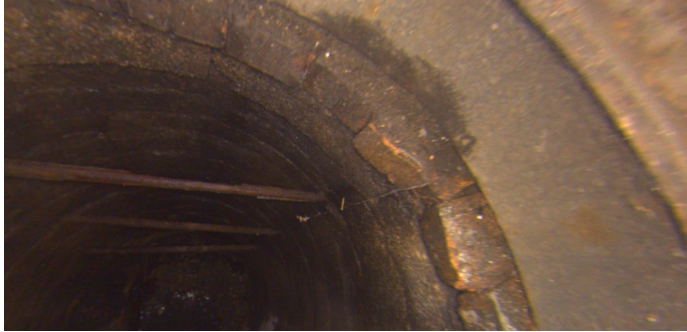
Code: **DB**  
Description: **Displaced Brick**

Distance (ft): **.0**  
Structural Grade: **3**  
O&M Grade: **0**  
Clock Start/From: **12**  
Clock To: **3**  
1st Value:  
2nd Value:  
Value Percent:  
Step: **NO**  
Remarks:

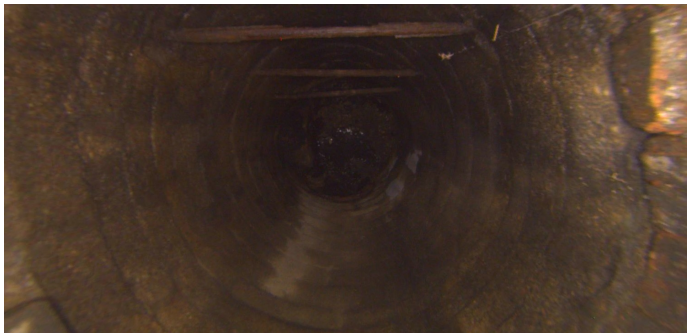
Code: **SAV**  
Description: **Surface Aggregate Visible**

Distance (ft): **.0**  
Structural Grade: **3**  
O&M Grade: **0**  
Clock Start/From: **12**  
Clock To: **12**  
1st Value:  
2nd Value:  
Value Percent:  
Step: **NO**  
Remarks:

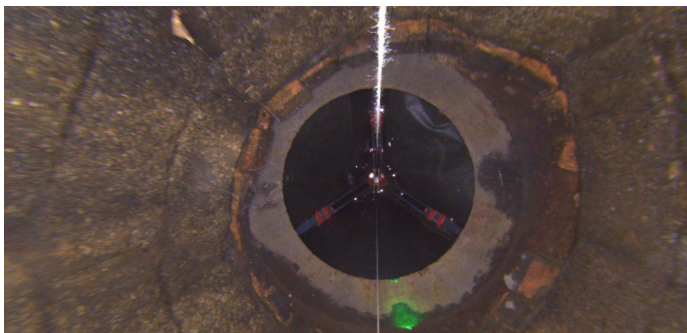
Code: **MGO**  
Description: **General Observation**

Distance (ft): **3.0**  
Structural Grade: **0**  
O&M Grade: **0**  
Clock Start/From:  
Clock To:  
1st Value:  
2nd Value:  
Value Percent:  
Step: **NO**  
Remarks: **underside of frame**

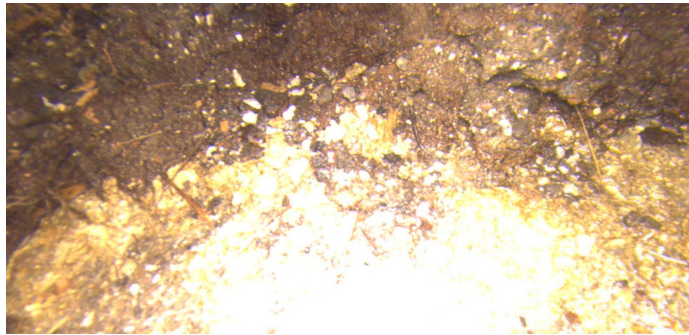
Code: **DSGV**  
Description: **Deposits Settled Gravel**

Distance (ft): **8.4**  
Structural Grade: **0**  
O&M Grade: **2**  
Clock Start/From: **12**  
Clock To: **12**  
1st Value:  
2nd Value:  
Value Percent: **10.000**  
Step: **NO**  
Remarks:

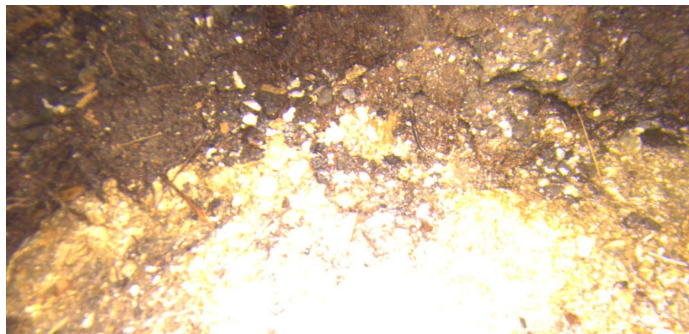
Code: **MGO**  
Description: **General Observation**

Distance (ft): **8.4**  
Structural Grade: **0**  
O&M Grade: **0**  
Clock Start/From:  
Clock To:  
1st Value:  
2nd Value:  
Value Percent:  
Step: **NO**  
Remarks: **end of survey**

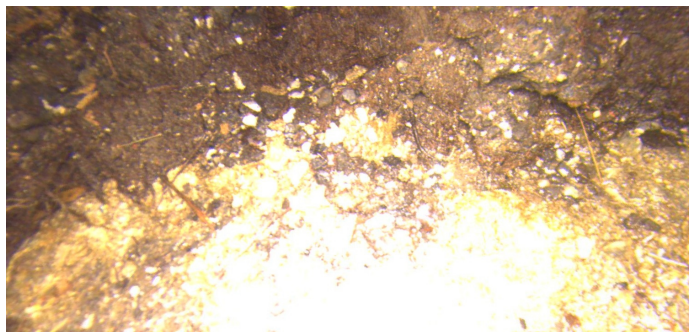
Code: **SAV**  
Description: **Surface Aggregate Visible**

Distance (ft): **8.4**  
Structural Grade: **3**  
O&M Grade: **0**  
Clock Start/From: **12**  
Clock To: **12**  
1st Value:  
2nd Value:  
Value Percent:  
Step: **NO**  
Remarks:
