# Manhole Inspection Report

Date:	<b>04/29/2018</b>	Weather:		Coding:	<b>RZMACP</b>
MH#:	<b>M-604-058</b>	Owner:	<b>NA</b>	Len. Surveyed:	<b>7.1</b>
P.O.#:		Surveyor:	<b>Jen Costello</b>	Rim to Invert:	<b>7.8</b>
Customer:		Cert. #:	<b>U-907-5518</b>	Wall Material:	<b>Brick</b>

Street:	<b>Intersection of Home Ave. and Conn</b>	Project:	<b>Hobart, IN</b>
City:	<b>Hobart, IN</b>	GPS Northing:	<b>2902813.624</b>
Location:		GPS Easting:	<b>2902813.624</b>
Drain Area:	<b>West</b>	GPS Accuracy:	<b>Sub-Meter</b>
Cover Shape:	<b>Circular</b>	Evidence of Surcharge:	<b>No</b>
Cover Size:	<b>22.5</b>	Potential for Runoff:	<b>None</b>
Comments:

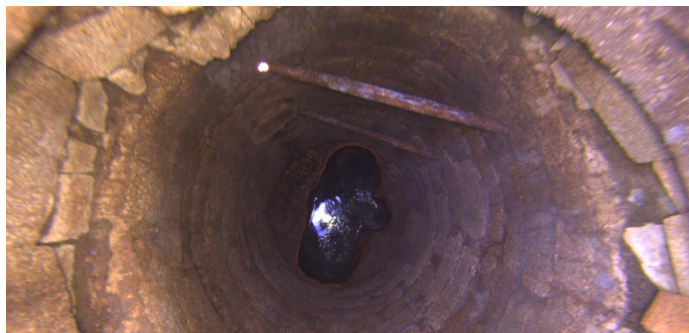
Code: **MGP**  
Description: **General Photo**

Distance (ft): **.0**  
Structural Grade: **0**  
O&M Grade: **0**  
Clock Start/From:  
Clock To:  
1st Value:  
2nd Value:  
Value Percent:  
Step: **NO**  
Remarks: **ACCESS MH**

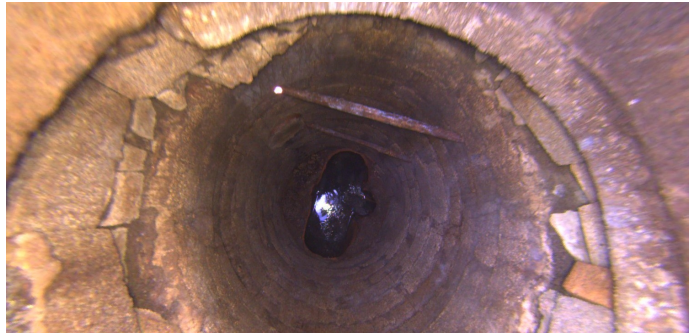
Code: **DB**  
Description: **Displaced Brick**

Distance (ft): **.0**  
Structural Grade: **3**  
O&M Grade: **0**  
Clock Start/From: **8**  
Clock To: **4**  
1st Value:  
2nd Value:  
Value Percent:  
Step: **NO**  
Remarks:

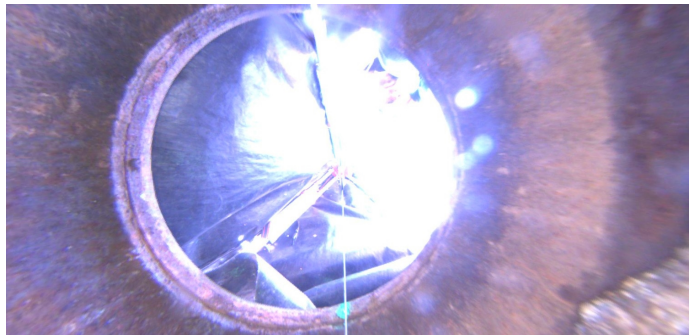
Code: **MGO**  
Description: **General Observation**

Distance (ft): **1.3**  
Structural Grade: **0**  
O&M Grade: **0**  
Clock Start/From:  
Clock To:  
1st Value:  
2nd Value:  
Value Percent:  
Step: **NO**  
Remarks: **UNDERSIDE OF FRAME**

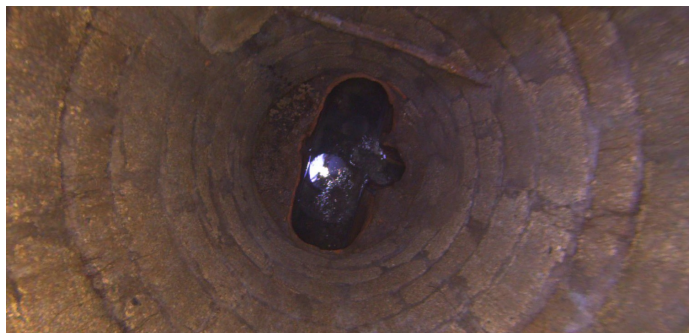
Code: **RFB**  
Description: **Roots Fine Barrel**

Distance (ft): **1.3**  
Structural Grade: **0**  
O&M Grade: **2**  
Clock Start/From: **12**  
Clock To: **12**  
1st Value:  
2nd Value:  
Value Percent:  
Step: **NO**  
Remarks:

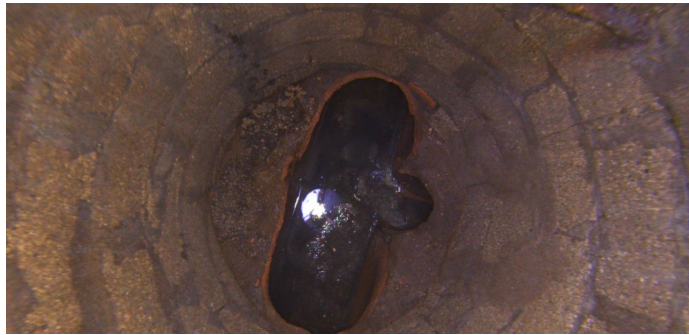
Code: **SAV**  
Description: **Surface Aggregate Visible**

Distance (ft): **3.0**  
Structural Grade: **3**  
O&M Grade: **0**  
Clock Start/From: **12**  
Clock To: **12**  
1st Value:  
2nd Value:  
Value Percent:  
Step: **NO**  
Remarks:

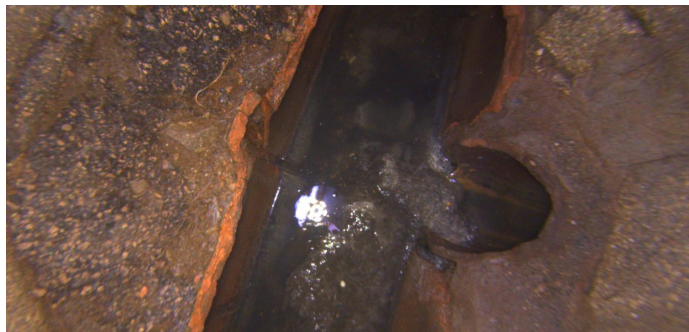
Code: **DSGV**  
Description: **Deposits Settled Gravel**

Distance (ft): **4.8**  
Structural Grade: **0**  
O&M Grade: **2**  
Clock Start/From: **12**  
Clock To: **12**  
1st Value:  
2nd Value:  
Value Percent: **5.000**  
Step: **NO**  
Remarks:

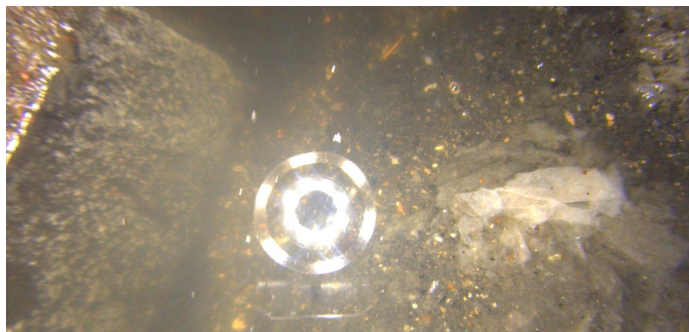
Code: **MGO**  
Description: **General Observation**

Distance (ft): **7.1**  
Structural Grade: **0**  
O&M Grade: **0**  
Clock Start/From:  
Clock To:  
1st Value:  
2nd Value:  
Value Percent:  
Step: **NO**  
Remarks: **END SURVEY**
