Manhole Inspection Report

Date:	04/29/2018	Weather:		Coding:	RZMACP
MH#:	M-604-059	Owner:	NA	Len. Surveyed:	6.3
P.O.#:		Surveyor:	Jen Costello	Rim to Invert:	6.4
Customer:		Cert. #:	U-907-5518	Wall Material:	Brick

Street:	Connecticut St. 219' South of Home	Project:	Hobart, IN
City:	Hobart, IN	GPS Northing:	2902803.629
Location:		GPS Easting:	2902803.629
Drain Area:	West	GPS Accuracy:	Sub-Meter
Cover Shape:	Circular	Evidence of Surcharge:	No
Cover Size:	22.5	Potential for Runoff:	None
Comments:

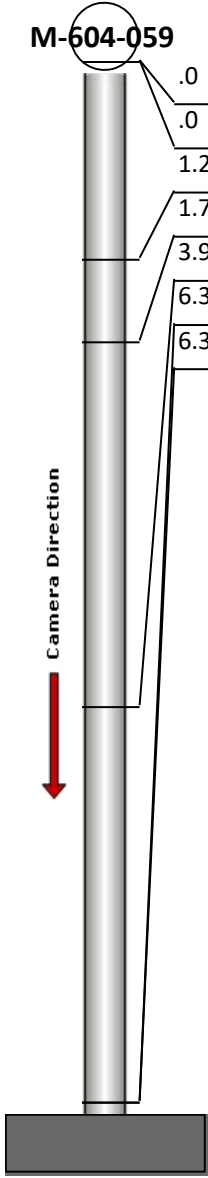
.0	MGO	General Observation	10	NA
	.0	FM	Fracture Multiple	21	S 4
	1.2	MGO	General Observation	37	NA
	1.7	SAV	Surface Aggregate Visible	51	S 3
	3.9	DSF	Deposits Settled Fine	67	M 2
	6.3	MGO	General Observation	83	NA
	6.3	DSF	Deposits Settled Fine	94	M 2

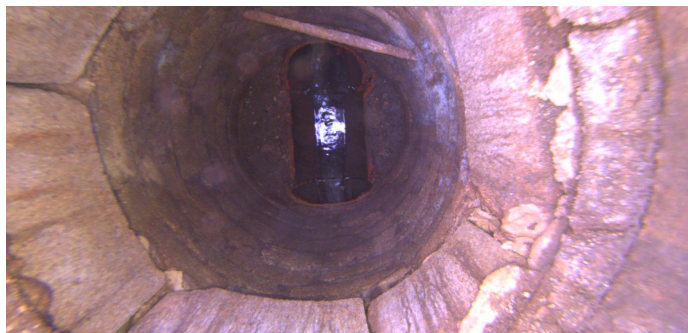
Code: **MGO**
Description: **General Observation**

Distance (ft): **.0**
Structural Grade: **0**
O&M Grade: **0**
Clock Start/From:
Clock To:
1st Value:
2nd Value:
Value Percent:
Step: **NO**
Remarks: **ACCESS MH**

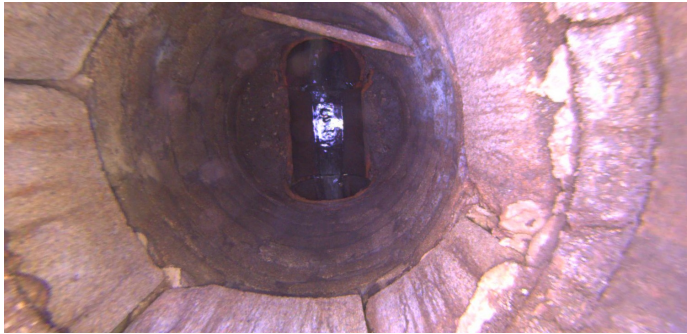
Code: **FM**
Description: **Fracture Multiple**

Distance (ft): **.0**
Structural Grade: **4**
O&M Grade: **0**
Clock Start/From: **2**
Clock To: **5**
1st Value:
2nd Value:
Value Percent:
Step: **NO**
Remarks:

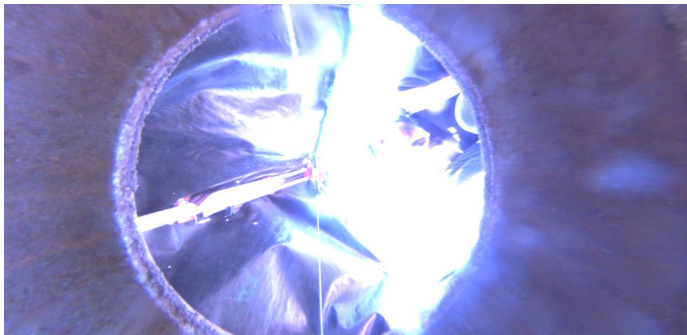
Code: **MGO**
Description: **General Observation**

Distance (ft): **1.2**
Structural Grade: **0**
O&M Grade: **0**
Clock Start/From:
Clock To:
1st Value:
2nd Value:
Value Percent:
Step: **NO**
Remarks: **UNDERSIDE OF FRAME**

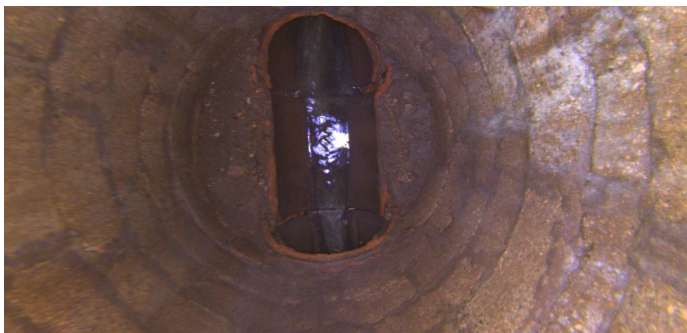
Code: **SAV**
Description: **Surface Aggregate Visible**

Distance (ft): **1.7**
Structural Grade: **3**
O&M Grade: **0**
Clock Start/From: **12**
Clock To: **12**
1st Value:
2nd Value:
Value Percent:
Step: **NO**
Remarks:

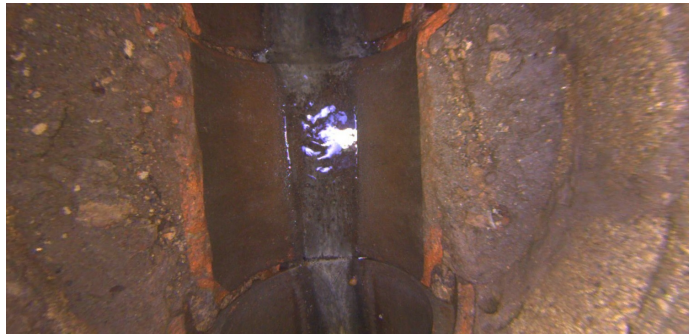
Code: **DSF**
Description: **Deposits Settled Fine**

Distance (ft): **3.9**
Structural Grade: **0**
O&M Grade: **2**
Clock Start/From: **12**
Clock To: **12**
1st Value:
2nd Value:
Value Percent: **5.000**
Step: **NO**
Remarks:

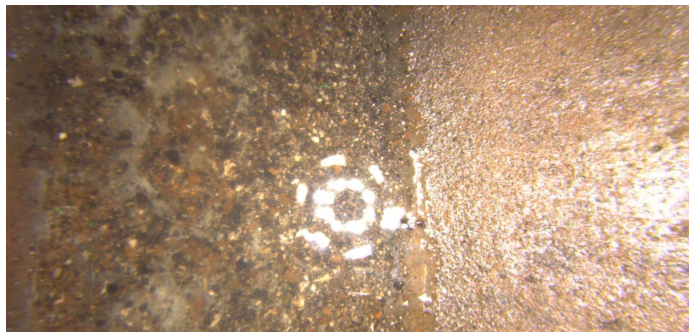
Code: **MGO**
Description: **General Observation**

Distance (ft): **6.3**
Structural Grade: **0**
O&M Grade: **0**
Clock Start/From:
Clock To:
1st Value:
2nd Value:
Value Percent:
Step: **NO**
Remarks: **END SURVEY**

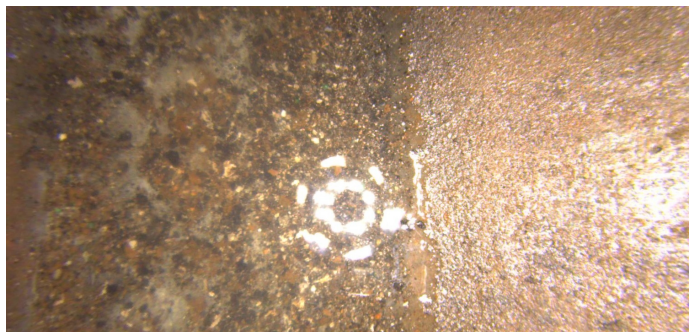
Code: **DSF**
Description: **Deposits Settled Fine**

Distance (ft): **6.3**
Structural Grade: **0**
O&M Grade: **2**
Clock Start/From: **6**
Clock To:
1st Value:
2nd Value:
Value Percent: **5.000**
Step: **NO**
Remarks:
