Manhole Inspection Report

Date:	04/29/2018	Weather:		Coding:	RZMACP
MH#:	M-604-065	Owner:	NA	Len. Surveyed:	2.8
P.O.#:		Surveyor:	Jen Costello	Rim to Invert:	3.0
Customer:		Cert. #:	U-907-5518	Wall Material:	Brick

Street:	Pennsylvania St. 206' North of 1st St	Project:	Hobart, IN
City:	Hobart, IN	GPS Northing:	41.53690338
Location:		GPS Easting:	-87.26696014
Drain Area:	West	GPS Accuracy:	Nearest Meter
Cover Shape:	Circular	Evidence of Surcharge:	No
Cover Size:	24.0	Potential for Runoff:	None
Comments:

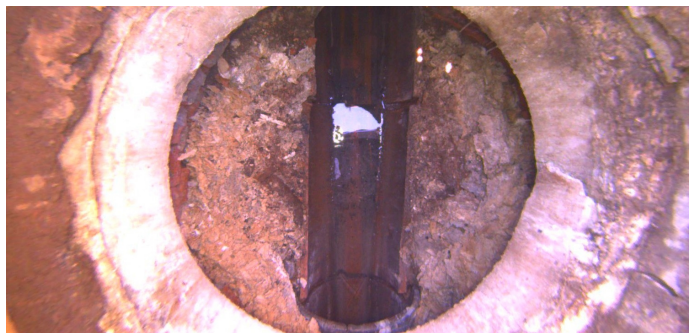
Code: **MGP**
Description: **General Photo**

Distance (ft): **.0**
Structural Grade: **0**
O&M Grade: **0**
Clock Start/From:
Clock To:
1st Value:
2nd Value:
Value Percent:
Step: **NO**
Remarks: **ACCESS MH**

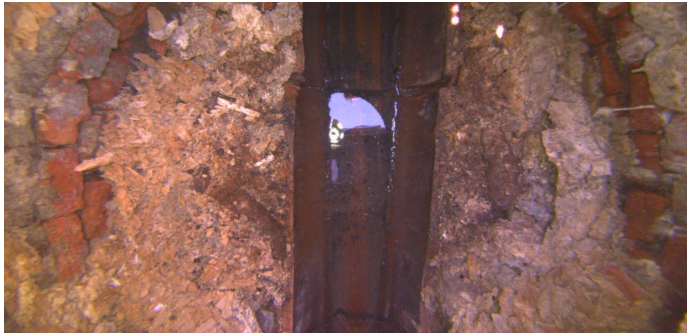
Code: **DSC**
Description: **Deposits Settled Compacted**

Distance (ft): **.7**
Structural Grade: **0**
O&M Grade: **2**
Clock Start/From: **12**
Clock To: **12**
1st Value:
2nd Value:
Value Percent: **10.000**
Step: **NO**
Remarks:

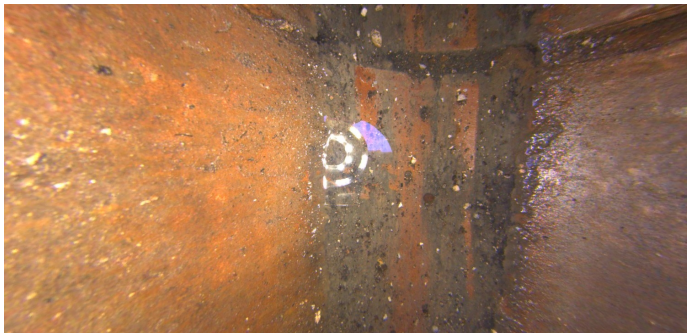
Code: **MGO**
Description: **General Observation**

Distance (ft): **2.8**
Structural Grade: **0**
O&M Grade: **0**
Clock Start/From:
Clock To:
1st Value:
2nd Value:
Value Percent:
Step: **NO**
Remarks: **END SURVEY**
