# Manhole Inspection Report

Date:	<b>04/29/2018</b>	Weather:		Coding:	<b>RZMACP</b>
MH#:	<b>M-604-066</b>	Owner:	<b>NA</b>	Len. Surveyed:	<b>4.5</b>
P.O.#:		Surveyor:	<b>Jen Costello</b>	Rim to Invert:	<b>4.8</b>
Customer:		Cert. #:	<b>U-907-5518</b>	Wall Material:	<b>Brick</b>

Street:	<b>Pennsylvania St. 232' South of Home</b>	Project:	<b>Hobart, IN</b>
City:	<b>Hobart, IN</b>	GPS Northing:	<b>2902477.301</b>
Location:		GPS Easting:	<b>2902477.301</b>
Drain Area:	<b>West</b>	GPS Accuracy:	<b>Sub-Meter</b>
Cover Shape:	<b>Circular</b>	Evidence of Surcharge:	<b>No</b>
Cover Size:	<b>24.0</b>	Potential for Runoff:	<b>None</b>
Comments:

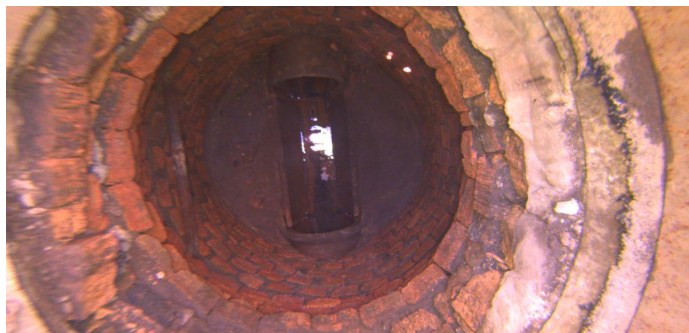
Code: **MGP**  
Description: **General Photo**

Distance (ft): **.0**  
Structural Grade: **0**  
O&M Grade: **0**  
Clock Start/From:  
Clock To:  
1st Value:  
2nd Value:  
Value Percent:  
Step: **NO**  
Remarks: **ACCESS MH**

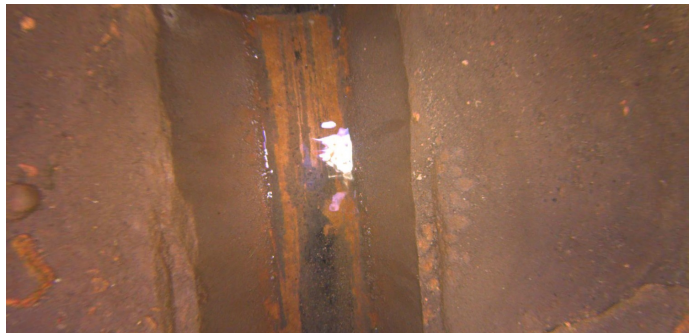
Code: **DSF**  
Description: **Deposits Settled Fine**

Distance (ft): **3.2**  
Structural Grade: **0**  
O&M Grade: **2**  
Clock Start/From: **12**  
Clock To: **12**  
1st Value:  
2nd Value:  
Value Percent: **5.000**  
Step: **NO**  
Remarks:

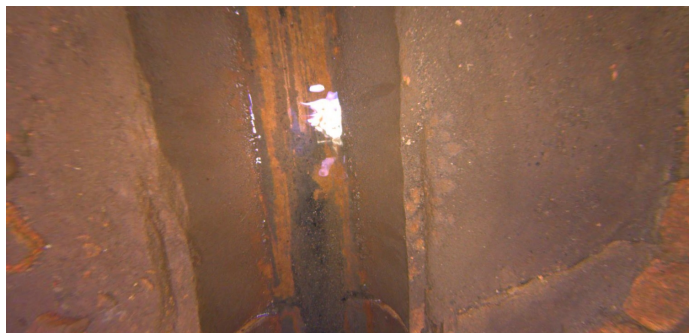
Code: **FS**  
Description: **Fracture Spiral**

Distance (ft): **3.2**  
Structural Grade: **3**  
O&M Grade: **0**  
Clock Start/From: **4**  
Clock To: **6**  
1st Value:  
2nd Value:  
Value Percent:  
Step: **NO**  
Remarks:
