Manhole Inspection Report

Date:	10/13/2022	Weather:		Coding:	RZMACP
MH#:	M-604-069	Owner:	NA	Len. Surveyed:	9.7
P.O.#:		Surveyor:	Jen Costello	Rim to Invert:	10.5
Customer:		Cert. #:	U-907-5518	Wall Material:	Brick

Street:	South of Old Ridge Rd. 59' East of W	Project:	Hobart, IN
City:	Hobart, IN	GPS Northing:	2291454.297
Location:	Local Rural Streets	GPS Easting:	2902206.58
Drain Area:	West	GPS Accuracy:	Sub-Meter
Cover Shape:	Circular	Evidence of Surcharge:	No
Cover Size:	24.0	Potential for Runoff:	None
Comments:

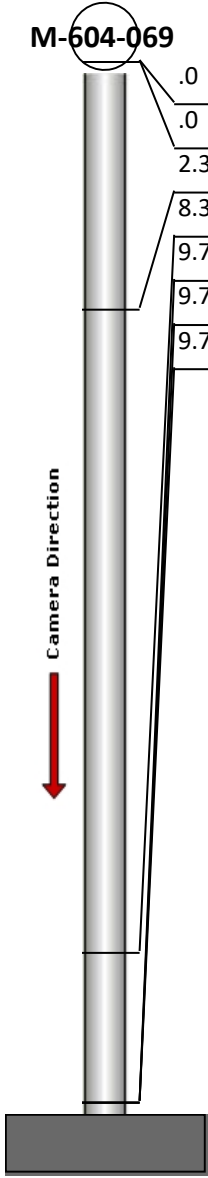
.0	MGO	General Observation	10	NA
	.0	SAV	Surface Aggregate Visible	21	S 3
	2.3	MGO	General Observation	39	NA
	8.3	IW	Infil Weeper	65	M 2
	9.7	DSF	Deposits Settled Fine	79	M 2
	9.7	MGO	General Observation	91	NA
	9.7	SAV	Surface Aggregate Visible	102	S 3

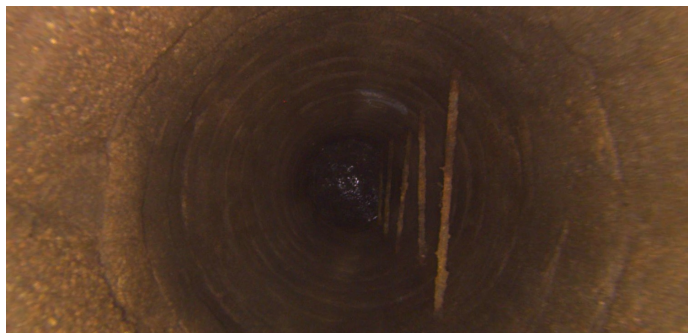
Code: **MGO**
Description: **General Observation**

Distance (ft): **.0**
Structural Grade: **0**
O&M Grade: **0**
Clock Start/From:
Clock To:
1st Value:
2nd Value:
Value Percent:
Step: **NO**
Remarks: **access mh**

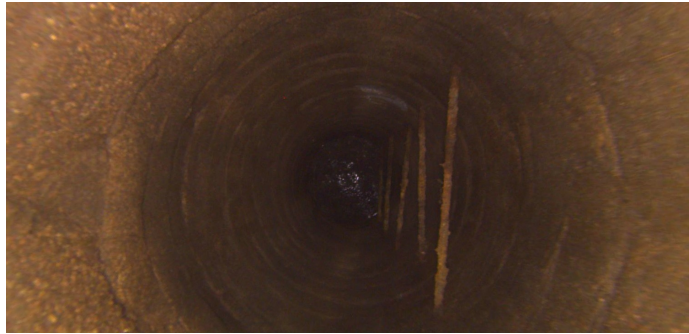
Code:	SAV
Description:	Surface Aggregate Visible
Distance (ft):	.0
Structural Grade:	3
O&M Grade:	0
Clock Start/From:	12
Clock To:	12
1st Value:	
2nd Value:	
Value Percent:	
Step:	NO
Remarks:

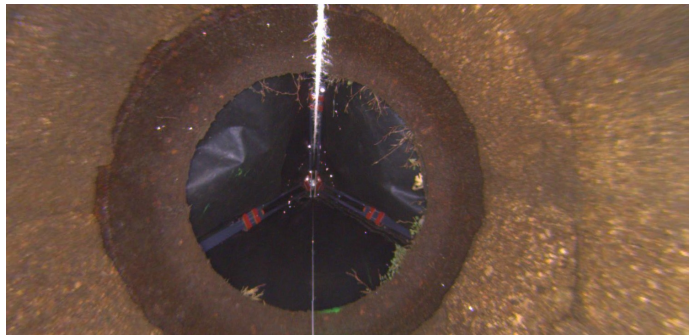
Code:	MGO
Description:	General Observation
Distance (ft):	2.3
Structural Grade:	0
O&M Grade:	0
Clock Start/From:	
Clock To:	
1st Value:	
2nd Value:	
Value Percent:	
Step:	NO
Remarks:	underside of frame

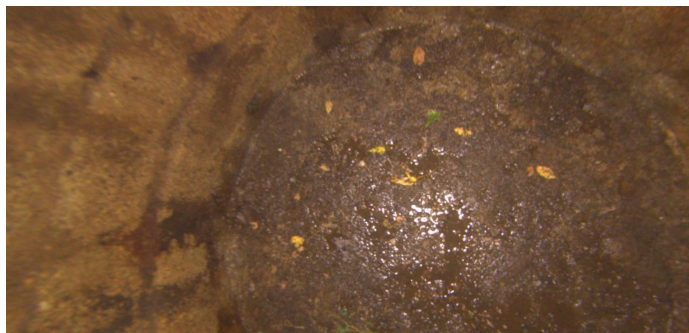
Code:	IW
Description:	Infil Weeper
Distance (ft):	8.3
Structural Grade:	0
O&M Grade:	2
Clock Start/From:	12
Clock To:	12
1st Value:	
2nd Value:	
Value Percent:	
Step:	NO
Remarks:

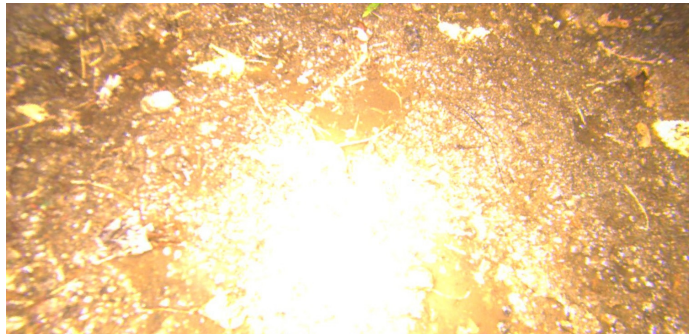
Code: **DSF**
Description: **Deposits Settled Fine**

Distance (ft): **9.7**
Structural Grade: **0**
O&M Grade: **2**
Clock Start/From: **12**
Clock To: **12**
1st Value:
2nd Value:
Value Percent: **5.000**
Step: **NO**
Remarks:

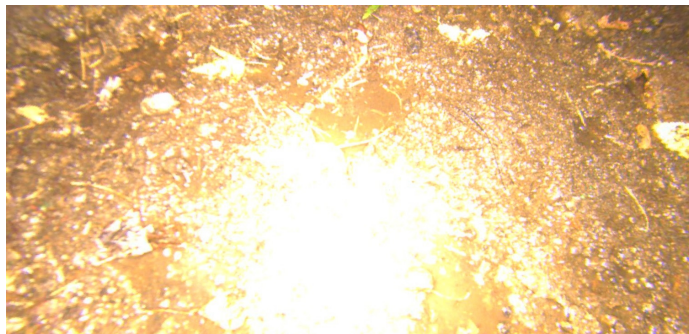
Code: **MGO**
Description: **General Observation**

Distance (ft): **9.7**
Structural Grade: **0**
O&M Grade: **0**
Clock Start/From:
Clock To:
1st Value:
2nd Value:
Value Percent:
Step: **NO**
Remarks: **end of survey**

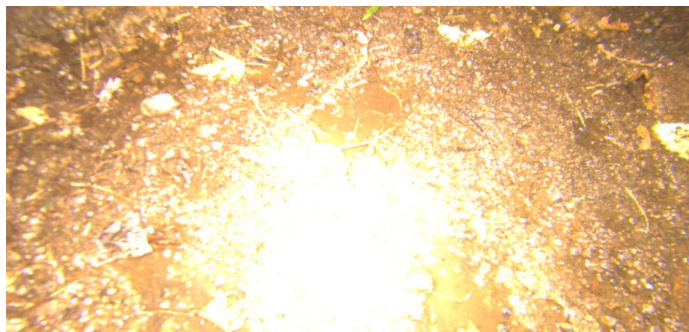
Code: **SAV**
Description: **Surface Aggregate Visible**

Distance (ft): **9.7**
Structural Grade: **3**
O&M Grade: **0**
Clock Start/From: **12**
Clock To: **12**
1st Value:
2nd Value:
Value Percent:
Step: **NO**
Remarks:
