Manhole Inspection Report

Date:	05/13/2018	Weather:		Coding:	RZMACP
MH#:	M-604-082	Owner:	NA	Len. Surveyed:	6.7
P.O.#:		Surveyor:	Jen Costello	Rim to Invert:	7.1
Customer:		Cert. #:	U-907-5518	Wall Material:	Brick

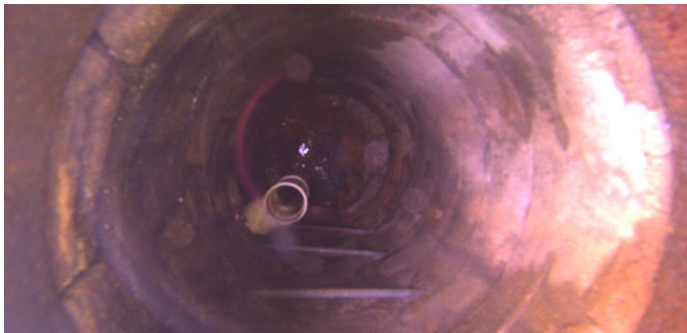
Code: **MGO**
Description: **General Observation**

Distance (ft): **.0**
Structural Grade: **0**
O&M Grade: **0**
Clock Start/From:
Clock To:
1st Value:
2nd Value:
Value Percent:
Step: **NO**
Remarks: **ACCESS MH**

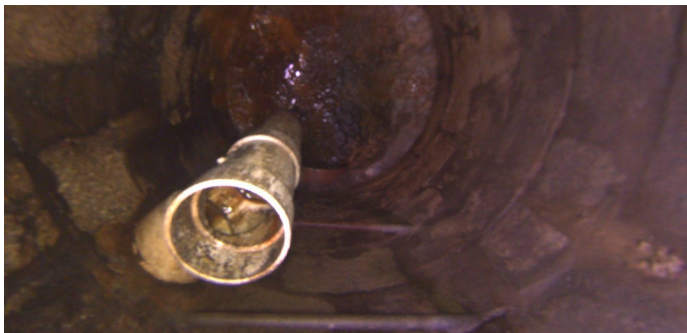
Code: **IW**
Description: **Infil Weeper**

Distance (ft): **2.8**
Structural Grade: **0**
O&M Grade: **2**
Clock Start/From: **8**
Clock To: **9**
1st Value:
2nd Value:
Value Percent:
Step: **NO**
Remarks:

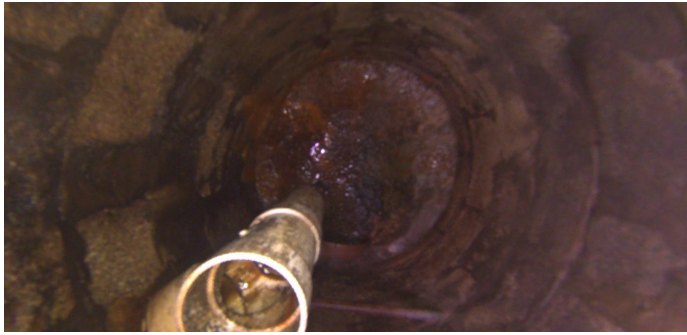
Code: **OBP**
Description: **Obstacle External Pipe or Cable**

Distance (ft): **2.9**
Structural Grade: **0**
O&M Grade: **2**
Clock Start/From: **8**
Clock To:
1st Value:
2nd Value:
Value Percent: **10.000**
Step: **NO**
Remarks:

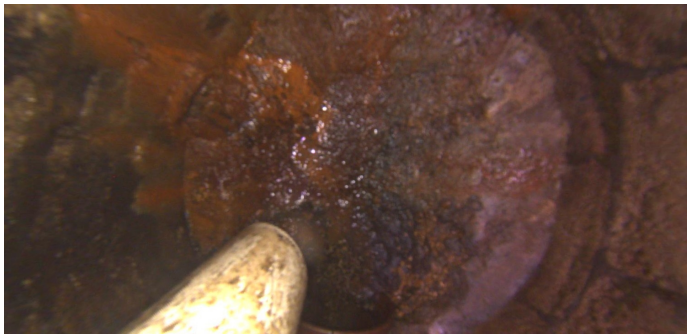
Code: **IW**
Description: **Infil Weeper**

Distance (ft): **4.9**
Structural Grade: **0**
O&M Grade: **2**
Clock Start/From: **9**
Clock To: **10**
1st Value:
2nd Value:
Value Percent:
Step: **NO**
Remarks:

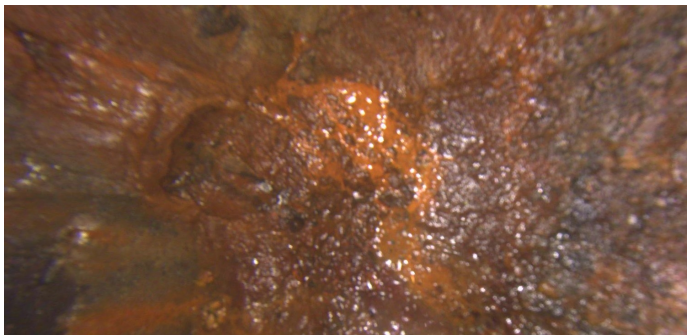
Code: **DAE**
Description: **Deposits Attached Encrustation**

Distance (ft): **6.2**
Structural Grade: **0**
O&M Grade: **2**
Clock Start/From: **8**
Clock To: **9**
1st Value:
2nd Value:
Value Percent: **5.000**
Step: **NO**
Remarks:
