# Manhole Inspection Report

Date:	<b>05/13/2018</b>	Weather:		Coding:	<b>RZMACP</b>
MH#:	<b>M-604-089</b>	Owner:	<b>NA</b>	Len. Surveyed:	<b>13.1</b>
P.O.#:		Surveyor:	<b>Jen Costello</b>	Rim to Invert:	<b>13.5</b>
Customer:		Cert. #:	<b>U-907-5518</b>	Wall Material:	<b>Brick</b>

Street:	<b>173' North of Ridge Rd. 193' West of</b>	Project:	<b>Hobart, IN</b>
City:	<b>Hobart, IN</b>	GPS Northing:	<b>2902553.581</b>
Location:		GPS Easting:	<b>2902553.581</b>
Drain Area:	<b>Northwest</b>	GPS Accuracy:	<b>Sub-Meter</b>
Cover Shape:	<b>Circular</b>	Evidence of Surcharge:	<b>No</b>
Cover Size:	<b>22.5</b>	Potential for Runoff:	<b>None</b>
Comments:

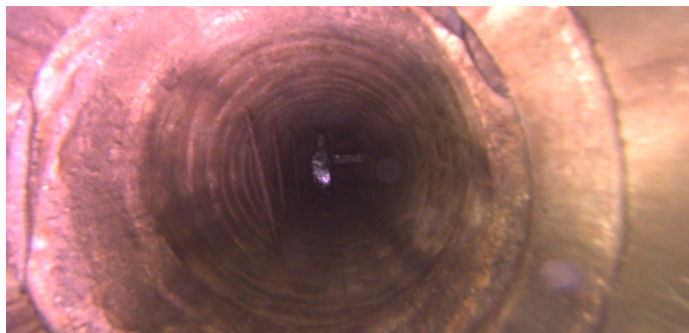
Code: **MGP**  
Description: **General Photo**

Distance (ft): **.0**  
Structural Grade: **0**  
O&M Grade: **0**  
Clock Start/From:  
Clock To:  
1st Value:  
2nd Value:  
Value Percent:  
Step: **NO**  
Remarks: **ACCESS MH**

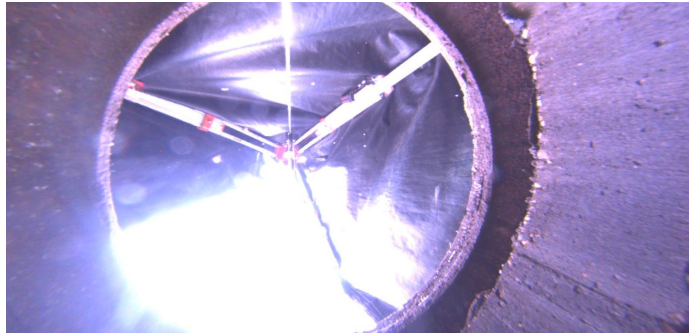
Code:	<b>MGO</b>
Description:	<b>General Observation</b>
Distance (ft):	<b>1.1</b>
Structural Grade:	<b>0</b>
O&M Grade:	<b>0</b>
Clock Start/From:	
Clock To:	
1st Value:	
2nd Value:	
Value Percent:	
Step:	<b>NO</b>
Remarks:	<b>UNDERSIDE OF FRAME</b>

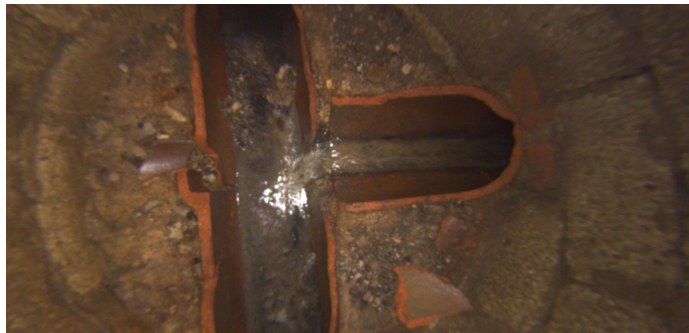
Code:	<b>DSGV</b>
Description:	<b>Deposits Settled Gravel</b>
Distance (ft):	<b>11.5</b>
Structural Grade:	<b>0</b>
O&M Grade:	<b>2</b>
Clock Start/From:	<b>12</b>
Clock To:	<b>12</b>
1st Value:	
2nd Value:	
Value Percent:	<b>5.000</b>
Step:	<b>NO</b>
Remarks:

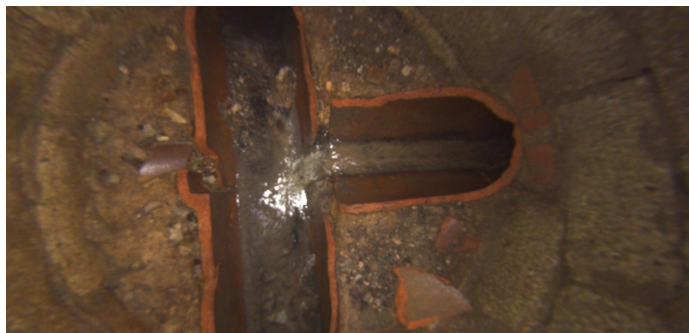
Code:	<b>OBM</b>
Description:	<b>Obstacle Pipe Material</b>
Distance (ft):	<b>11.5</b>
Structural Grade:	<b>0</b>
O&M Grade:	<b>2</b>
Clock Start/From:	<b>5</b>
Clock To:	
1st Value:	
2nd Value:	
Value Percent:	<b>5.000</b>
Step:	<b>NO</b>
Remarks:

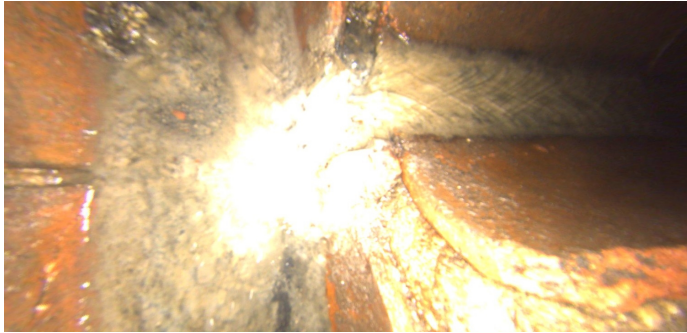
Code: **MGO**  
Description: **General Observation**

Distance (ft): **13.1**  
Structural Grade: **0**  
O&M Grade: **0**  
Clock Start/From:  
Clock To:  
1st Value:  
2nd Value:  
Value Percent:  
Step: **NO**  
Remarks: **END SURVEY**
