Manhole Inspection Report

Date:	05/13/2018	Weather:		Coding:	RZMACP
MH#:	M-604-091	Owner:	NA	Len. Surveyed:	10.9
P.O.#:		Surveyor:	Jen Costello	Rim to Invert:	11.0
Customer:		Cert. #:	U-907-5518	Wall Material:	Concrete (reinforced)

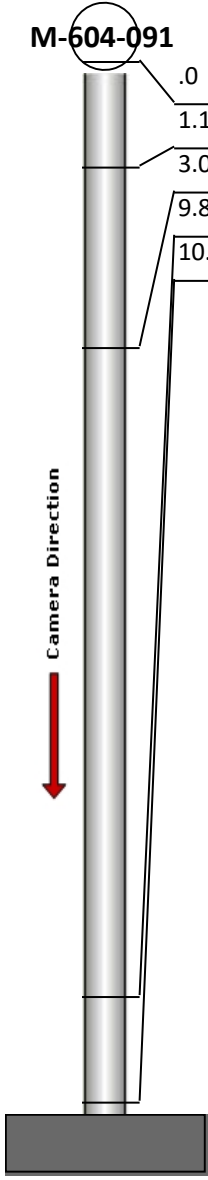
.0	MGP	General Photo	10	NA
	1.1	MGO	General Observation	26	NA
	3.0	MGO	General Observation	42	NA
	9.8	OBR	Obstacle Rocks	67	M 2
	10.9	MGO	General Observation	81	NA

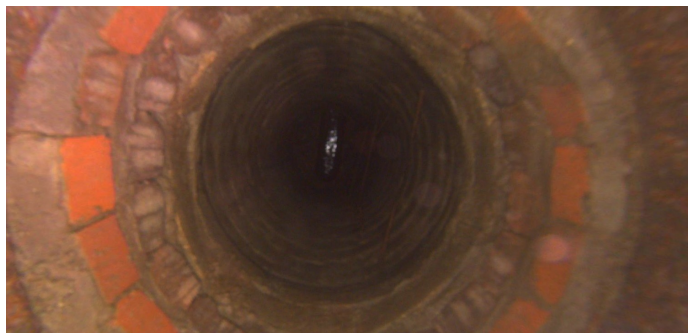
Code: **MGP**
Description: **General Photo**

Distance (ft): **.0**
Structural Grade: **0**
O&M Grade: **0**
Clock Start/From:
Clock To:
1st Value:
2nd Value:
Value Percent:
Step: **NO**
Remarks: **ACCESS MH**

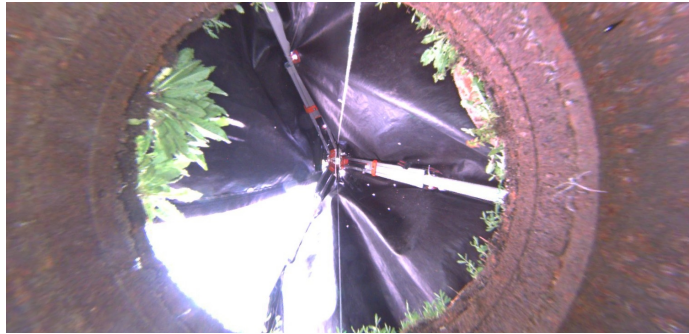
Code: **MGO**
Description: **General Observation**

Distance (ft): **1.1**
Structural Grade: **0**
O&M Grade: **0**
Clock Start/From:
Clock To:
1st Value:
2nd Value:
Value Percent:
Step: **NO**
Remarks: **UNDERSIDE OF FRAME**

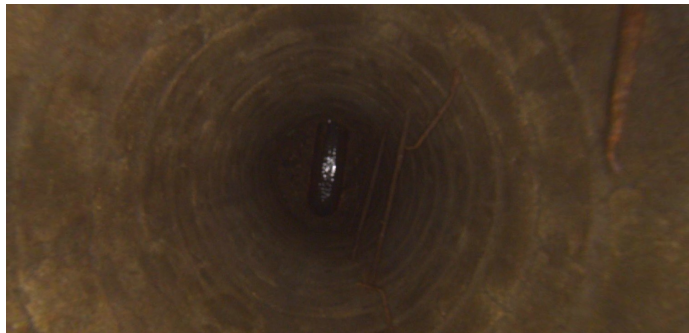
Code: **MGO**
Description: **General Observation**

Distance (ft): **3.0**
Structural Grade: **0**
O&M Grade: **0**
Clock Start/From:
Clock To:
1st Value:
2nd Value:
Value Percent:
Step: **NO**
Remarks: **MISSING AND BROKEN STEP**

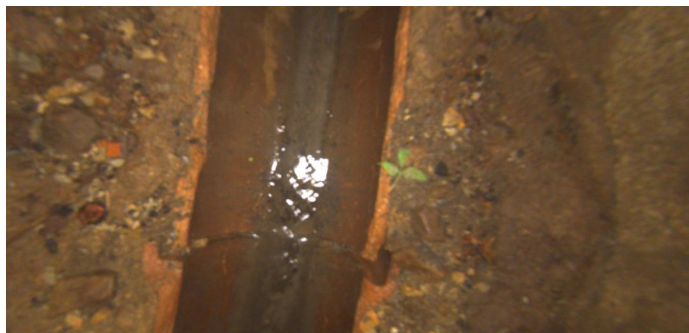
Code: **OBR**
Description: **Obstacle Rocks**

Distance (ft): **9.8**
Structural Grade: **0**
O&M Grade: **2**
Clock Start/From: **12**
Clock To: **12**
1st Value:
2nd Value:
Value Percent: **5.000**
Step: **NO**
Remarks:

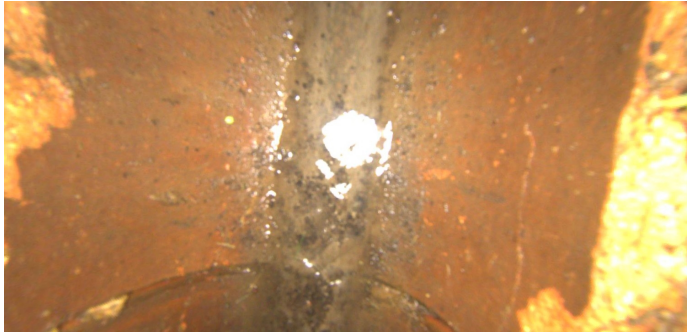
Code:	MGO
Description:	General Observation
Distance (ft):	10.9
Structural Grade:	0
O&M Grade:	0
Clock Start/From:	
Clock To:	
1st Value:	
2nd Value:	
Value Percent:	
Step:	NO
Remarks:	END SURVEY
