# Manhole Inspection Report

Date:	<b>05/13/2018</b>	Weather:		Coding:	<b>RZMACP</b>
MH#:	<b>M-604-093</b>	Owner:	<b>NA</b>	Len. Surveyed:	<b>7.2</b>
P.O.#:		Surveyor:	<b>Jen Costello</b>	Rim to Invert:	<b>7.5</b>
Customer:		Cert. #:	<b>U-907-5518</b>	Wall Material:	<b>Concrete (reinforced)</b>

Street:	<b>Connecticut St. and Pennsylvania St.</b>	Project:	<b>Hobart, IN</b>
City:	<b>Hobart, IN</b>	GPS Northing:	<b>2902538.617</b>
Location:		GPS Easting:	<b>2902538.617</b>
Drain Area:	<b>Northwest</b>	GPS Accuracy:	<b>Sub-Meter</b>
Cover Shape:	<b>Circular</b>	Evidence of Surcharge:	<b>No</b>
Cover Size:	<b>22.5</b>	Potential for Runoff:	<b>None</b>
Comments:

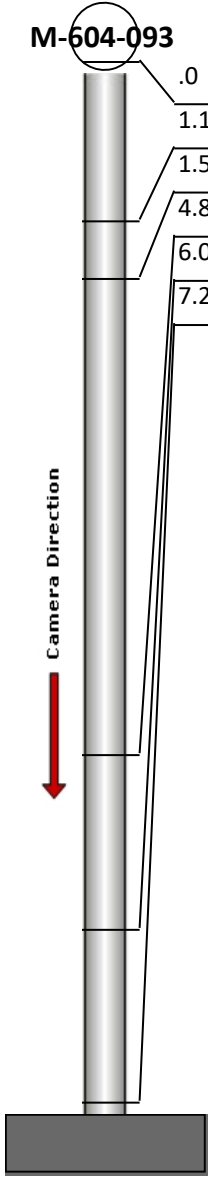
.0	MGP	General Photo	10	NA
	1.1	B	Broken	24	S 3
	1.5	MGO	General Observation	38	NA
	4.8	OBZ	Obstacle Other	58	M 2
	6.0	OBR	Obstacle Rocks	72	M 2
	7.2	MGO	General Observation	86	NA

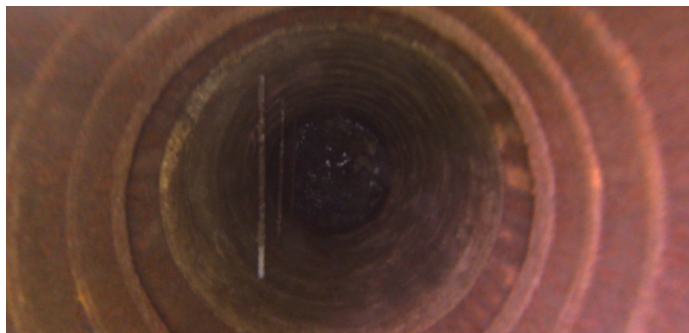
Code: **MGP**  
Description: **General Photo**

Distance (ft): **.0**  
Structural Grade: **0**  
O&M Grade: **0**  
Clock Start/From:  
Clock To:  
1st Value:  
2nd Value:  
Value Percent:  
Step: **NO**  
Remarks: **ACCESS MH**

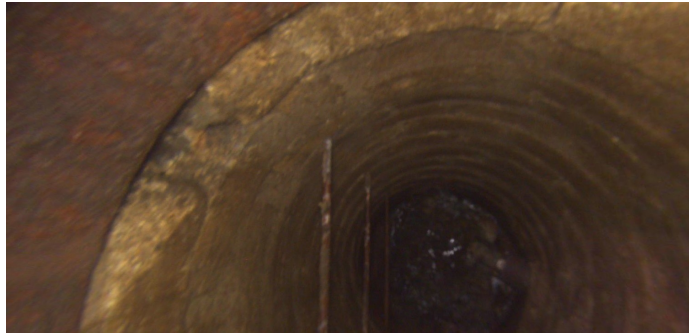
Code: **B**  
Description: **Broken**

Distance (ft): **1.1**  
Structural Grade: **3**  
O&M Grade: **0**  
Clock Start/From: **10**  
Clock To:  
1st Value:  
2nd Value:  
Value Percent:  
Step: **NO**  
Remarks:

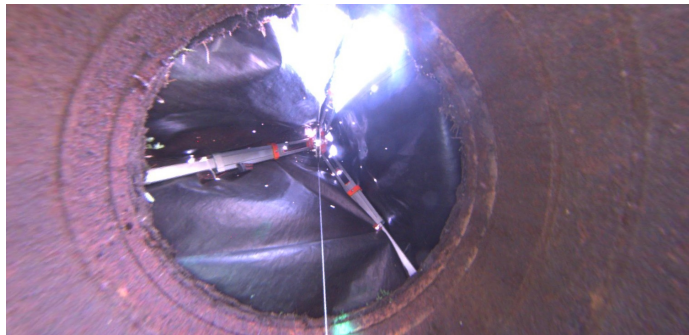
Code: **MGO**  
Description: **General Observation**

Distance (ft): **1.5**  
Structural Grade: **0**  
O&M Grade: **0**  
Clock Start/From:  
Clock To:  
1st Value:  
2nd Value:  
Value Percent:  
Step: **NO**  
Remarks: **UNDERSIDE OF FRAME**

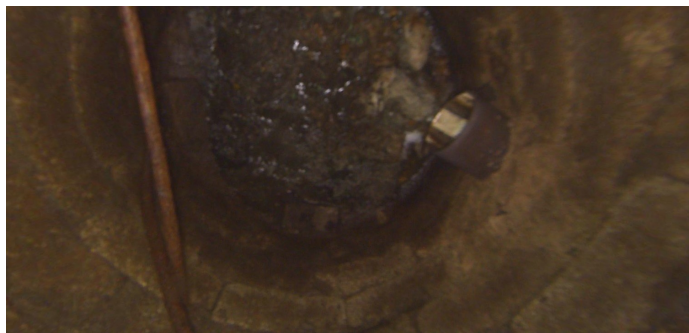
Code: **OBZ**  
Description: **Obstacle Other**

Distance (ft): **4.8**  
Structural Grade: **0**  
O&M Grade: **2**  
Clock Start/From: **6**  
Clock To: **9**  
1st Value:  
2nd Value:  
Value Percent: **5.000**  
Step: **NO**  
Remarks: **STEP PIECE**

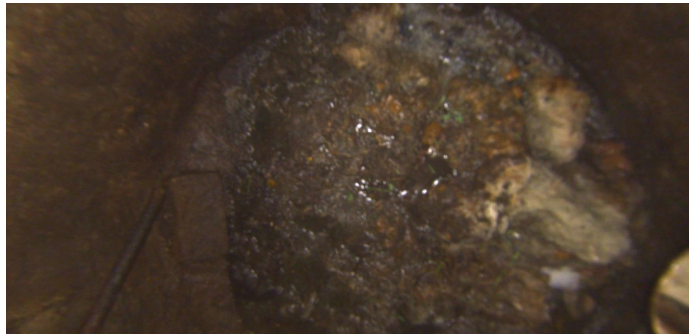
Code: **OBR**  
Description: **Obstacle Rocks**

Distance (ft): **6.0**  
Structural Grade: **0**  
O&M Grade: **2**  
Clock Start/From: **9**  
Clock To:  
1st Value:  
2nd Value:  
Value Percent: **5.000**  
Step: **NO**  
Remarks:

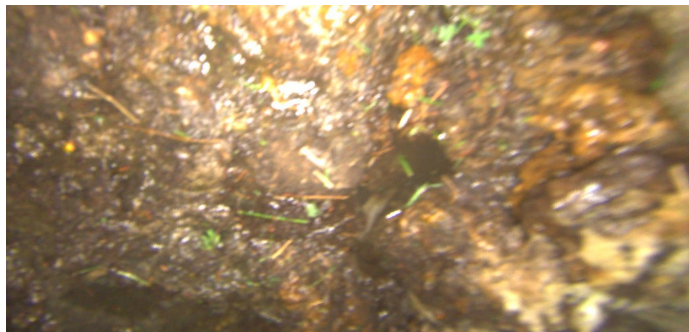
Code: **MGO**  
Description: **General Observation**

Distance (ft): **7.2**  
Structural Grade: **0**  
O&M Grade: **0**  
Clock Start/From:  
Clock To:  
1st Value:  
2nd Value:  
Value Percent:  
Step: **NO**  
Remarks: **END SURVEY**
