Manhole Inspection Report

Date:	04/29/2018	Weather:		Coding:	RZMACP
MH#:	M-604-111	Owner:	NA	Len. Surveyed:	4.4
P.O.#:		Surveyor:	Jen Costello	Rim to Invert:	4.6
Customer:		Cert. #:	U-907-5518	Wall Material:	Brick

Street:	Ash St. South of Home Ave.	Project:	Hobart, IN
City:	Hobart, IN	GPS Northing:	2903137.187
Location:		GPS Easting:	2903137.187
Drain Area:	West	GPS Accuracy:	Sub-Meter
Cover Shape:	Circular	Evidence of Surcharge:	No
Cover Size:	22.5	Potential for Runoff:	None
Comments:

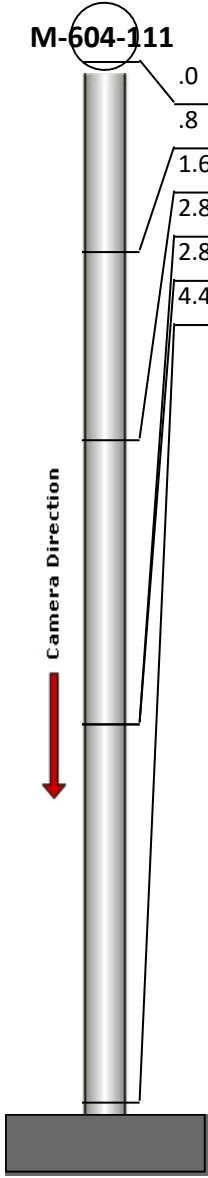
<p>M-604-111</p> <p>Camera Direction</p>	.0	MGO	General Observation	10	NA
	.8	DB	Displaced Brick	24	S 3
	1.6	MGO	General Observation	39	NA
	2.8	DSF	Deposits Settled Fine	55	M 2
	2.8	OBM	Obstacle Pipe Material	66	M 2
	4.4	MGO	General Observation	81	NA

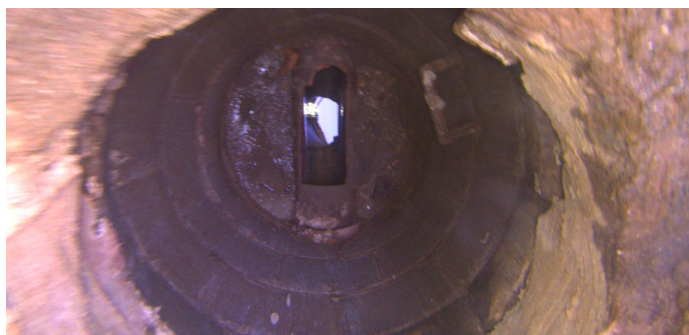
Code: **MGO**

Description: **General Observation**

Distance (ft): **.0**

Structural Grade: **0**

O&M Grade: **0**

Step: **NO**

Remarks: **ACCESS MH**

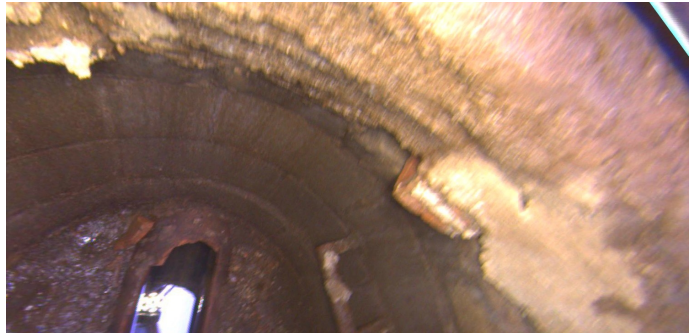
Code: **DB**
Description: **Displaced Brick**

Distance (ft): **.8**
Structural Grade: **3**
O&M Grade: **0**
Clock Start/From: **2**
Clock To:
1st Value:
2nd Value:
Value Percent:
Step: **NO**
Remarks:

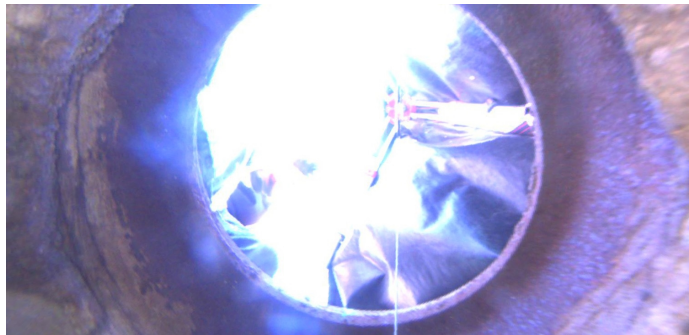
Code: **MGO**
Description: **General Observation**

Distance (ft): **1.6**
Structural Grade: **0**
O&M Grade: **0**
Clock Start/From:
Clock To:
1st Value:
2nd Value:
Value Percent:
Step: **NO**
Remarks: **UNDERSIDE OF FRAME**

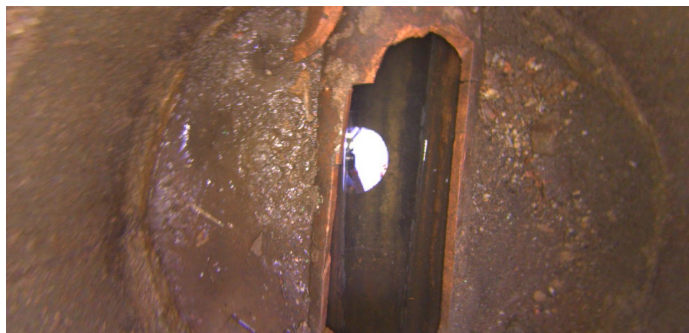
Code: **DSF**
Description: **Deposits Settled Fine**

Distance (ft): **2.8**
Structural Grade: **0**
O&M Grade: **2**
Clock Start/From: **12**
Clock To: **12**
1st Value:
2nd Value:
Value Percent: **5.000**
Step: **NO**
Remarks:

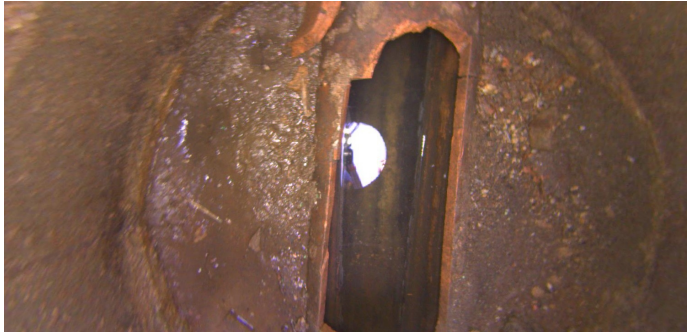
Code: **OBM**
Description: **Obstacle Pipe Material**

Distance (ft): **2.8**
Structural Grade: **0**
O&M Grade: **2**
Clock Start/From: **11**
Clock To:
1st Value:
2nd Value:
Value Percent: **5.000**
Step: **NO**
Remarks:

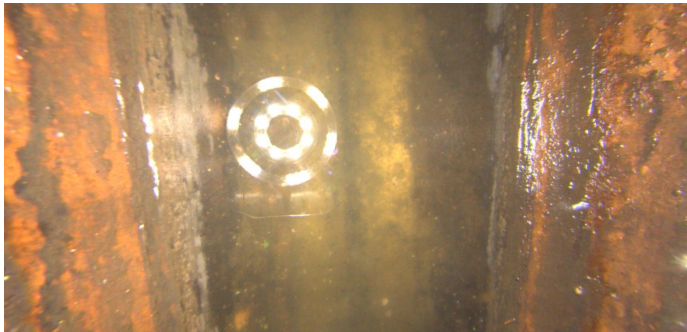
Code: **MGO**
Description: **General Observation**

Distance (ft): **4.4**
Structural Grade: **0**
O&M Grade: **0**
Clock Start/From:
Clock To:
1st Value:
2nd Value:
Value Percent:
Step: **NO**
Remarks: **END SURVEY**
