Manhole Inspection Report

Date:	04/29/2018	Weather:		Coding:	RZMACP
MH#:	M-604-116	Owner:	NA	Len. Surveyed:	4.2
P.O.#:		Surveyor:	Jen Costello	Rim to Invert:	4.1
Customer:		Cert. #:	U-907-5518	Wall Material:	Concrete (reinforced)

Street:	Cleveland Ave. and Connecticut St. t	Project:	Hobart, IN
City:	Hobart, IN	GPS Northing:	2902989.505
Location:		GPS Easting:	2902989.505
Drain Area:	West	GPS Accuracy:	Sub-Meter
Cover Shape:	Circular	Evidence of Surcharge:	No
Cover Size:	22.5	Potential for Runoff:	None
Comments:

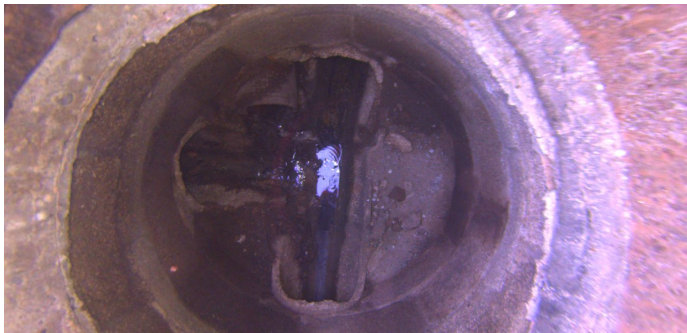
Code: **MGO**
Description: **General Observation**

Distance (ft): **.0**
Structural Grade: **0**
O&M Grade: **0**
Clock Start/From:
Clock To:
1st Value:
2nd Value:
Value Percent:
Step: **NO**
Remarks: **access MH**

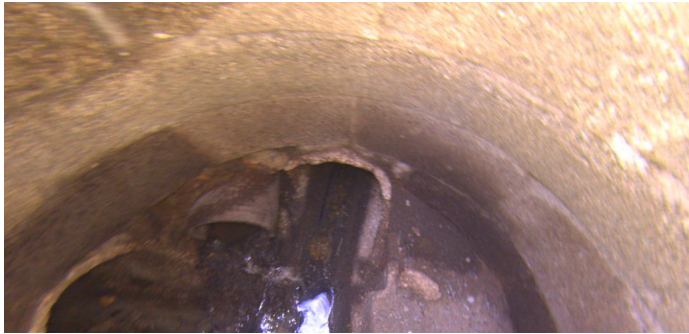
Code: **SAV**
Description: **Surface Aggregate Visible**

Distance (ft): **1.3**
Structural Grade: **3**
O&M Grade: **0**
Clock Start/From: **12**
Clock To: **12**
1st Value:
2nd Value:
Value Percent:
Step: **NO**
Remarks:

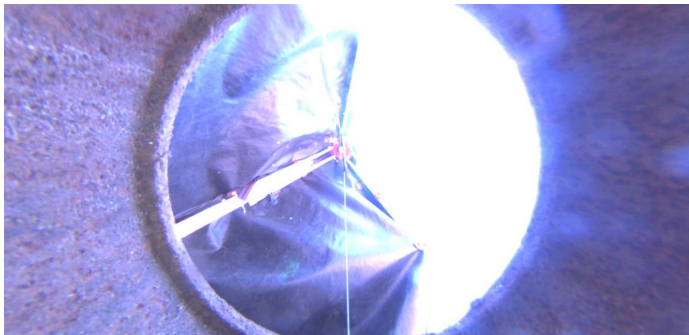
Code: **MGO**
Description: **General Observation**

Distance (ft): **1.3**
Structural Grade: **0**
O&M Grade: **0**
Clock Start/From:
Clock To:
1st Value:
2nd Value:
Value Percent:
Step: **NO**
Remarks: **UNDERSIDE OF FRAME**

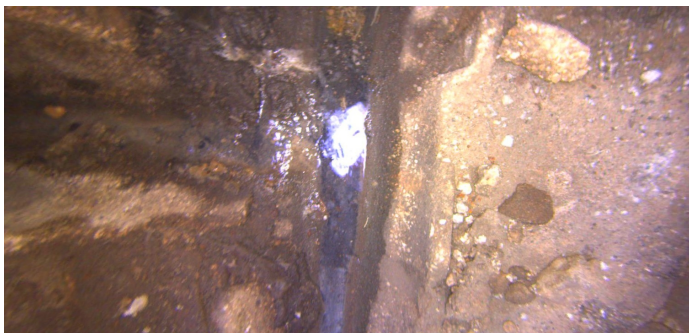
Code: **OBR**
Description: **Obstacle Rocks**

Distance (ft): **2.5**
Structural Grade: **0**
O&M Grade: **2**
Clock Start/From: **2**
Clock To: **4**
1st Value:
2nd Value:
Value Percent: **5.000**
Step: **NO**
Remarks:

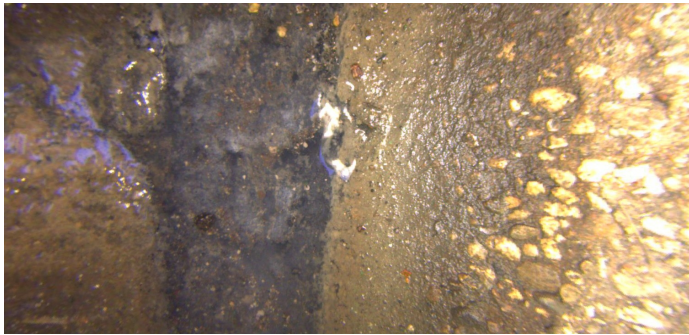
Code: **SAP**
Description: **Surface Aggregate Projecting**

Distance (ft): **3.9**
Structural Grade: **3**
O&M Grade: **0**
Clock Start/From: **3**
Clock To: **9**
1st Value:
2nd Value:
Value Percent:
Step: **NO**
Remarks:

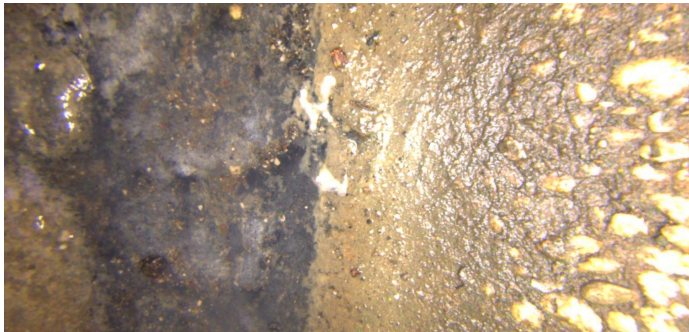
Code: **MGO**
Description: **General Observation**

Distance (ft): **4.2**
Structural Grade: **0**
O&M Grade: **0**
Clock Start/From:
Clock To:
1st Value:
2nd Value:
Value Percent:
Step: **NO**
Remarks: **END SURVEY**
