Manhole Inspection Report

Date:	04/29/2018	Weather:		Coding:	RZMACP
MH#:	M-604-120	Owner:	NA	Len. Surveyed:	6.6
P.O.#:		Surveyor:	Jen Costello	Rim to Invert:	6.9
Customer:		Cert. #:	U-907-5518	Wall Material:	Brick

Street:	Lake Park Ave. North of Old Ridge R	Project:	Hobart, IN
City:	Hobart, IN	GPS Northing:	2904433.631
Location:		GPS Easting:	2904433.631
Drain Area:	North	GPS Accuracy:	Sub-Meter
Cover Shape:	Circular	Evidence of Surcharge:	No
Cover Size:	22.5	Potential for Runoff:	None
Comments:

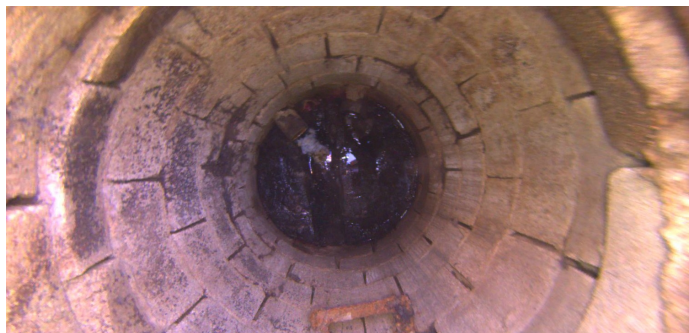
Code: **MGO**
 Description: **General Observation**

Distance (ft): **.0**
 Structural Grade: **0**
 O&M Grade: **0**
 Clock Start/From:
 Clock To:
 1st Value:
 2nd Value:
 Value Percent:
 Step: **NO**
 Remarks: **END SURVEY**

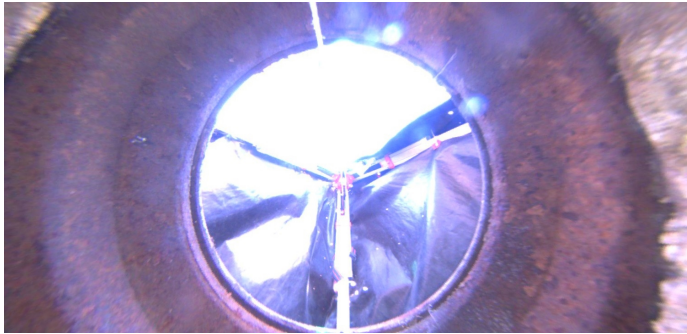
Code:	MGO
Description:	General Observation
Distance (ft):	1.6
Structural Grade:	0
O&M Grade:	0
Clock Start/From:	
Clock To:	
1st Value:	
2nd Value:	
Value Percent:	
Step:	NO
Remarks:	UNDERSIDE OF FRAME

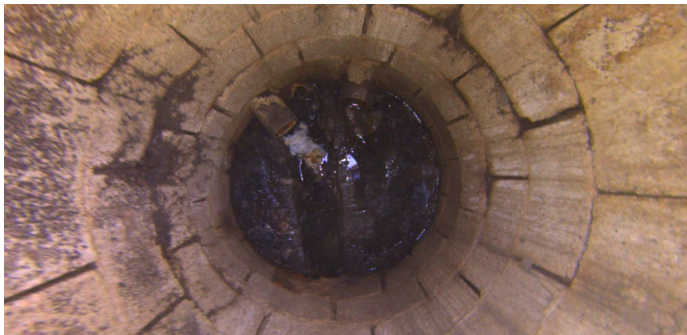
Code:	RFB
Description:	Roots Fine Barrel
Distance (ft):	1.6
Structural Grade:	0
O&M Grade:	2
Clock Start/From:	9
Clock To:	10
1st Value:	
2nd Value:	
Value Percent:	
Step:	NO
Remarks:

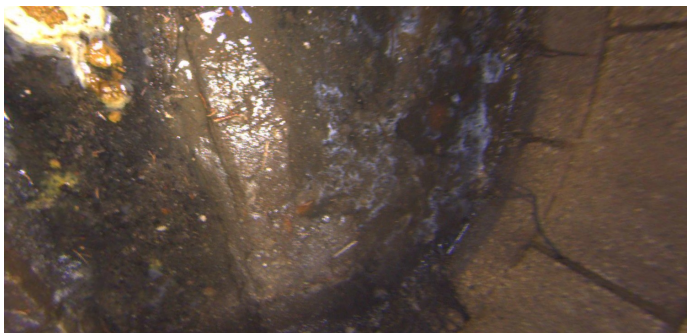
Code:	RFB
Description:	Roots Fine Barrel
Distance (ft):	5.6
Structural Grade:	0
O&M Grade:	2
Clock Start/From:	4
Clock To:	5
1st Value:	
2nd Value:	
Value Percent:	
Step:	NO
Remarks:

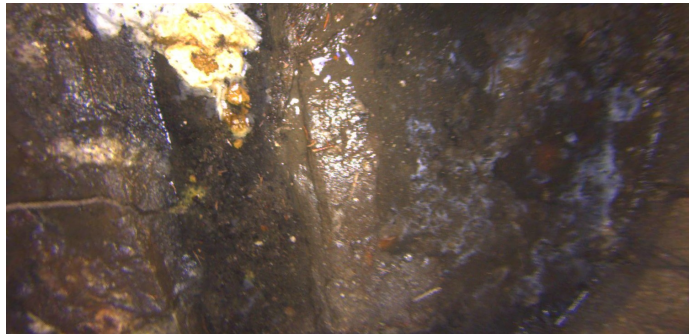
Code: **DSF**
Description: **Deposits Settled Fine**

Distance (ft): **5.6**
Structural Grade: **0**
O&M Grade: **2**
Clock Start/From: **12**
Clock To: **12**
1st Value:
2nd Value:
Value Percent: **5.000**
Step: **NO**
Remarks:

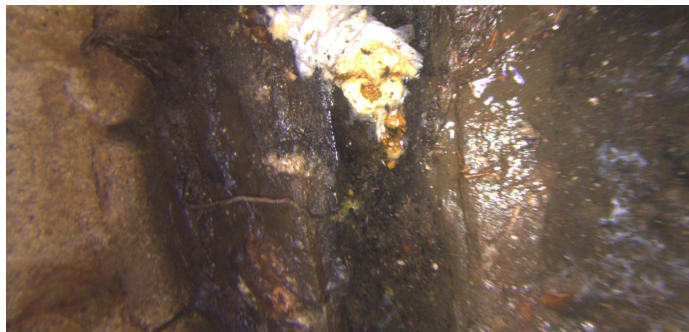
Code: **RFB**
Description: **Roots Fine Barrel**

Distance (ft): **5.6**
Structural Grade: **0**
O&M Grade: **2**
Clock Start/From: **8**
Clock To: **9**
1st Value:
2nd Value:
Value Percent:
Step: **NO**
Remarks:

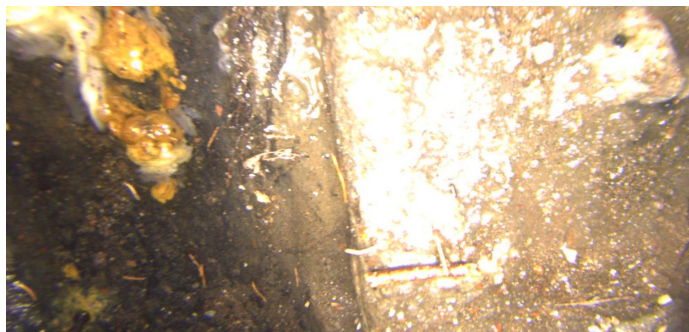
Code: **MGO**
Description: **General Observation**

Distance (ft): **6.6**
Structural Grade: **0**
O&M Grade: **0**
Clock Start/From:
Clock To:
1st Value:
2nd Value:
Value Percent:
Step: **NO**
Remarks: **END SURVEY**

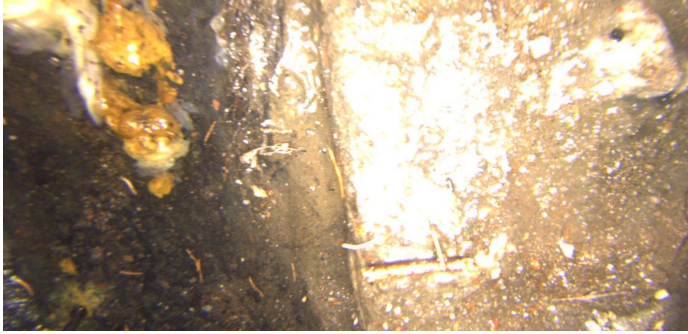
Code:	SAP
Description:	Surface Aggregate Projecting
Distance (ft):	6.6
Structural Grade:	3
O&M Grade:	0
Clock Start/From:	12
Clock To:	6
1st Value:	
2nd Value:	
Value Percent:	
Step:	NO
Remarks:
