Manhole Inspection Report

Date:	05/01/2018	Weather:		Coding:	RZMACP
MH#:	M-605-005	Owner:	NA	Len. Surveyed:	11.2
P.O.#:		Surveyor:	Jen Costello	Rim to Invert:	11.9
Customer:		Cert. #:	U-907-5518	Wall Material:	Brick

Street:	Intersection of Ellendale St. and 3rd	Project:	Hobart, IN
City:	Hobart, IN	GPS Northing:	41.53195953
Location:		GPS Easting:	-87.2620163
Drain Area:	West	GPS Accuracy:	Nearest Meter
Cover Shape:	Circular	Evidence of Surcharge:	No
Cover Size:	22.5	Potential for Runoff:	None
Comments:

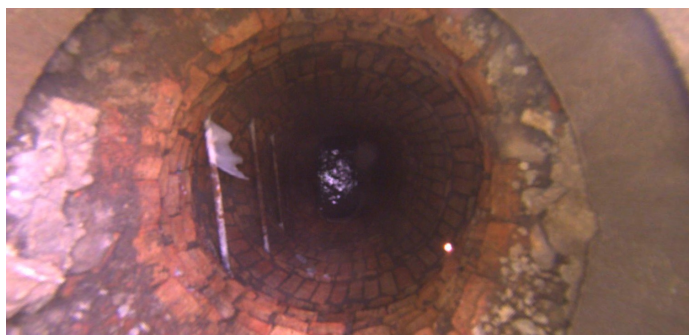
Code: **MGP**
Description: **General Photo**

Distance (ft): **.0**
Structural Grade: **0**
O&M Grade: **0**
Clock Start/From:
Clock To:
1st Value:
2nd Value:
Value Percent:
Step: **NO**
Remarks: **ACCESS MH**

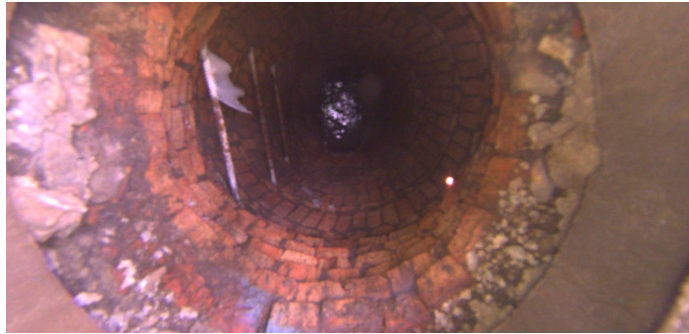
Code: **B**
Description: **Broken**

Distance (ft): **.0**
Structural Grade: **5**
O&M Grade: **0**
Clock Start/From: **12**
Clock To: **12**
1st Value:
2nd Value:
Value Percent:
Step: **NO**
Remarks:

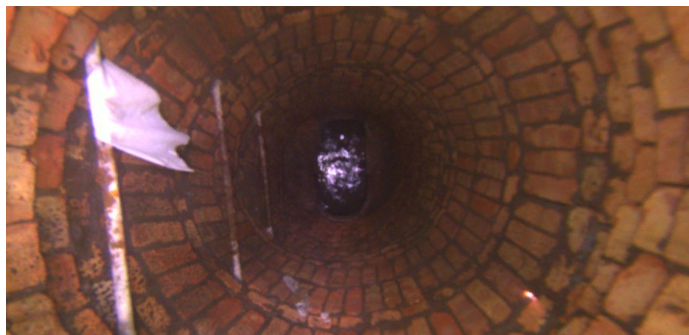
Code: **DAR**
Description: **Deposits Attached Ragging**

Distance (ft): **1.6**
Structural Grade: **0**
O&M Grade: **2**
Clock Start/From: **10**
Clock To:
1st Value:
2nd Value:
Value Percent: **5.000**
Step: **YES**
Remarks:

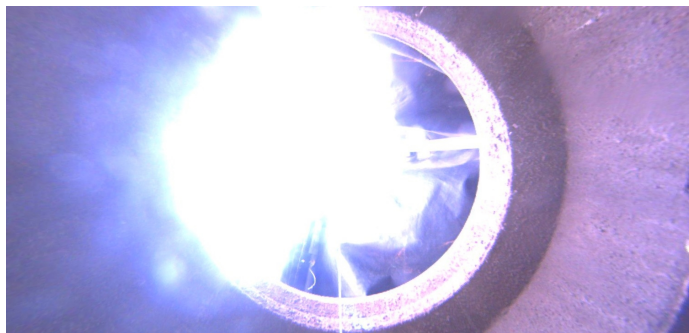
Code: **MGO**
Description: **General Observation**

Distance (ft): **1.6**
Structural Grade: **0**
O&M Grade: **0**
Clock Start/From:
Clock To:
1st Value:
2nd Value:
Value Percent:
Step: **NO**
Remarks: **UNDERSIDE OF FRAME**

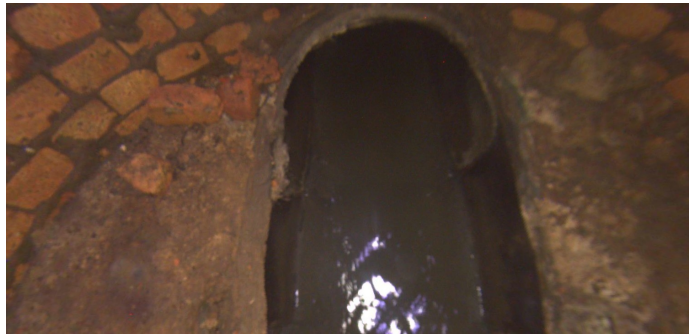
Code: **OBR**
Description: **Obstacle Rocks**

Distance (ft): **9.2**
Structural Grade: **0**
O&M Grade: **2**
Clock Start/From: **11**
Clock To:
1st Value:
2nd Value:
Value Percent: **5.000**
Step: **NO**
Remarks:

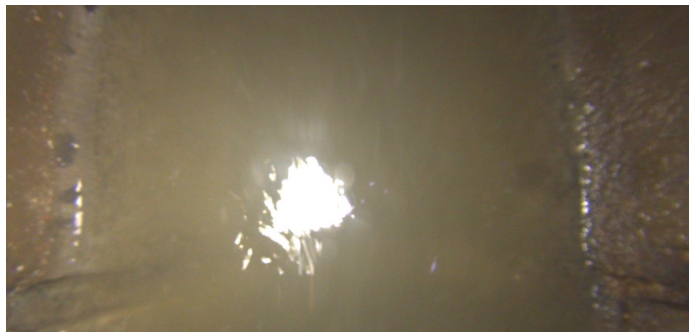
Code: **MGO**
Description: **General Observation**

Distance (ft): **11.2**
Structural Grade: **0**
O&M Grade: **0**
Clock Start/From:
Clock To:
1st Value:
2nd Value:
Value Percent:
Step: **NO**
Remarks: **END SURVEY**
