Manhole Inspection Report

Date:	09/29/2022	Weather:		Coding:	RZMACP
MH#:	M-605-011	Owner:	NA	Len. Surveyed:	7.6
P.O.#:		Surveyor:	Jen Costello	Rim to Invert:	8.7
Customer:		Cert. #:	U-907-5518	Wall Material:	Brick

Street:	Intersection of Washington St. and 3	Project:	Hobart, IN
City:	Hobart, IN	GPS Northing:	2289117.536
Location:	Local Rural Streets	GPS Easting:	2902176.101
Drain Area:	West	GPS Accuracy:	Sub-Meter
Cover Shape:	Circular	Evidence of Surcharge:	No
Cover Size:	24.0	Potential for Runoff:	None
Comments:

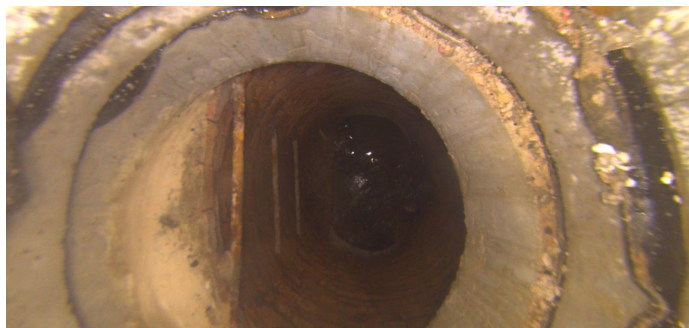
Code: **MGO**
Description: **General Observation**

Distance (ft): **.0**
Structural Grade: **0**
O&M Grade: **0**
Clock Start/From:
Clock To:
1st Value:
2nd Value:
Value Percent:
Step: **NO**
Remarks: **access mh**

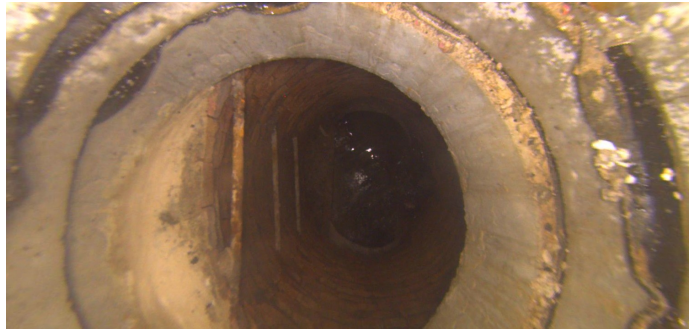
Code: **ISGT**
Description: **Intruding Sealing Grout**

Distance (ft): **.0**
Structural Grade: **0**
O&M Grade: **2**
Clock Start/From: **12**
Clock To: **12**
1st Value:
2nd Value:
Value Percent: **5.000**
Step: **NO**
Remarks:

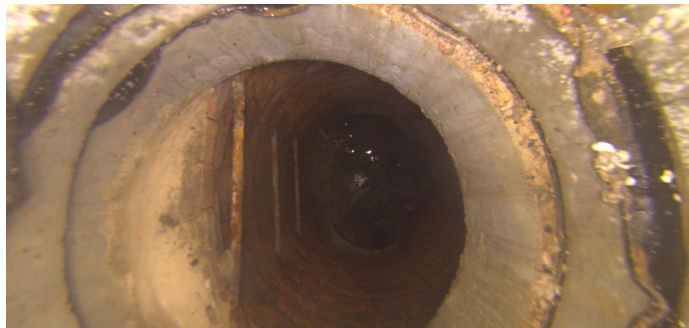
Code: **SRI**
Description: **Surface Roughness Increased**

Distance (ft): **.0**
Structural Grade: **1**
O&M Grade: **0**
Clock Start/From: **12**
Clock To: **12**
1st Value:
2nd Value:
Value Percent:
Step: **NO**
Remarks:

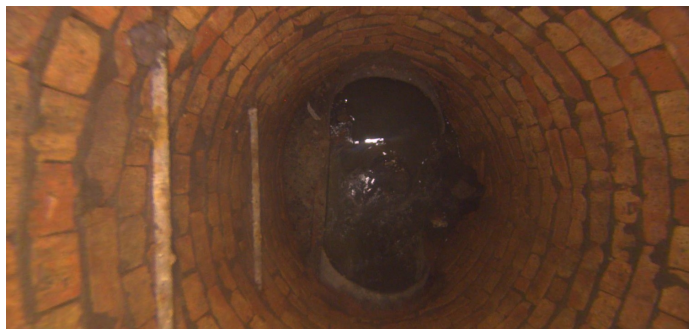
Code: **MMC**
Description: **Material Change**

Distance (ft): **2.6**
Structural Grade: **0**
O&M Grade: **0**
Clock Start/From:
Clock To:
1st Value:
2nd Value:
Value Percent:
Step: **NO**
Remarks: **brick**

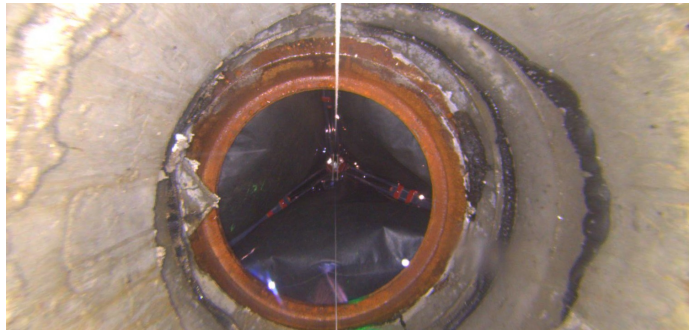
Code: **MGO**
Description: **General Observation**

Distance (ft): **2.6**
Structural Grade: **0**
O&M Grade: **0**
Clock Start/From:
Clock To:
1st Value:
2nd Value:
Value Percent:
Step: **NO**
Remarks: **underside of frame**

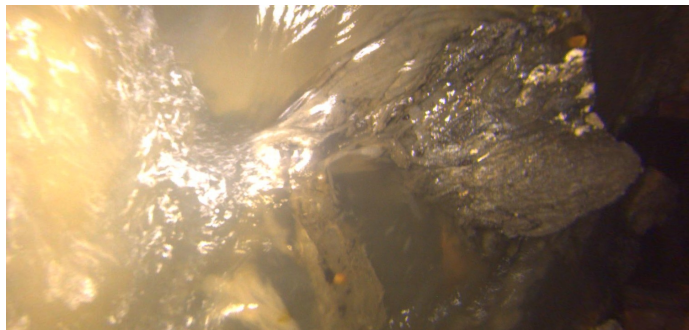
Code: **DSF**
Description: **Deposits Settled Fine**

Distance (ft): **7.4**
Structural Grade: **0**
O&M Grade: **3**
Clock Start/From: **4**
Clock To: **8**
1st Value:
2nd Value:
Value Percent: **20.000**
Step: **NO**
Remarks:

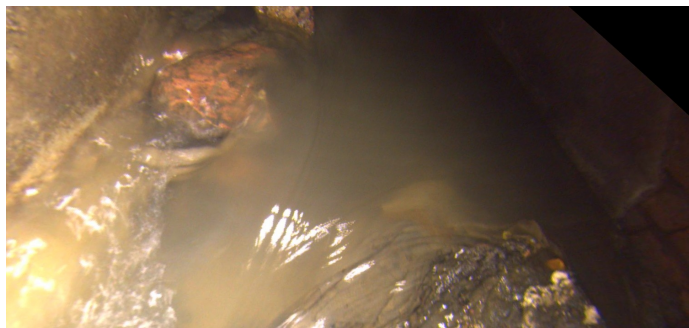
Code: **MGO**
Description: **General Observation**

Distance (ft): **7.4**
Structural Grade: **0**
O&M Grade: **0**
Clock Start/From:
Clock To:
1st Value:
2nd Value:
Value Percent:
Step: **NO**
Remarks: **end of survey**

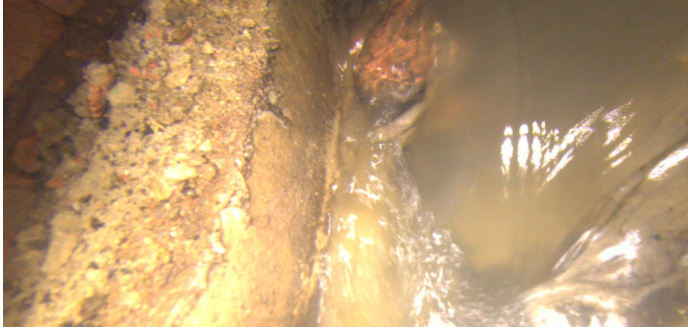
Code:	DSF
Description:	Deposits Settled Fine
Distance (ft):	7.4
Structural Grade:	0
O&M Grade:	2
Clock Start/From:	12
Clock To:	12
1st Value:	
2nd Value:	
Value Percent:	5.000
Step:	NO
Remarks:
