# Manhole Inspection Report

Date:	<b>04/29/2018</b>	Weather:		Coding:	<b>RZMACP</b>
MH#:	<b>M-605-016</b>	Owner:	<b>NA</b>	Len. Surveyed:	<b>7.0</b>
P.O.#:		Surveyor:	<b>Jen Costello</b>	Rim to Invert:	<b>7.4</b>
Customer:		Cert. #:	<b>U-907-5518</b>	Wall Material:	<b>Brick</b>

Street:	<b>Intersection of 2nd St. and Beverly L</b>	Project:	<b>Hobart, IN</b>
City:	<b>Hobart, IN</b>	GPS Northing:	<b>2903652.534</b>
Location:		GPS Easting:	<b>2903652.534</b>
Drain Area:	<b>West</b>	GPS Accuracy:	<b>Sub-Meter</b>
Cover Shape:	<b>Circular</b>	Evidence of Surcharge:	<b>No</b>
Cover Size:	<b>22.5</b>	Potential for Runoff:	<b>None</b>
Comments:

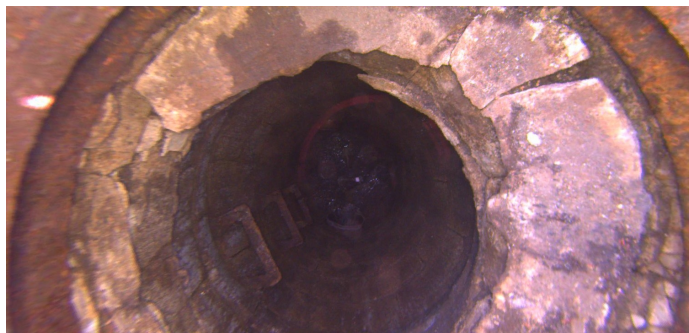
Code: **MGO**  
Description: **General Observation**

Distance (ft): **.0**  
Structural Grade: **0**  
O&M Grade: **0**  
Clock Start/From:  
Clock To:  
1st Value:  
2nd Value:  
Value Percent:  
Step: **NO**  
Remarks: **ACCESS MH**

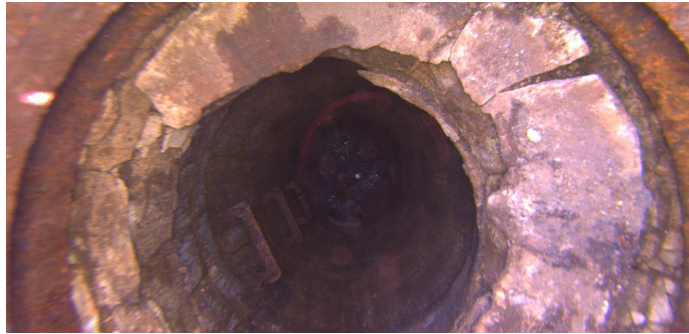
Code: **B**  
Description: **Broken**

Distance (ft): **.0**  
Structural Grade: **5**  
O&M Grade: **0**  
Clock Start/From: **8**  
Clock To: **2**  
1st Value:  
2nd Value:  
Value Percent:  
Step: **NO**  
Remarks:

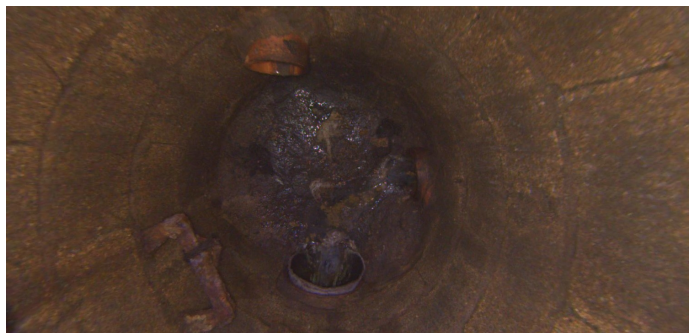
Code: **SAV**  
Description: **Surface Aggregate Visible**

Distance (ft): **3.3**  
Structural Grade: **3**  
O&M Grade: **0**  
Clock Start/From: **12**  
Clock To: **12**  
1st Value:  
2nd Value:  
Value Percent:  
Step: **NO**  
Remarks:

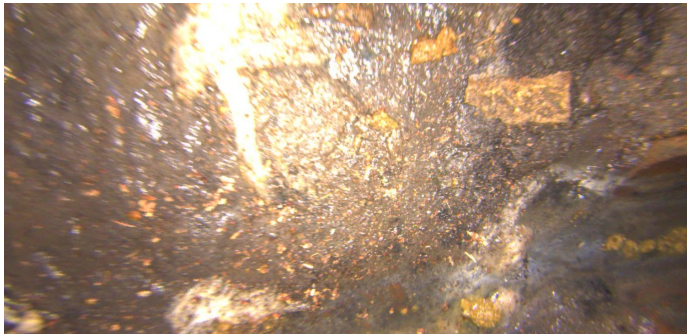
Code:	<b>DSF</b>
Description:	<b>Deposits Settled Fine</b>
Distance (ft):	<b>6.8</b>
Structural Grade:	<b>0</b>
O&M Grade:	<b>2</b>
Clock Start/From:	<b>12</b>
Clock To:	<b>12</b>
1st Value:	
2nd Value:	
Value Percent:	<b>5.000</b>
Step:	<b>NO</b>
Remarks:
