Manhole Inspection Report

O&M Index:	2.00	O&M Quick:	2200	O&M Rating:	4.00
Structural Index:	0.00	Structural Quick:	0000	Structural Rating:	0.00
Overall Index:	2.00	Overall Quick:	2200	Overall Rating:	4.00

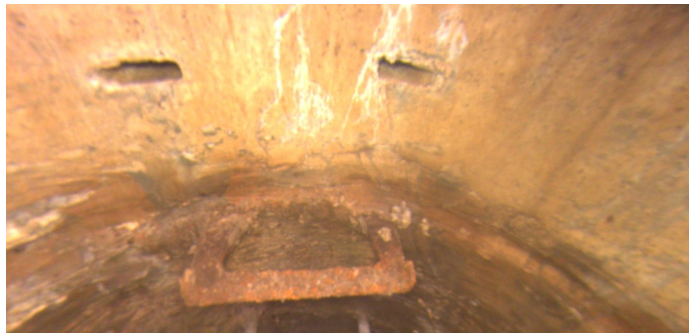
Code: **MGO**
Description: **General Observation**

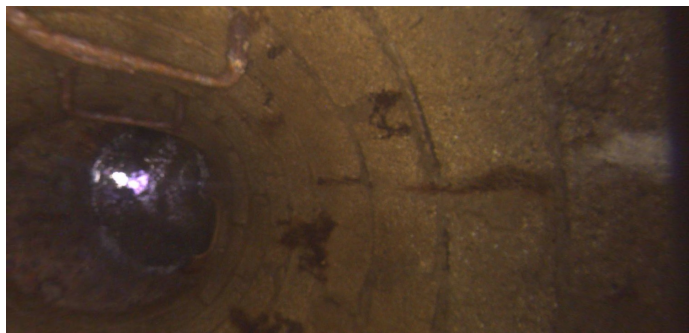
Code: **RFB**
Description: **Roots Fine Barrel**
