Manhole Inspection Report

Date:	04/29/2018	Weather:		Coding:	RZMACP
MH#:	M-605-021	Owner:	NA	Len. Surveyed:	8.5
P.O.#:		Surveyor:	Jen Costello	Rim to Invert:	8.9
Customer:		Cert. #:	U-907-5518	Wall Material:	Brick

Street:	Henry St. 158' South of 2nd St.	Project:	Hobart, IN
City:	Hobart, IN	GPS Northing:	2903481.698
Location:		GPS Easting:	2903481.698
Drain Area:	West	GPS Accuracy:	Sub-Meter
Cover Shape:	Circular	Evidence of Surcharge:	No
Cover Size:	22.5	Potential for Runoff:	None
Comments:

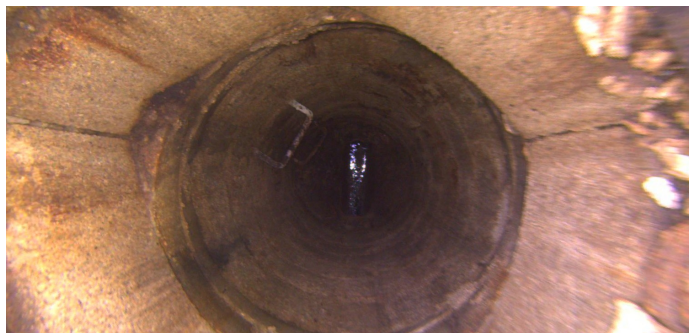
Code: **MGO**
Description: **General Observation**

Distance (ft): **.0**
Structural Grade: **0**
O&M Grade: **0**
Clock Start/From:
Clock To:
1st Value:
2nd Value:
Value Percent:
Step: **NO**
Remarks: **ACCESS MH**

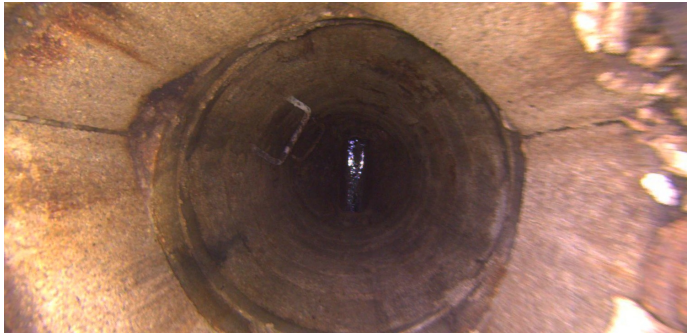
Code:	SAV
Description:	Surface Aggregate Visible
Distance (ft):	.0
Structural Grade:	3
O&M Grade:	0
Clock Start/From:	12
Clock To:	12
1st Value:	
2nd Value:	
Value Percent:	
Step:	NO
Remarks:

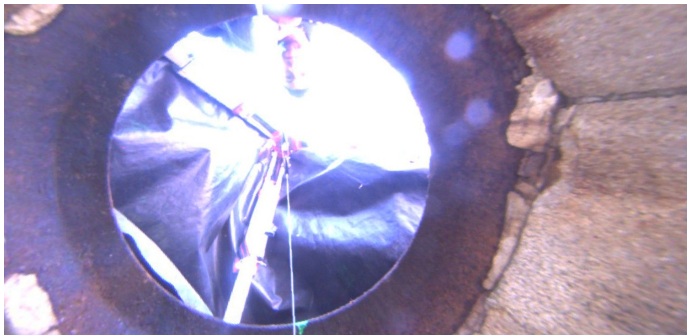
Code:	MGO
Description:	General Observation
Distance (ft):	1.8
Structural Grade:	0
O&M Grade:	0
Clock Start/From:	
Clock To:	
1st Value:	
2nd Value:	
Value Percent:	
Step:	NO
Remarks:	UNDERSIDE OF FRAME

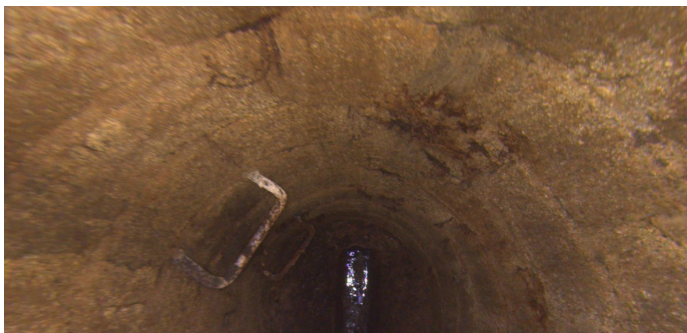
Code:	RFJ
Description:	Roots Fine Joint
Distance (ft):	1.8
Structural Grade:	0
O&M Grade:	1
Clock Start/From:	11
Clock To:	
1st Value:	
2nd Value:	
Value Percent:	
Step:	NO
Remarks:

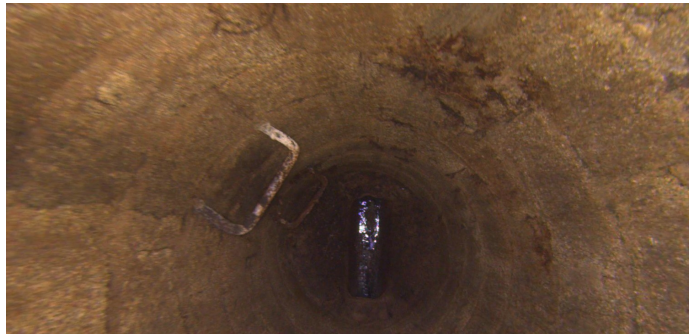
Code: **SAV**
Description: **Surface Aggregate Visible**

Distance (ft): **1.8**
Structural Grade: **3**
O&M Grade: **0**
Clock Start/From: **12**
Clock To: **12**
1st Value:
2nd Value:
Value Percent:
Step: **NO**
Remarks:

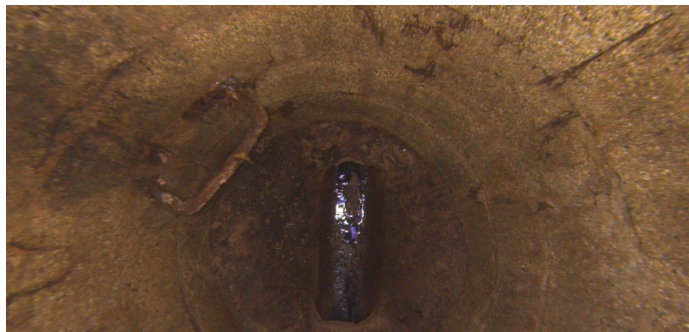
Code: **RFB**
Description: **Roots Fine Barrel**

Distance (ft): **4.2**
Structural Grade: **0**
O&M Grade: **2**
Clock Start/From: **10**
Clock To: **2**
1st Value:
2nd Value:
Value Percent:
Step: **NO**
Remarks:

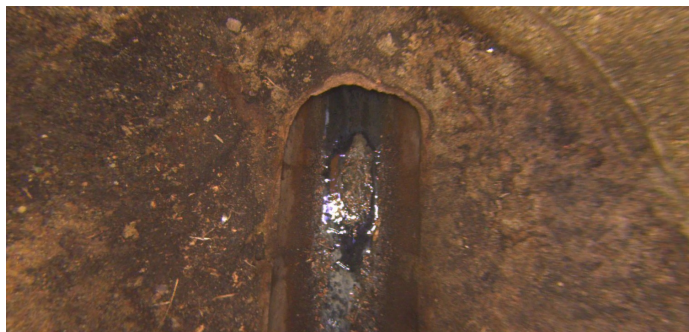
Code: **DSF**
Description: **Deposits Settled Fine**

Distance (ft): **6.5**
Structural Grade: **0**
O&M Grade: **2**
Clock Start/From: **12**
Clock To: **12**
1st Value:
2nd Value:
Value Percent: **5.000**
Step: **NO**
Remarks:

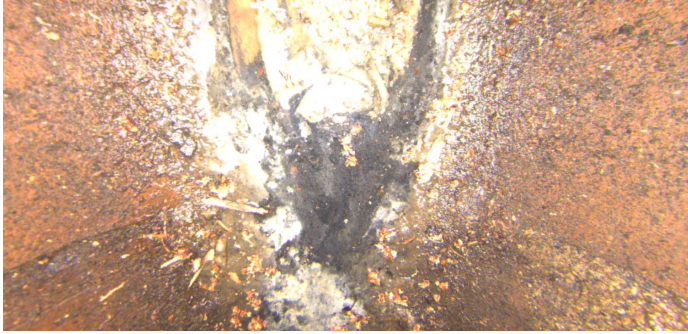
Code:	MGO
Description:	General Observation
Distance (ft):	8.5
Structural Grade:	0
O&M Grade:	0
Clock Start/From:	
Clock To:	
1st Value:	
2nd Value:	
Value Percent:	
Step:	NO
Remarks:	END SURVEY
