# Manhole Inspection Report

Date:	<b>04/29/2018</b>	Weather:		Coding:	<b>RZMACP</b>
MH#:	<b>M-605-023</b>	Owner:	<b>NA</b>	Len. Surveyed:	<b>6.6</b>
P.O.#:		Surveyor:	<b>Jen Costello</b>	Rim to Invert:	<b>7.3</b>
Customer:		Cert. #:	<b>U-907-5518</b>	Wall Material:	<b>Brick</b>

Street:	<b>Intersection of Henry St. and 2nd St.</b>	Project:	<b>Hobart, IN</b>
City:	<b>Hobart, IN</b>	GPS Northing:	<b>2903487.038</b>
Location:		GPS Easting:	<b>2903487.038</b>
Drain Area:	<b>West</b>	GPS Accuracy:	<b>Sub-Meter</b>
Cover Shape:	<b>Circular</b>	Evidence of Surcharge:	<b>No</b>
Cover Size:	<b>22.5</b>	Potential for Runoff:	<b>None</b>
Comments:

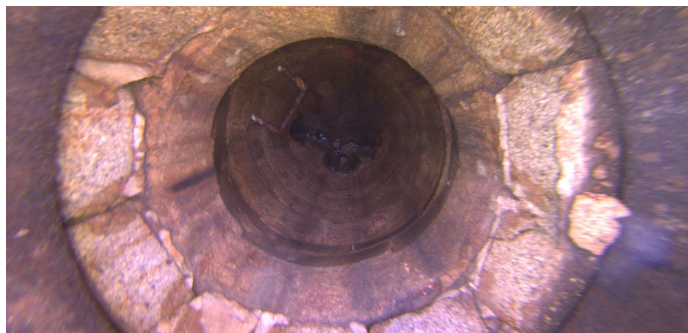
Code: **MGO**  
Description: **General Observation**

Distance (ft): **.0**  
Structural Grade: **0**  
O&M Grade: **0**  
Clock Start/From:  
Clock To:  
1st Value:  
2nd Value:  
Value Percent:  
Step: **NO**  
Remarks: **ACCESS MH**

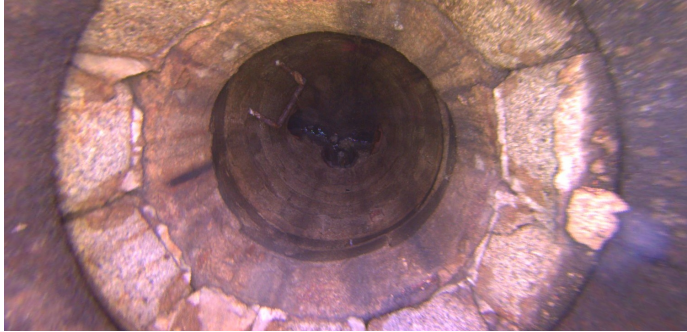
Code: **FM**  
Description: **Fracture Multiple**

Distance (ft): **.0**  
Structural Grade: **4**  
O&M Grade: **0**  
Clock Start/From: **3**  
Clock To: **4**  
1st Value:  
2nd Value:  
Value Percent:  
Step: **NO**  
Remarks:

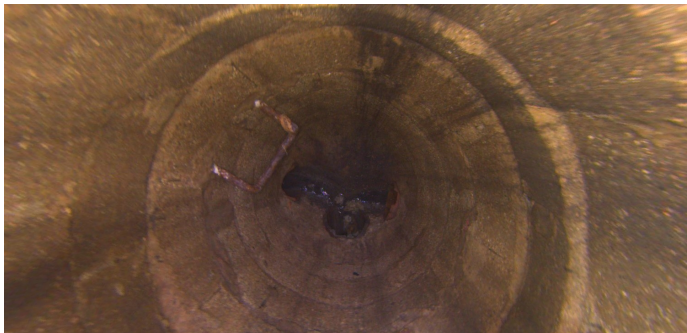
Code: **SAV**  
Description: **Surface Aggregate Visible**

Distance (ft): **1.4**  
Structural Grade: **3**  
O&M Grade: **0**  
Clock Start/From: **12**  
Clock To: **12**  
1st Value:  
2nd Value:  
Value Percent:  
Step: **NO**  
Remarks:

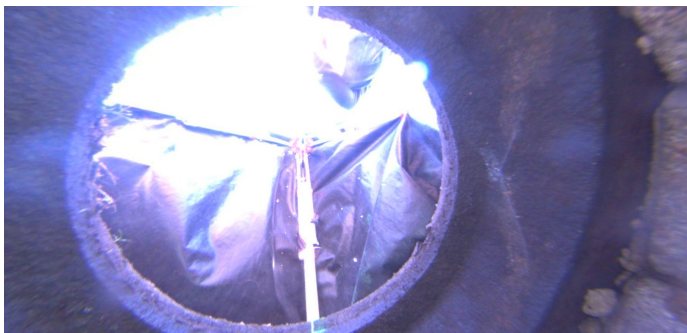
Code: **MGO**  
Description: **General Observation**

Distance (ft): **1.4**  
Structural Grade: **0**  
O&M Grade: **0**  
Clock Start/From:  
Clock To:  
1st Value:  
2nd Value:  
Value Percent:  
Step: **NO**  
Remarks: **UNDERSIDE OF FRAME**

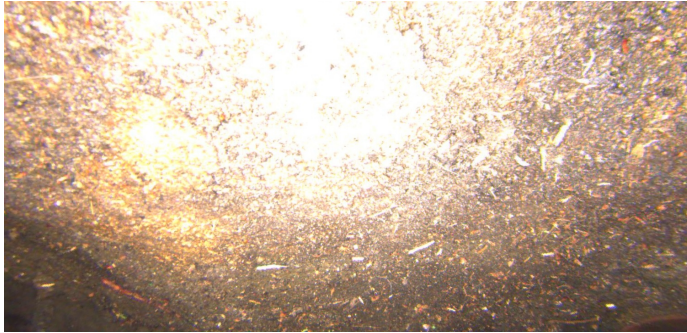
Code:	<b>MGO</b>
Description:	<b>General Observation</b>
Distance (ft):	<b>6.6</b>
Structural Grade:	<b>0</b>
O&M Grade:	<b>0</b>
Clock Start/From:	
Clock To:	
1st Value:	
2nd Value:	
Value Percent:	
Step:	<b>NO</b>
Remarks:	<b>end survey</b>
