Manhole Inspection Report

Date:	04/29/2018	Weather:		Coding:	RZMACP
MH#:	M-605-026	Owner:	NA	Len. Surveyed:	8.2
P.O.#:		Surveyor:	Jen Costello	Rim to Invert:	9.0
Customer:		Cert. #:	U-907-5518	Wall Material:	Brick

Street:	Ash St. 236' South of 2nd St.	Project:	Hobart, IN
City:	Hobart, IN	GPS Northing:	2903151.204
Location:		GPS Easting:	2903151.204
Drain Area:	West	GPS Accuracy:	Sub-Meter
Cover Shape:	Circular	Evidence of Surcharge:	No
Cover Size:	22.5	Potential for Runoff:	None
Comments:

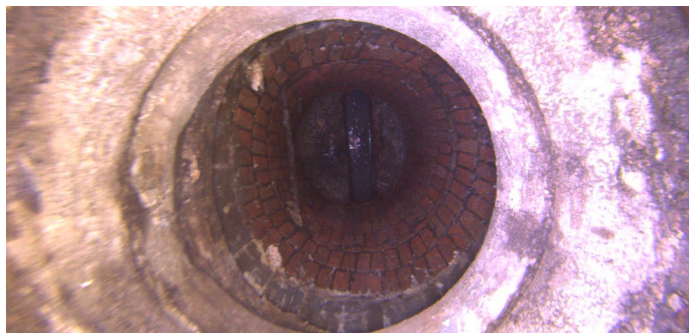
Code: **MGO**
Description: **General Observation**

Distance (ft): **.0**
Structural Grade: **0**
O&M Grade: **0**
Clock Start/From:
Clock To:
1st Value:
2nd Value:
Value Percent:
Step: **NO**
Remarks: **ACCESS MH**

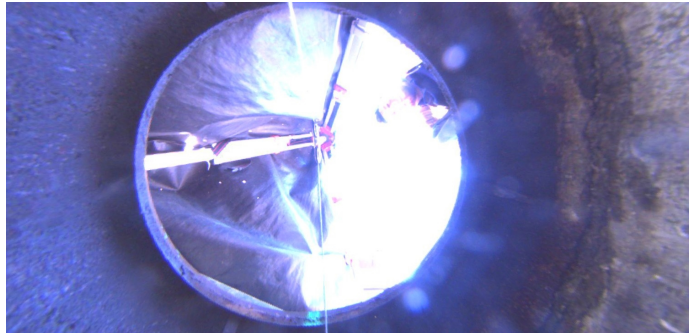
Code:	MGP
Description:	General Photo
Distance (ft):	1.5
Structural Grade:	0
O&M Grade:	0
Clock Start/From:	
Clock To:	
1st Value:	
2nd Value:	
Value Percent:	
Step:	NO
Remarks:	UNDERSIDE OF FRAME

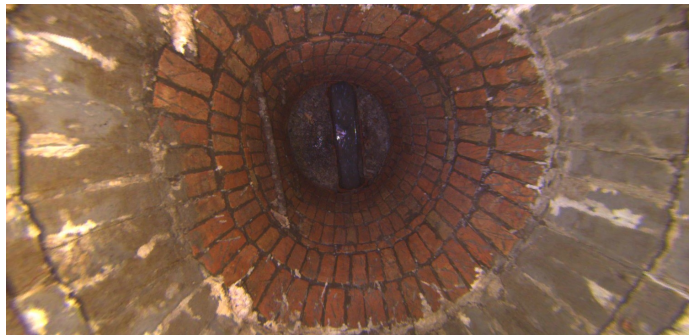
Code:	FM
Description:	Fracture Multiple
Distance (ft):	1.5
Structural Grade:	4
O&M Grade:	0
Clock Start/From:	12
Clock To:	12
1st Value:	
2nd Value:	
Value Percent:	
Step:	NO
Remarks:

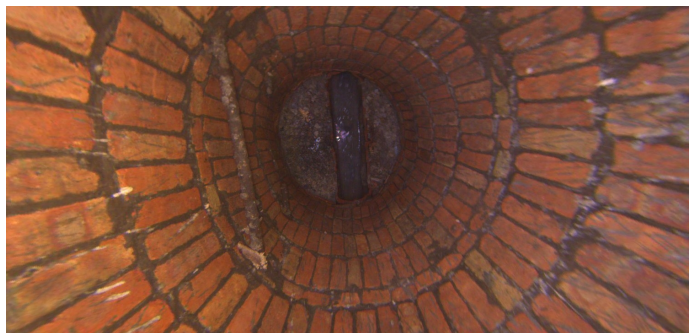
Code:	MMC
Description:	Material Change
Distance (ft):	2.6
Structural Grade:	0
O&M Grade:	0
Clock Start/From:	
Clock To:	
1st Value:	
2nd Value:	
Value Percent:	
Step:	NO
Remarks:	BR

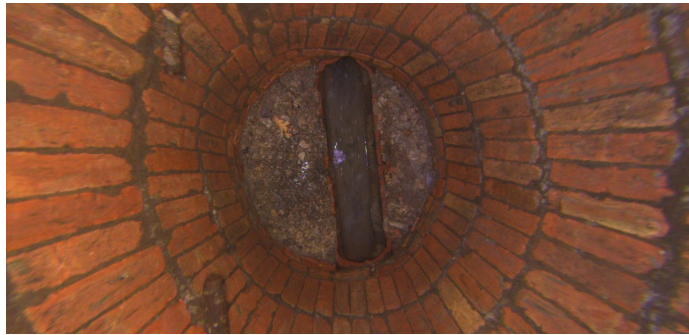
Code: **MGO**
Description: **General Observation**

Distance (ft): **4.7**
Structural Grade: **0**
O&M Grade: **0**
Clock Start/From:
Clock To:
1st Value:
2nd Value:
Value Percent:
Step: **NO**
Remarks: **BROKEN STEP**

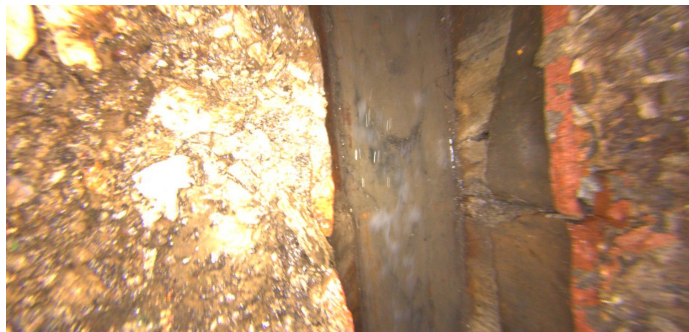
Code: **DSGV**
Description: **Deposits Settled Gravel**

Distance (ft): **7.7**
Structural Grade: **0**
O&M Grade: **2**
Clock Start/From: **12**
Clock To: **12**
1st Value:
2nd Value:
Value Percent: **5.000**
Step: **NO**
Remarks:

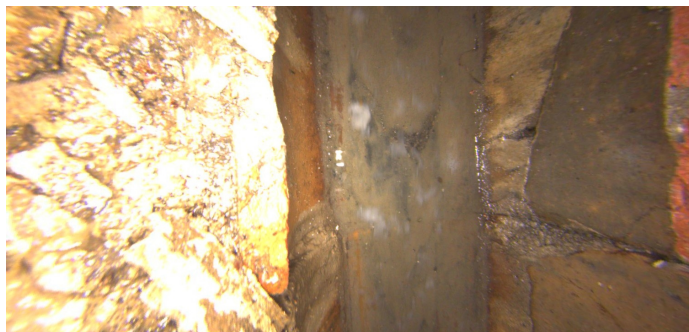
Code: **MGO**
Description: **General Observation**

Distance (ft): **8.2**
Structural Grade: **0**
O&M Grade: **0**
Clock Start/From:
Clock To:
1st Value:
2nd Value:
Value Percent:
Step: **NO**
Remarks: **END SURVEY**
