# Manhole Inspection Report

Date:	<b>04/29/2018</b>	Weather:		Coding:	<b>RZMACP</b>
MH#:	<b>M-605-027</b>	Owner:	<b>NA</b>	Len. Surveyed:	<b>7.6</b>
P.O.#:		Surveyor:	<b>Jen Costello</b>	Rim to Invert:	<b>7.9</b>
Customer:		Cert. #:	<b>U-907-5518</b>	Wall Material:	<b>Brick</b>

Street:	<b>Intersection of 2nd St. and Ash St.</b>	Project:	<b>Hobart, IN</b>
City:	<b>Hobart, IN</b>	GPS Northing:	<b>2903150.342</b>
Location:		GPS Easting:	<b>2903150.342</b>
Drain Area:	<b>West</b>	GPS Accuracy:	<b>Sub-Meter</b>
Cover Shape:	<b>Circular</b>	Evidence of Surcharge:	<b>No</b>
Cover Size:	<b>22.5</b>	Potential for Runoff:	<b>None</b>
Comments:

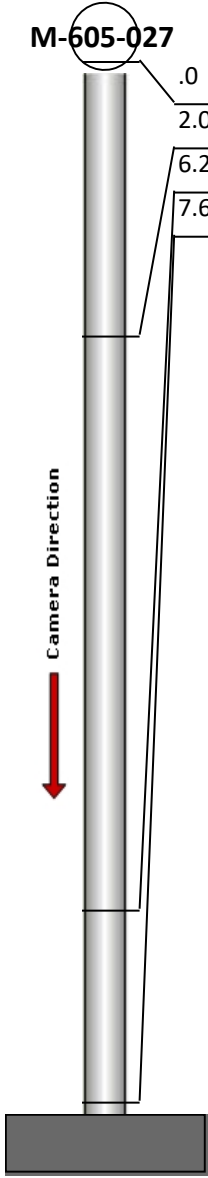
Position	Code	Observation	Video (sec)	Grade

.0	MGO	General Observation	10	NA
	2.0	MGO	General Observation	28	NA
	6.2	DSGV	Deposits Settled Gravel	50	M 2
	7.6	MGO	General Observation	64	NA

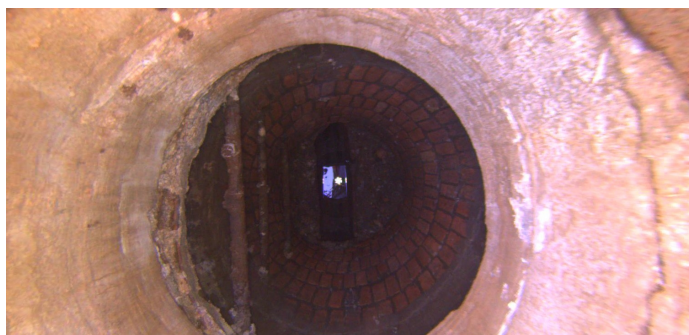
Code: **MGO**  
Description: **General Observation**

Distance (ft): **.0**  
Structural Grade: **0**  
O&M Grade: **0**  
Clock Start/From:  
Clock To:  
1st Value:  
2nd Value:  
Value Percent:  
Step: **NO**  
Remarks: **ACCESS MH**

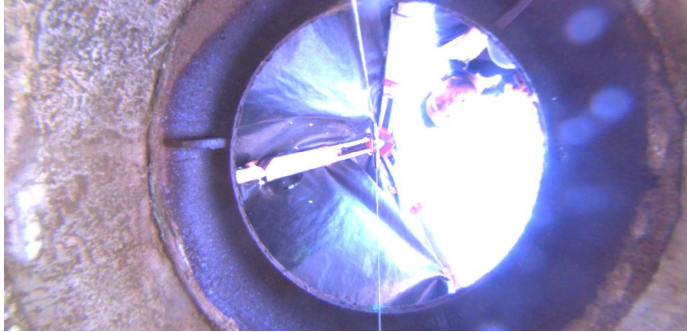
Code: **MGO**  
Description: **General Observation**

Distance (ft): **2.0**  
Structural Grade: **0**  
O&M Grade: **0**  
Clock Start/From:  
Clock To:  
1st Value:  
2nd Value:  
Value Percent:  
Step: **NO**  
Remarks: **UNDERSIDE OF FRAME**

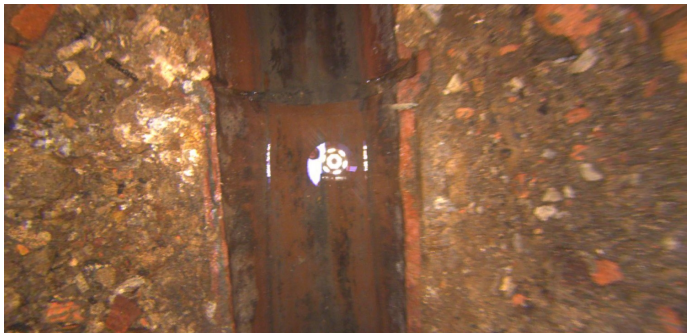
Code: **DSGV**  
Description: **Deposits Settled Gravel**

Distance (ft): **6.2**  
Structural Grade: **0**  
O&M Grade: **2**  
Clock Start/From: **12**  
Clock To: **12**  
1st Value:  
2nd Value:  
Value Percent: **5.000**  
Step: **NO**  
Remarks:

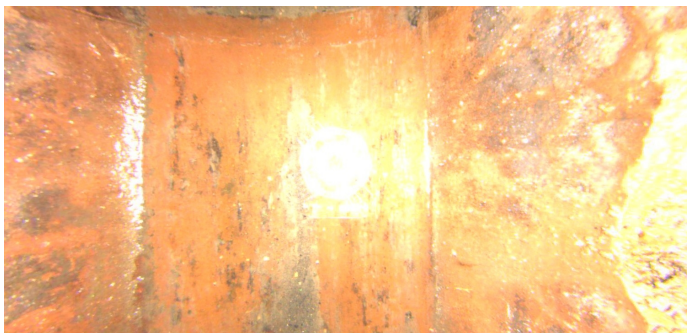
Code: **MGO**  
Description: **General Observation**

Distance (ft): **7.6**  
Structural Grade: **0**  
O&M Grade: **0**  
Clock Start/From:  
Clock To:  
1st Value:  
2nd Value:  
Value Percent:  
Step: **NO**  
Remarks: **END SURVEY**
