Manhole Inspection Report

Date:	04/29/2018	Weather:		Coding:	RZMACP
MH#:	M-605-028	Owner:	NA	Len. Surveyed:	6.2
P.O.#:		Surveyor:	Jen Costello	Rim to Invert:	6.7
Customer:		Cert. #:	U-907-5518	Wall Material:	Concrete (reinforced)

Street:	Ash St. 168' North of 2nd St.	Project:	Hobart, IN
City:	Hobart, IN	GPS Northing:	2903150.002
Location:		GPS Easting:	2903150.002
Drain Area:	West	GPS Accuracy:	Sub-Meter
Cover Shape:	Circular	Evidence of Surcharge:	No
Cover Size:	22.5	Potential for Runoff:	None
Comments:

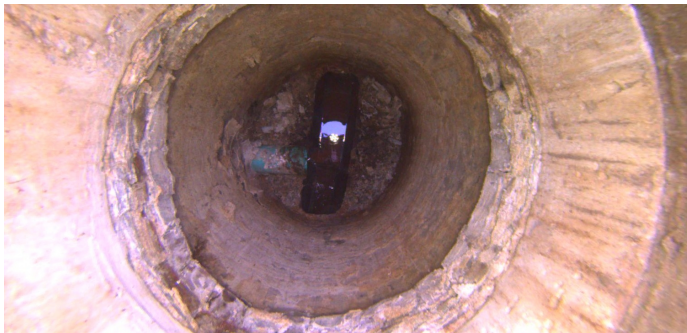
Code: **MGO**
Description: **General Observation**

Distance (ft): **.0**
Structural Grade: **0**
O&M Grade: **0**
Clock Start/From:
Clock To:
1st Value:
2nd Value:
Value Percent:
Step: **NO**
Remarks: **ACCESS MH**

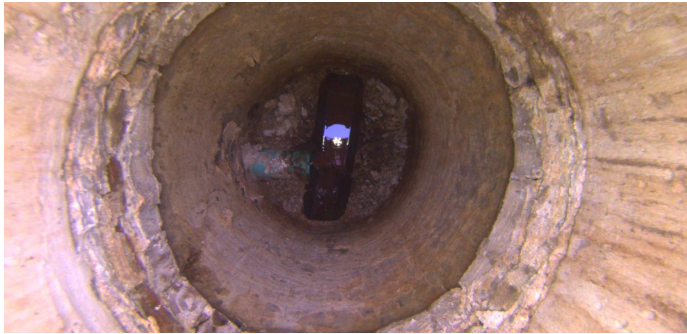
Code: **FM**
Description: **Fracture Multiple**

Distance (ft): **.3**
Structural Grade: **4**
O&M Grade: **0**
Clock Start/From: **12**
Clock To: **12**
1st Value:
2nd Value:
Value Percent:
Step: **NO**
Remarks:

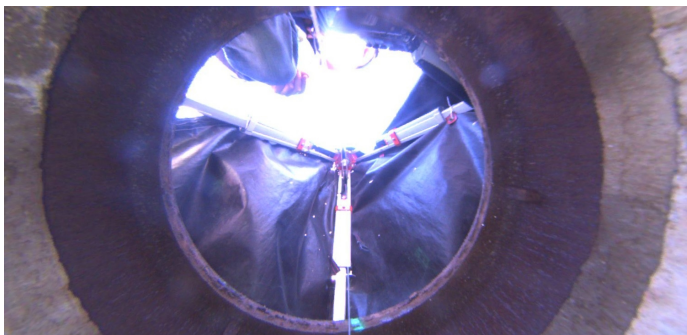
Code: **MGO**
Description: **General Observation**

Distance (ft): **1.6**
Structural Grade: **0**
O&M Grade: **0**
Clock Start/From:
Clock To:
1st Value:
2nd Value:
Value Percent:
Step: **NO**
Remarks: **UNDERSIDE OF FRAME**

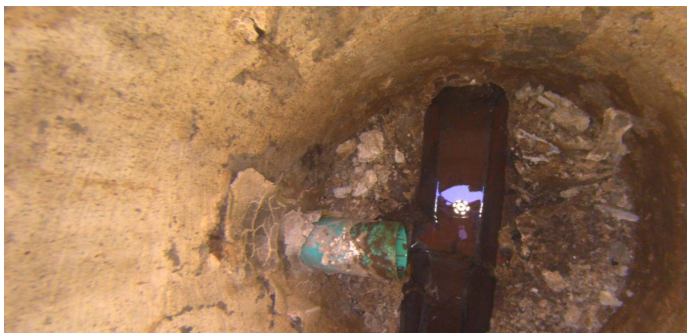
Code: **CM**
Description: **Crack Multiple**

Distance (ft): **2.6**
Structural Grade: **3**
O&M Grade: **0**
Clock Start/From: **7**
Clock To: **11**
1st Value:
2nd Value:
Value Percent:
Step: **NO**
Remarks:

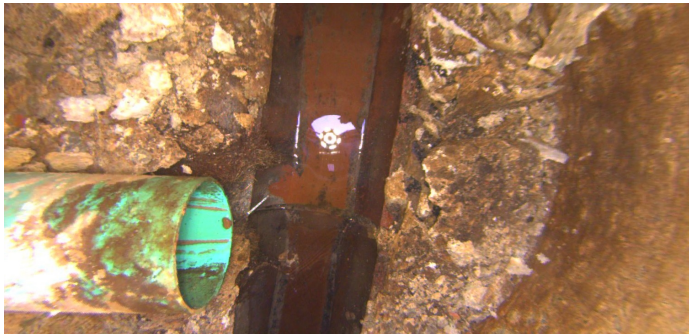
Code: **OBR**
Description: **Obstacle Rocks**

Distance (ft): **4.2**
Structural Grade: **0**
O&M Grade: **2**
Clock Start/From: **12**
Clock To: **12**
1st Value:
2nd Value:
Value Percent: **10.000**
Step: **NO**
Remarks:

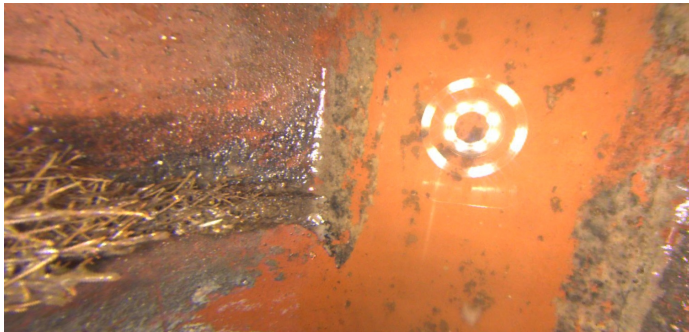
Code: **RFJ**
Description: **Roots Fine Joint**

Distance (ft): **6.2**
Structural Grade: **0**
O&M Grade: **1**
Clock Start/From: **7**
Clock To: **9**
1st Value:
2nd Value:
Value Percent:
Step: **NO**
Remarks:

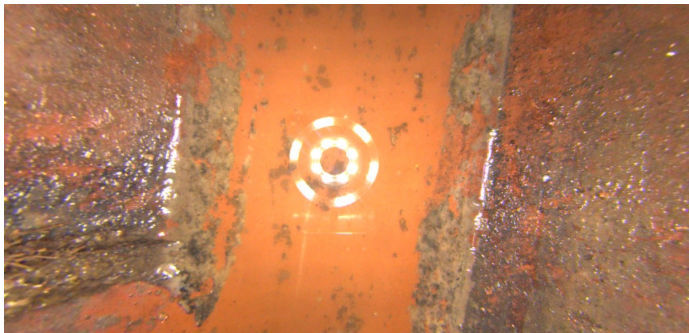
Code: **MGO**
Description: **General Observation**

Distance (ft): **6.2**
Structural Grade: **0**
O&M Grade: **0**
Clock Start/From:
Clock To:
1st Value:
2nd Value:
Value Percent:
Step: **NO**
Remarks: **END SURVEY**
