Manhole Inspection Report

| MH#: | M-605-030 | Owner: | NA | Len. Surveyed: | 7.5 |

| Street: | Connecticut St. 228' North of 3rd St. | Project: | Hobart, IN |

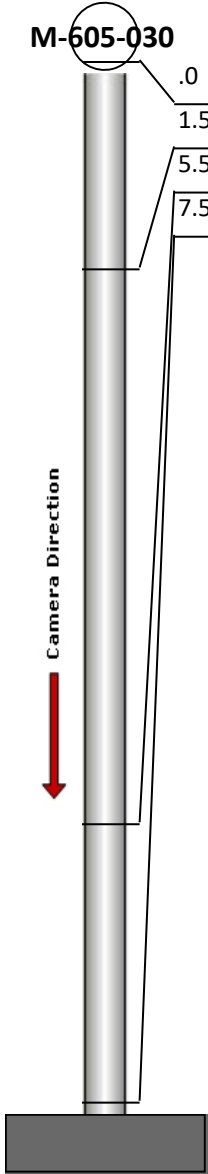
| | Position | Code | Observation | Video (sec) | Grade |
|--|---|---|---|---|---|
| | .0 | MGP | General Photo | 10 | NA |
| | 1.5 | MGO | General Observation | 26 | NA |
| | 5.5 | DSGV | Deposits Settled Gravel | 47 | M 2 |
| | 7.5 | MGO | General Observation | 63 | NA |

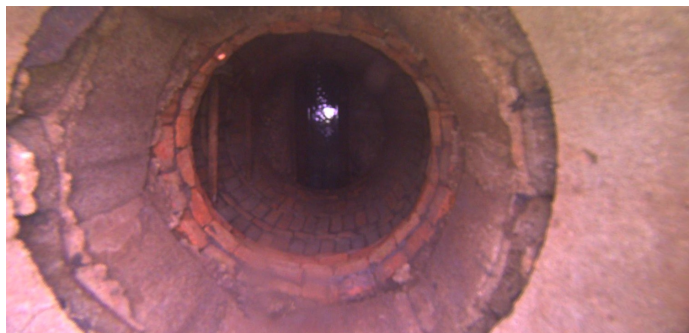
Code: **MGP**
Description: **General Photo**

Distance (ft): **.0**
Structural Grade: **0**
O&M Grade: **0**
Clock Start/From:
Clock To:
1st Value:
2nd Value:
Value Percent:
Step: **NO**
Remarks: **ACCESS MH**

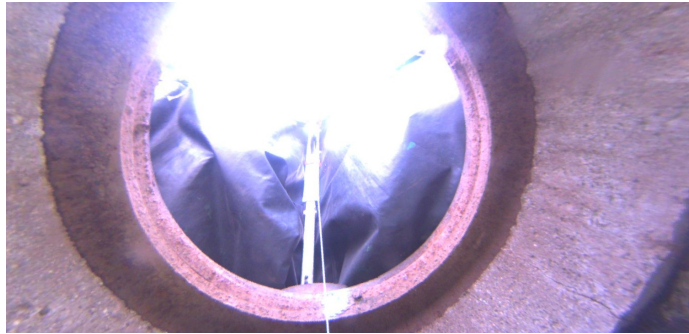
Code: **MGO**
Description: **General Observation**

Distance (ft): **1.5**
Structural Grade: **0**
O&M Grade: **0**
Clock Start/From:
Clock To:
1st Value:
2nd Value:
Value Percent:
Step: **NO**
Remarks: **UNDERSIDE OF FRAME**

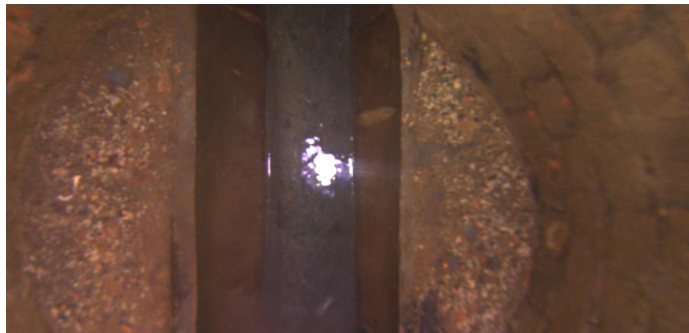
Code: **DSGV**
Description: **Deposits Settled Gravel**

Distance (ft): **5.5**
Structural Grade: **0**
O&M Grade: **2**
Clock Start/From: **12**
Clock To: **12**
1st Value:
2nd Value:
Value Percent: **5.000**
Step: **NO**
Remarks:

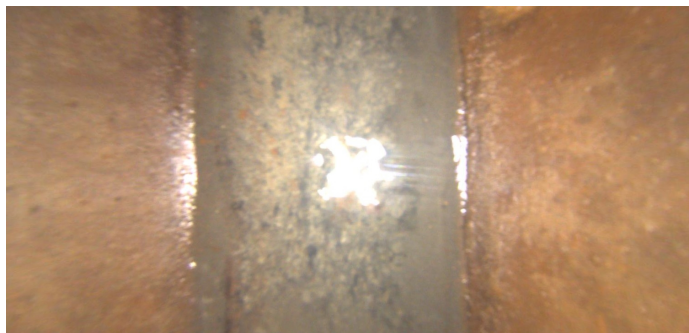
Code: **MGO**
Description: **General Observation**

Distance (ft): **7.5**
Structural Grade: **0**
O&M Grade: **0**
Clock Start/From:
Clock To:
1st Value:
2nd Value:
Value Percent:
Step: **NO**
Remarks: **END SURVEY**
