Manhole Inspection Report

Date:	05/01/2018	Weather:		Coding:	RZMACP
MH#:	M-605-065	Owner:	NA	Len. Surveyed:	5.7
P.O.#:		Surveyor:	Jen Costello	Rim to Invert:	6.5
Customer:		Cert. #:	U-907-5518	Wall Material:	Concrete (reinforced)

Street:	Beverly Ln. 115' South of Cleveland	Project:	Hobart, IN
City:	Hobart, IN	GPS Northing:	41.53596878
Location:		GPS Easting:	-87.26081085
Drain Area:	West	GPS Accuracy:	Nearest Meter
Cover Shape:	Circular	Evidence of Surcharge:	No
Cover Size:	22.5	Potential for Runoff:	None
Comments:

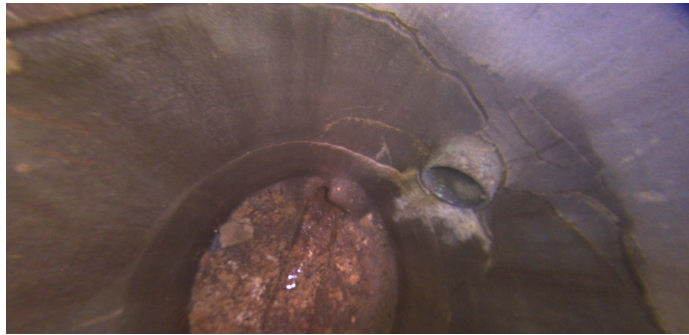
Code: **FM**
Description: **Fracture Multiple**

Distance (ft): **3.0**
Structural Grade: **4**
O&M Grade: **0**
Clock Start/From: **12**
Clock To: **3**
1st Value:
2nd Value:
Value Percent:
Step: **NO**
Remarks:

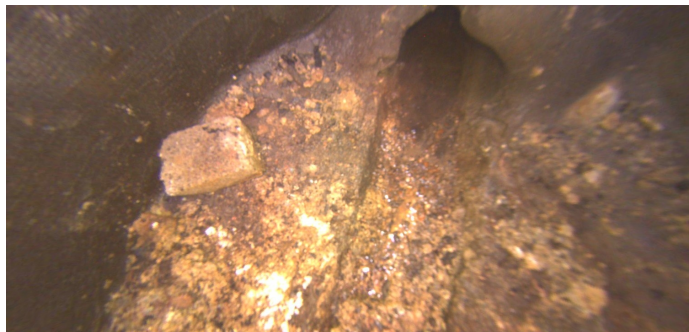
Code: **OBR**
Description: **Obstacle Rocks**

Distance (ft): **5.4**
Structural Grade: **0**
O&M Grade: **2**
Clock Start/From: **10**
Clock To:
1st Value:
2nd Value:
Value Percent: **5.000**
Step: **NO**
Remarks:

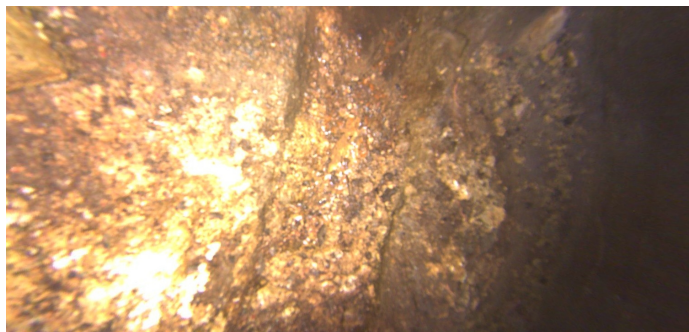
Code: **DSC**
Description: **Deposits Settled Compacted**

Distance (ft): **5.7**
Structural Grade: **0**
O&M Grade: **4**
Clock Start/From: **4**
Clock To: **8**
1st Value:
2nd Value:
Value Percent: **30.000**
Step: **NO**
Remarks:

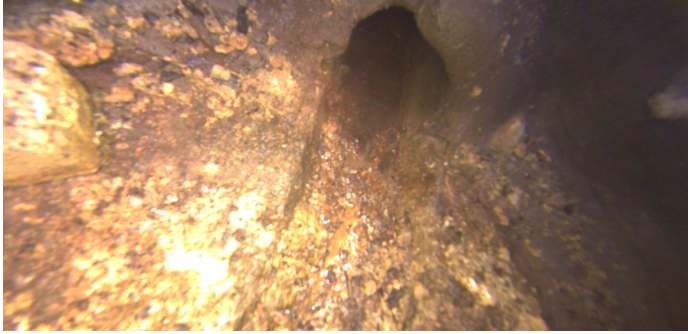
Code:	MGO
Description:	General Observation
Distance (ft):	5.7
Structural Grade:	0
O&M Grade:	0
Clock Start/From:	
Clock To:	
1st Value:	
2nd Value:	
Value Percent:	
Step:	NO
Remarks:	end survey
