# Manhole Inspection Report

Date:	<b>04/29/2018</b>	Weather:		Coding:	<b>RZMACP</b>
MH#:	<b>M-605-067</b>	Owner:	<b>NA</b>	Len. Surveyed:	<b>11.3</b>
P.O.#:		Surveyor:	<b>Jen Costello</b>	Rim to Invert:	<b>11.9</b>
Customer:		Cert. #:	<b>U-907-5518</b>	Wall Material:	<b>Concrete (reinforced)</b>

Street:	<b>Beverly Blvd. 238' South of Clevelan</b>	Project:	<b>Hobart, IN</b>
City:	<b>Hobart, IN</b>	GPS Northing:	<b>2903643.739</b>
Location:		GPS Easting:	<b>2903643.739</b>
Drain Area:	<b>West</b>	GPS Accuracy:	<b>Sub-Meter</b>
Cover Shape:	<b>Circular</b>	Evidence of Surcharge:	<b>No</b>
Cover Size:	<b>22.5</b>	Potential for Runoff:	<b>None</b>
Comments:

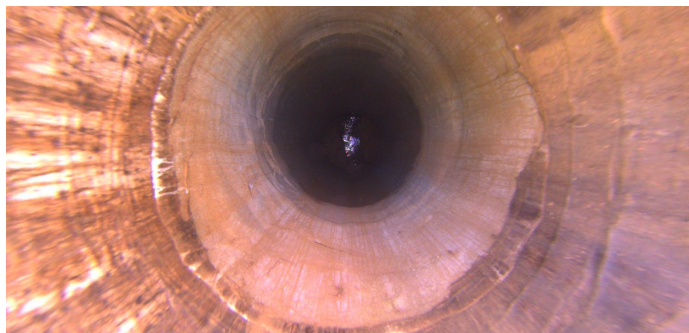
Code: **MGO**  
Description: **General Observation**

Distance (ft): **.0**  
Structural Grade: **0**  
O&M Grade: **0**  
Clock Start/From:  
Clock To:  
1st Value:  
2nd Value:  
Value Percent:  
Step: **NO**  
Remarks: **access MH**

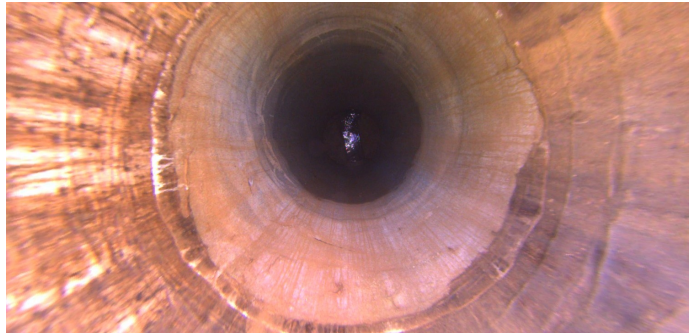
Code: **IS**  
Description: **Infil Stain**

Distance (ft): **.0**  
Structural Grade: **0**  
O&M Grade: **0**  
Clock Start/From: **8**  
Clock To: **12**  
1st Value:  
2nd Value:  
Value Percent:  
Step: **NO**  
Remarks:

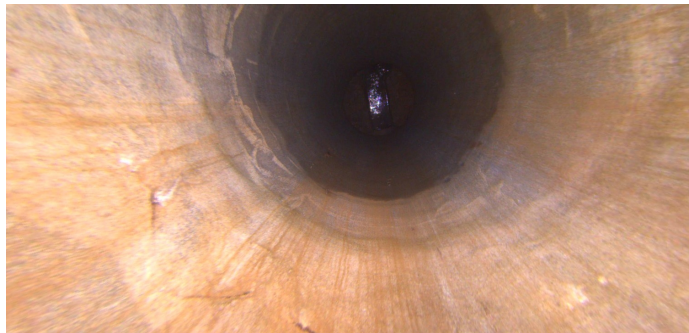
Code: **CM**  
Description: **Crack Multiple**

Distance (ft): **1.4**  
Structural Grade: **3**  
O&M Grade: **0**  
Clock Start/From: **6**  
Clock To: **9**  
1st Value:  
2nd Value:  
Value Percent:  
Step: **NO**  
Remarks:

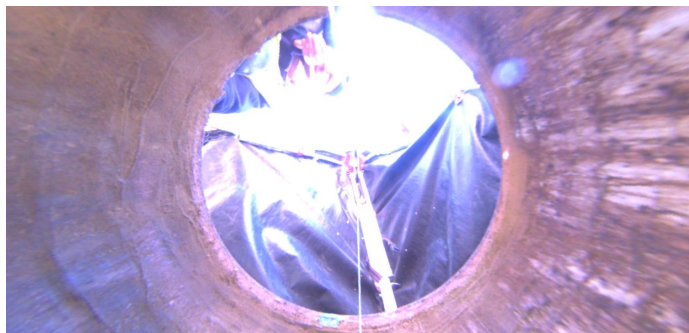
Code: **MGO**  
Description: **General Observation**

Distance (ft): **1.4**  
Structural Grade: **0**  
O&M Grade: **0**  
Clock Start/From:  
Clock To:  
1st Value:  
2nd Value:  
Value Percent:  
Step: **NO**  
Remarks: **UNDERSIDE OF FRAME**

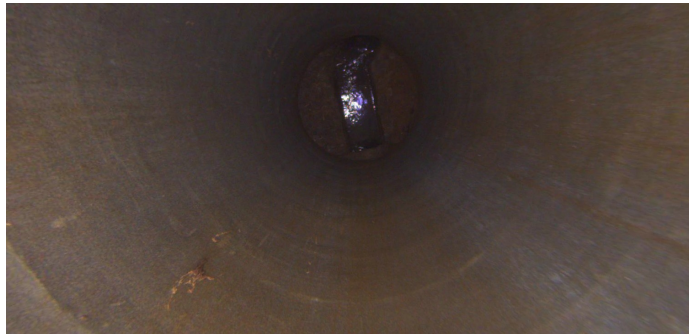
Code: **RFB**  
Description: **Roots Fine Barrel**

Distance (ft): **4.2**  
Structural Grade: **0**  
O&M Grade: **2**  
Clock Start/From: **7**  
Clock To:  
1st Value:  
2nd Value:  
Value Percent:  
Step: **NO**  
Remarks:

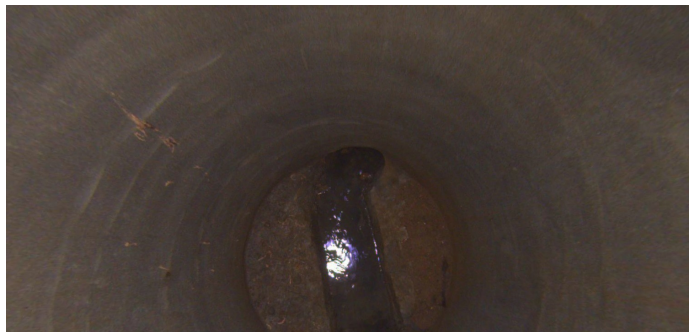
Code: **RFB**  
Description: **Roots Fine Barrel**

Distance (ft): **7.2**  
Structural Grade: **0**  
O&M Grade: **2**  
Clock Start/From: **10**  
Clock To:  
1st Value:  
2nd Value:  
Value Percent:  
Step: **NO**  
Remarks:

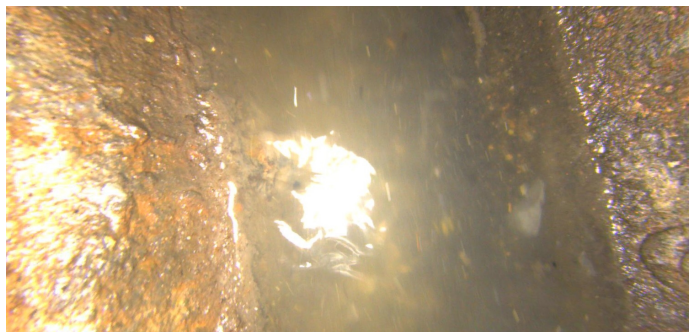
Code: **MGO**  
Description: **General Observation**

Distance (ft): **11.3**  
Structural Grade: **0**  
O&M Grade: **0**  
Clock Start/From:  
Clock To:  
1st Value:  
2nd Value:  
Value Percent:  
Step: **NO**  
Remarks: **END SURVEY**
