Manhole Inspection Report

Date:	09/25/2022	Weather:		Coding:	RZMACP
MH#:	M-606-005	Owner:	NA	Len. Surveyed:	10.8
P.O.#:		Surveyor:	Jen Costello	Rim to Invert:	12.3
Customer:		Cert. #:	U-907-5518	Wall Material:	Concrete (cast in place)

Street:	Lake Park Ave. 483' South of 8th St.	Project:	Hobart, IN
City:	Hobart, IN	GPS Northing:	2286003.401
Location:	Local Rural Streets	GPS Easting:	2904519.245
Drain Area:	Southeast	GPS Accuracy:	Sub-Meter
Cover Shape:	Circular	Evidence of Surcharge:	No
Cover Size:	24.0	Potential for Runoff:	None
Comments:

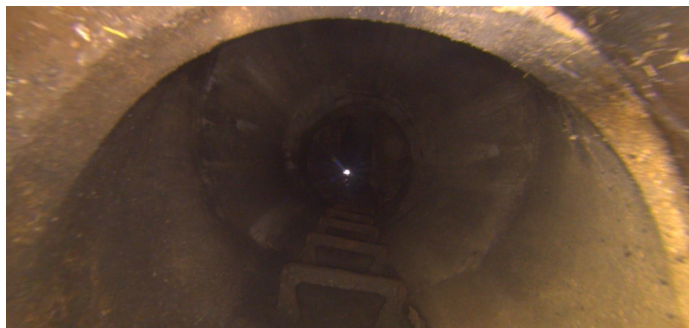
Code: **MGO**
Description: **General Observation**

Distance (ft): **.0**
Structural Grade: **0**
O&M Grade: **0**
Clock Start/From:
Clock To:
1st Value:
2nd Value:
Value Percent:
Step: **NO**
Remarks: **access mh**

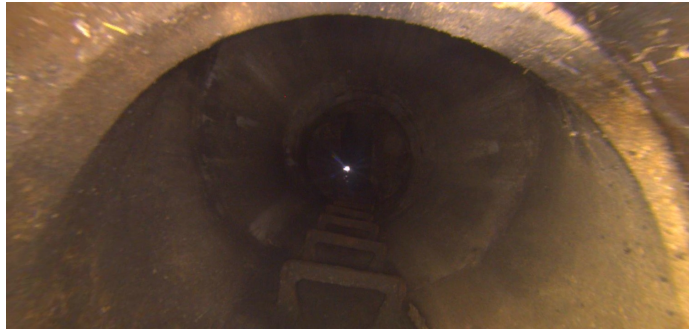
Code: **SAV**
Description: **Surface Aggregate Visible**

Distance (ft): **.0**
Structural Grade: **3**
O&M Grade: **0**
Clock Start/From: **12**
Clock To: **12**
1st Value:
2nd Value:
Value Percent:
Step: **NO**
Remarks:

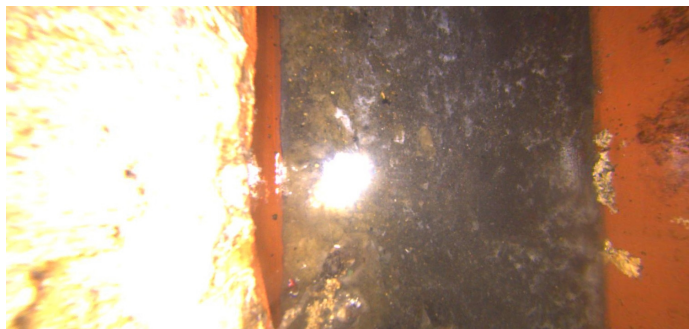
Code: **DSF**
Description: **Deposits Settled Fine**

Distance (ft): **10.8**
Structural Grade: **0**
O&M Grade: **2**
Clock Start/From: **12**
Clock To: **12**
1st Value:
2nd Value:
Value Percent: **5.000**
Step: **NO**
Remarks:

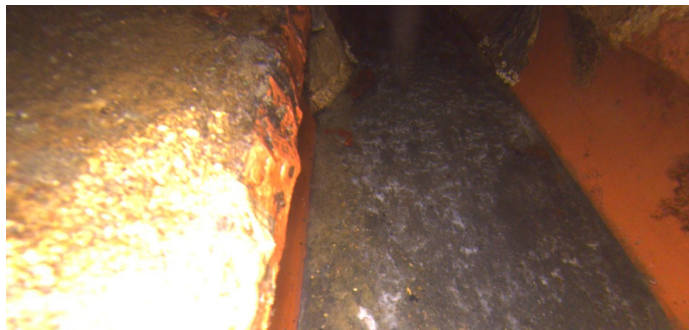
Code:	MGO
Description:	General Observation
Distance (ft):	10.8
Structural Grade:	0
O&M Grade:	0
Clock Start/From:	
Clock To:	
1st Value:	
2nd Value:	
Value Percent:	
Step:	NO
Remarks:	end of survey
