Manhole Inspection Report

O&M Index:	2.00	O&M Quick:	2500	O&M Rating:	10.00
Structural Index:	4.00	Structural Quick:	4100	Structural Rating:	4.00
Overall Index:	2.33	Overall Quick:	4125	Overall Rating:	14.00

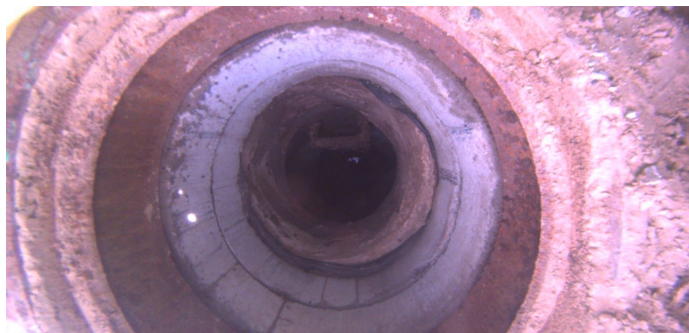
Code: **MGO**
Description: **General Observation**

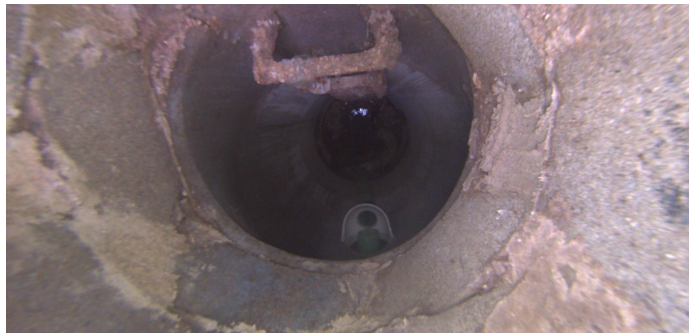
Code:	FM
Description:	Fracture Multiple
Distance (ft):	2.8
Structural Grade:	4
O&M Grade:	0
Clock Start/From:	12
Clock To:	12
1st Value:	
2nd Value:	
Value Percent:	
Step:	NO
Remarks:

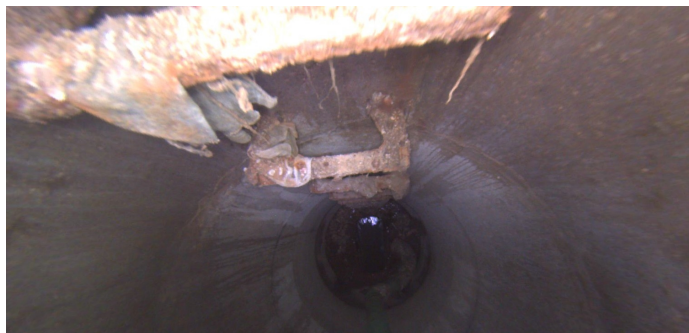
Code:	DAR
Description:	Deposits Attached Ragging
Distance (ft):	4.8
Structural Grade:	0
O&M Grade:	2
Clock Start/From:	11
Clock To:	
1st Value:	
2nd Value:	
Value Percent:	5.000
Step:	YES
Remarks:
